This attachment contains FCA US’ response to the IR issued in Investigation PE19-017, as clarified via email with Ryan Rahimpour of the National Highway Traffic Safety Administration’s (“NHTSA”) Office of Defects Investigation (“ODI”) on January 6, 2020, January 24, 2020 and January 28, 2020.

Mr. Bruce York
Reference: NEF-106 RR; PE19-017
February 28, 2020

ATTACHMENT

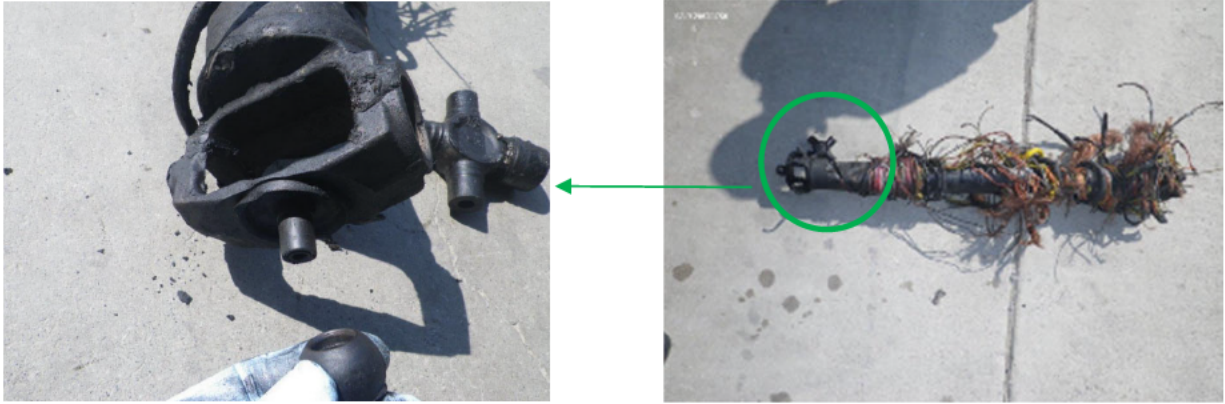
driveshaft, running the risk that the wiring might come in contact with, and become wrapped around, the spinning driveshaft while the Subject Vehicle is in motion. This can lead to driveshaft failure. Several examples are below.

The above images were taken of the same driveshaft from the same Subject Vehicle. The left image does not show evidence of damage to the centering mechanism, which indicates that the double Cardan joint was not lacking grease. The right image shows wiring wrapped around the driveshaft and was likely the cause of the failure.

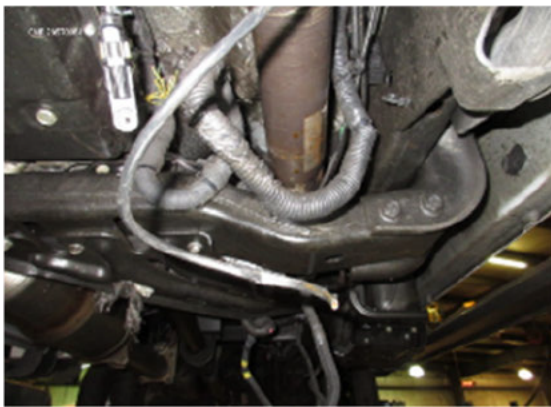
The image above also illustrates aftermarket wiring looped around the driveshaft.

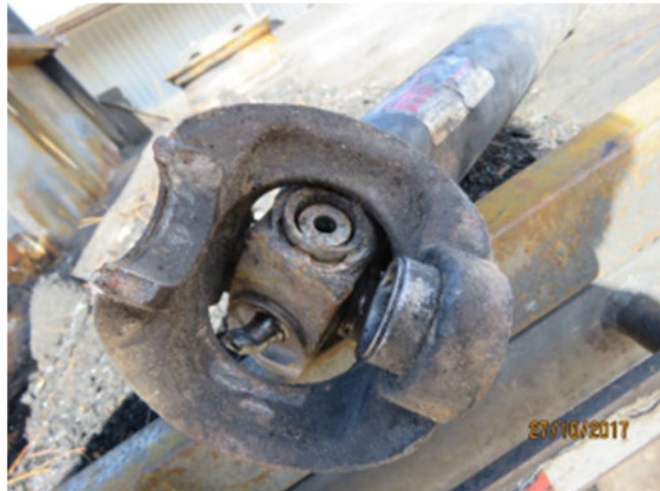
A review of the records identified in response to this IR indicates that the Alleged Defect in the front driveshaft is caused by improper maintenance and, more specifically, a failure to inspect and lubricate the driveshaft in the intervals described above. Due to lack of inspection and maintenance, the grease within the double Cardan centering mechanism becomes compromised, resulting in wear to the needle bearings, ball stud, centering ball, ball seat, and seals. Heat generation from breakdown of the grease within the centering mechanism eventually will anneal the ball stud and needle bearings, causing them to begin to wear away. Continued heat buildup can cause the ball stud to become malleable. Wear of the ball stud, needle bearings, and between the centering ball and ball seat creates clearance, resulting in unbalanced movement. This unbalanced movement results in severe forces reacting within the transfer case that can also lead to noise and vibration. If ignored, this eventually can lead to catastrophic failure of the transfer case, followed by separation of the driveshaft. Evidence of this failure mode is found in the deformed shape of the centering mechanism/ball stud as a result of overarticulating the double Cardan joint prior to fracture (as seen in the two photos below). If separated from the transfer case, the front driveshaft will continue to spin, potentially impacting and causing damage to other components in proximity.

The images above are examples of a double Cardan joint that has failed due to insufficient lubrication.
