Thomas McCarthy
Head, Vehicle Safety Compliance and
Product Analysis

Reference: NEF-106rr; PE19-017

This attachment contains FCA US’ response to the IR issued in Investigation PE19-017, as clarified via email with Ryan Rahimpour of the National Highway Traffic Safety Administration’s (“NHTSA”) Office of Defects Investigation (“ODI”) on January 6, 2020, January 24, 2020 and January 28, 2020.

ATTACHMENT

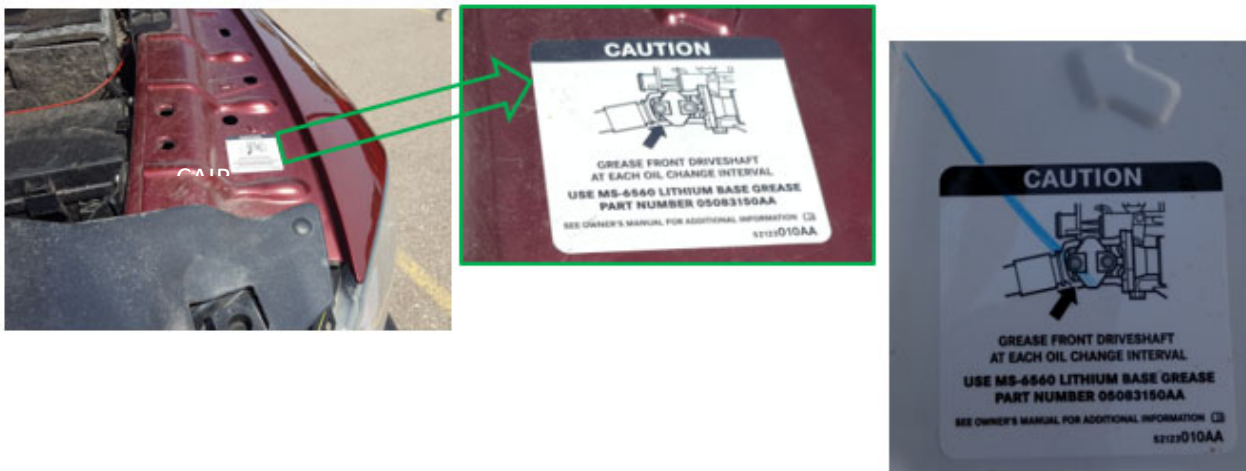
- To reinforce the need to lubricate the front driveshaft at every oil change, every Subject Vehicle also contains an under hood label to remind owners and technicians alike of this important maintenance requirement. Examples of this are shown below.

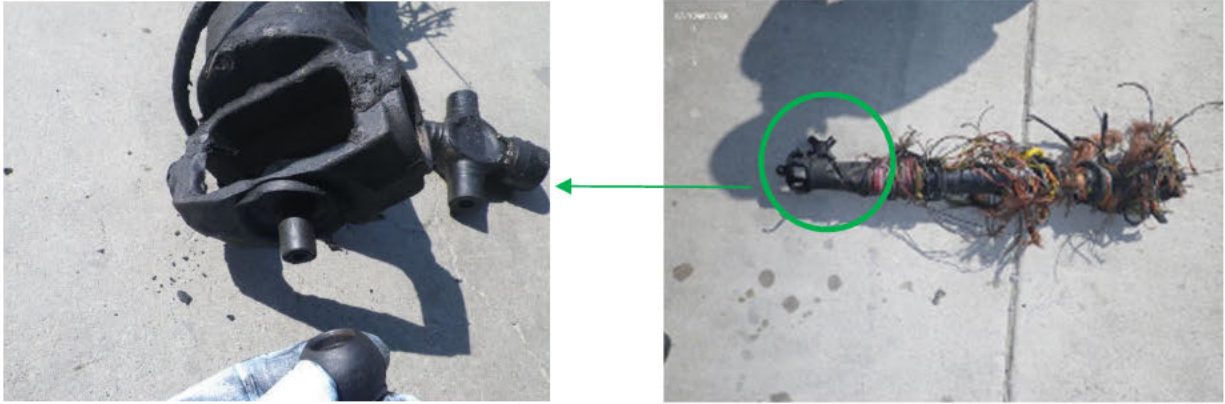
driveshaft, running the risk that the wiring might come in contact with, and become wrapped around, the spinning driveshaft while the Subject Vehicle is in motion. This can lead to driveshaft failure. Several examples are below.

The above images were taken of the same driveshaft from the same Subject Vehicle. The left image does not show evidence of damage to the centering mechanism, which indicates that the double Cardan joint was not lacking grease. The right image shows wiring wrapped around the driveshaft and was likely the cause of the failure.

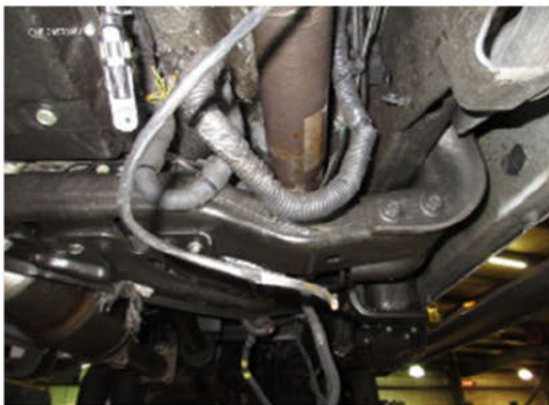
The image above also illustrates aftermarket wiring looped around the driveshaft.

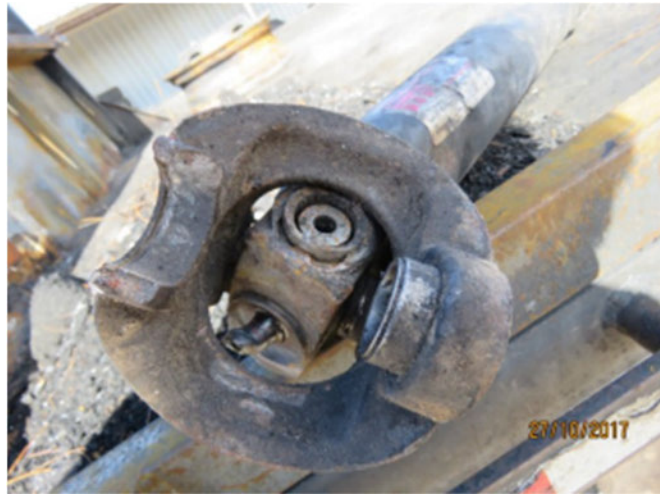
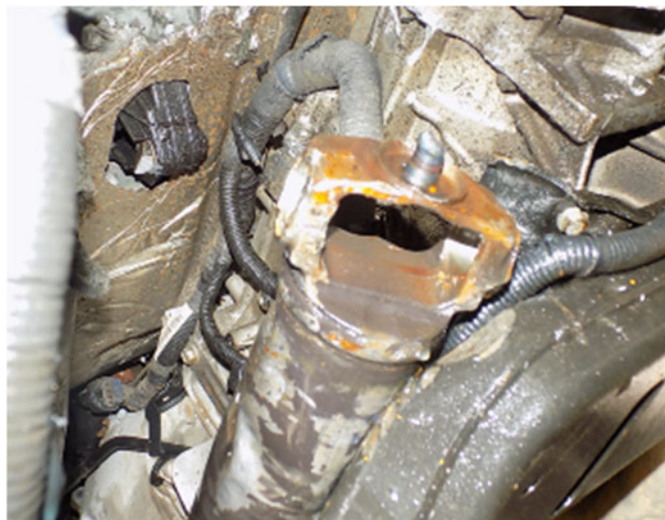
A review of the records identified in response to this IR indicates that the Alleged Defect in the front driveshaft is caused by improper maintenance and, more specifically, a failure to inspect and lubricate the driveshaft in the intervals described above. Due to lack of inspection and maintenance, the grease within the double Cardan centering mechanism becomes compromised, resulting in wear to the needle bearings, ball stud, centering ball, ball seat, and seals. Heat generation from breakdown of the grease within the centering mechanism eventually will anneal the ball stud and needle bearings, causing them to begin to wear away. Continued heat buildup can cause the ball stud to become malleable. Wear of the ball stud, needle bearings, and between the centering ball and ball seat creates clearance, resulting in unbalanced movement. This unbalanced movement results in severe forces reacting within the transfer case that can also lead to noise and vibration. If ignored, this eventually can lead to catastrophic failure of the transfer case, followed by separation of the driveshaft. Evidence of this failure mode is found in the deformed shape of the centering mechanism/ball stud as a result of overarticulating the double Cardan joint prior to fracture (as seen in the two photos below). If separated from the transfer case, the front driveshaft will continue to spin, potentially impacting and causing damage to other components in proximity.

The images above are examples of a double Cardan joint that has failed due to insufficient lubrication.

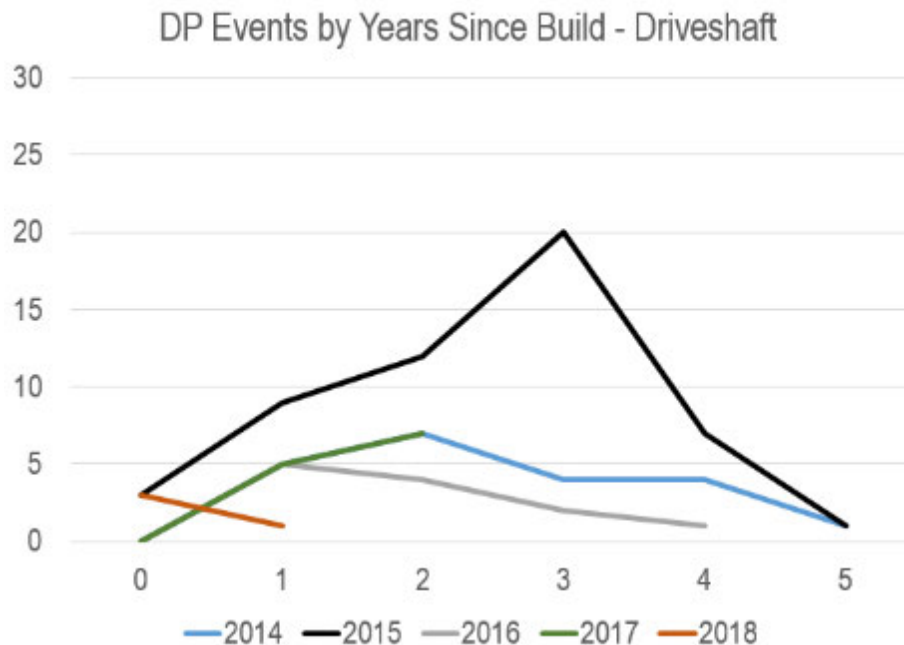
Third, FCA US' records reflect failures only for 2014-2018MY Subject Vehicles. Data of unique driveshaft events stratified by years since build reflects a predominance of driveshaft issues related to 2015MY Subject Vehicles, increasing to a peak at three years, but reducing to low levels consistent with the remaining Subject Vehicle population by the fifth year in service.
