ODI RESUME

Investigation: DP 20-001
Prompted by: Defect Petition
Date Opened: 01/13/2020
Investigator: Ajit Alkondon
Approver: Stephen Ridella
Subject: Sudden Unintended Acceleration

Manufacturer: Tesla, Inc.
Products: MY2012-2020 Tesla Model S, Model X, Model 3 and Model Y
Population: 662,109

Denial of Motor Vehicle Defect Petition

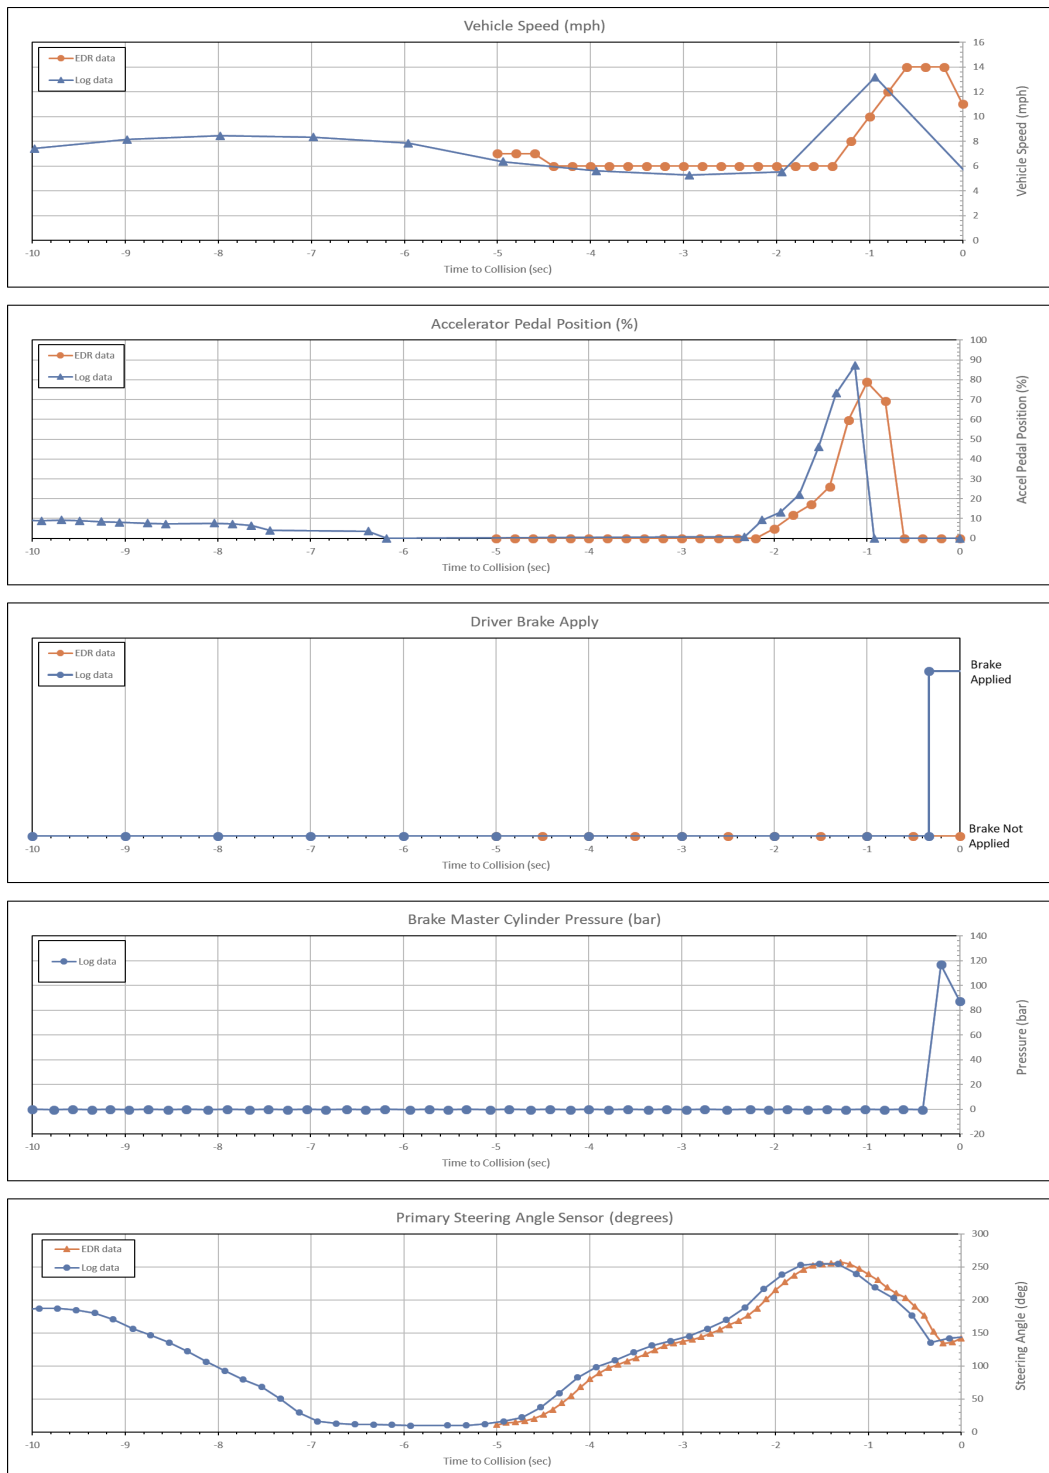
ODI's review of the vehicle log data shows that, approximately seven seconds before the crash, the vehicle is completing a right turn as the steering angle returns from a large positive value to neutral. Over the next second, the driver releases the accelerator pedal and the vehicle begins a moderate deceleration under regenerative braking. The vehicle begins to turn right toward the owner's driveway approximately five seconds before impact. Approximately two seconds before impact, as the vehicle nears the apex of the turn into the driveway, the accelerator pedal position begins to increase. The accelerator pedal increases from 0% to 88% in about one

Figure 1. Pre-crash operator control data, from top-to-bottom: vehicle speed, accelerator pedal position, brake pedal application, brake master cylinder pressure, and steering angle.

second. The accelerator pedal returns to 0% approximately 0.9 seconds before impact and the brake pedal is applied approximately 0.5 seconds later. The late brake application initiates ABS braking approximately 0.2 seconds before impact.

- The evidence shows that the brake light switch functioned as designed in the event analyzed by Dr. Belt (see Figure 1).
- The ESC and Traction Control systems cannot request positive torque in the subject vehicles.

- The vehicle does not veer to the left at any point during the crash event (see Figure 1 and section 3.3.4 ODI Analysis of Event Video File).
