DP20-001

Petitioner email attachment 6-22-2020 - Fifth Addendum to Motor Vehicle Defect Petition

**Fifth Addendum to Motor Vehicle Defect Petition:
Petition to Recall Tesla Vehicles Due To SUA**

June 22, 2020

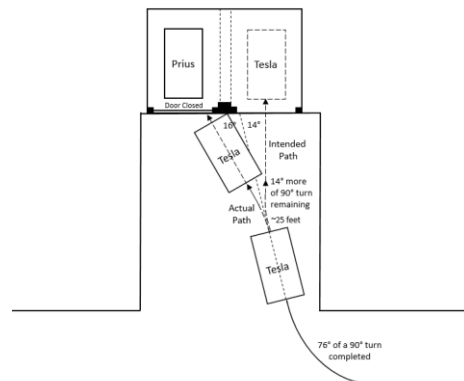
Fig 2. Vehicle path for the incident as inferred from the EDR data

Figure 2 shows the vehicle path during the incident. The street and driveway were both flat and on the same horizontal level. Figure 3 shows the EDR data for the pre-crash values of the accelerator pedal (%), rear motor speed (RPM), and vehicle speed (MPH). The accelerator pedal data shows that a value of 80% was reached one second prior to the crash. The vehicle speed data shows that the speed changed from 6 MPH before the crash to 14 MPH at the time of the crash. These alone might suggest that the driver pressed on the accelerator pedal to cause the crash. However, the pre-crash accelerometer data tell a different story.

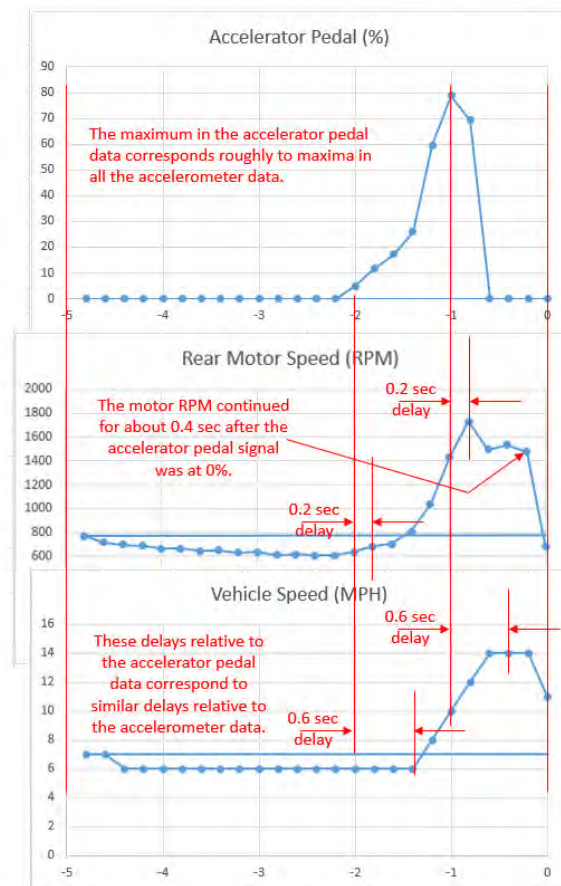
Figure 3. EDR data showing pre-crash values of accelerator pedal (%), rear motor speed (RPM), and vehicle speed (MPH)

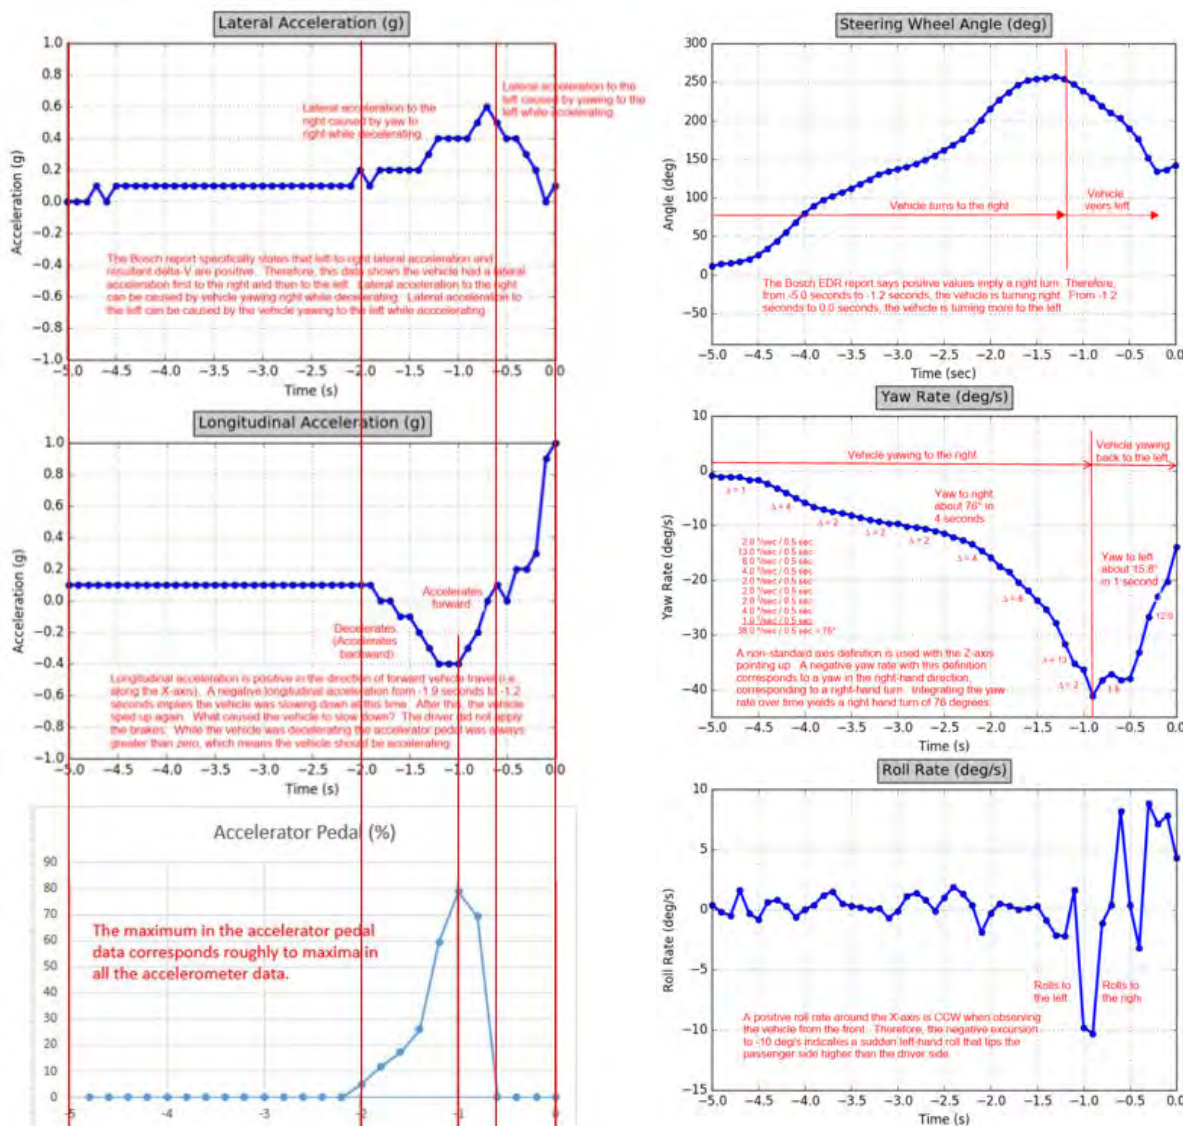
Figure 4 shows the pre-crash accelerometer data. The longitudinal accelerometer data show that the vehicle had a rapid deceleration of **-5 g's from +1 g to -4 g** one second before the crash. Since the Model 3's regeneration is limited to **-2 g's (increased to -3 g's by software update 2018.42 v9 on October 25, 2018)**, this higher -5 g deceleration could not have been caused by **the vehicle's regen system. Instead, it can only have been caused by the vehicle's braking system.** This conclusion is supported by the high resolution log data described by Tesla which shows that the brakes were applied even though the EDR data says they were not (Fig 5). Therefore, the driver was pressing on the brake pedal at the time the drive motor revved up, exactly as she described.

Figure 4. Pre-crash accelerometer data. An ISO 8855 coordinate system is used in which the longitudinal x-axis points forward, the y-axis points to the driver's left, and the z-axis points up. The steering wheel angle is positive when turned to the right.

The longitudinal acceleration data in Figure 4 also shows no evidence that regen is occurring as the vehicle is turning into the driveway before the drive motor revs up. This observation is supported by the vehicle speed data of Figure 3, which shows that the vehicle speed remains constant at 6 MPH before the drive motor revs up. Yet, the driver maintains that the vehicle was in the HOLD mode with STANDARD regen throughout the incident. If the driver is correct, then why isn't regen apparent in the data of these two sensors?

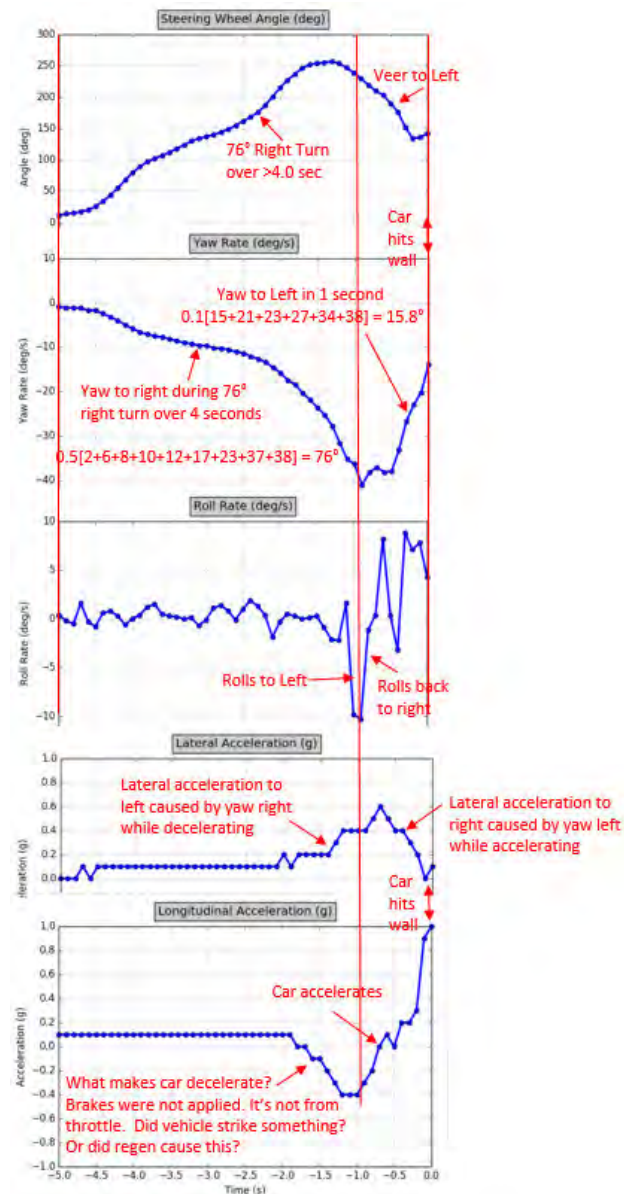
More inconsistencies become apparent if we compare the accelerometer data while aligned in time, as shown in Figure 6. Both the steering wheel data and the yaw rate data agree with each other and show that the vehicle was turning to the right into the driveway. At about 76° into the 90° turn, as the drive motor revs up to cause the vehicle to accelerator forward, both the steering wheel data and the yaw rate data change direction, indicating a veer to the left. The acceleration in the forward direction appears to be causing the veer to the left. This change of direction in the yaw data **reconciles the difference between the driver's testimony and the EDR data and Tesla's letter** as shown in table of Figure 5.

A closer look at the steering wheel angle data and the yaw rate data reveals that the yaw rate is still increasing while the steering wheel angle is leveling off or even decreasing. This suggests that front wheel slip is occurring to cause an oversteer condition, which could activate the

Figure 6. Accelerometer plots aligned in time show that the peaks roughly align at -1.0 seconds

vehicle's stability control system. The normal response of a vehicle stability control system to an oversteer condition is to brake the outside front wheel to cause a yaw moment in the direction opposite to the oversteer direction. In this case, during an oversteer to the right, the left front wheel would be braked, causing the vehicle to yaw to the left. This is exactly what is observed. This appears to **explain the driver's testimony that the vehicle "turned to the left" to cause damage to the right front corner of her vehicle.**

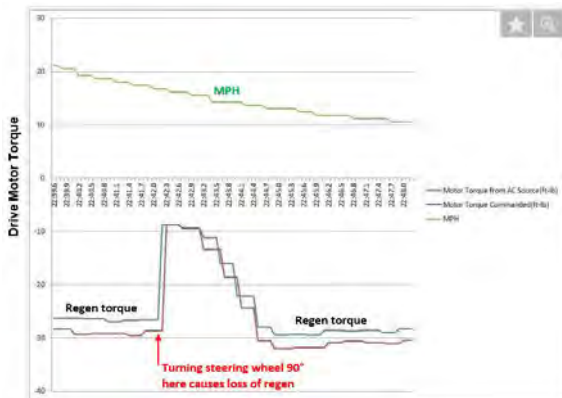
Figure 28. When the steering wheel is turned 90°, regen is lost and a forward surge is felt.⁴⁴

From these two discussions we see that all Tesla vehicles, as well as Ford Fusion hybrid vehicles, can experience a loss of regen while cornering. This loss of regen is caused by the ABS system turning off regen when the wheels on one side of the vehicle have a speed that differs from the wheels on the other side of the vehicle, which happens during cornering.. It is not the result of a design decision made by Tesla, but of the algorithms in the ABS modulator that were designed **by Tesla's brake supplier, Bosch. And Bosch designers had no choice but to turn off regen when their algorithms activate, because their algorithms must have control over all the braking forces on the vehicle while the algorithms are active. And, having no control over the regen magnitude, they must shut off regen while their algorithms are active.** This is true for all electric vehicles with regen, and not just Tesla for vehicles.

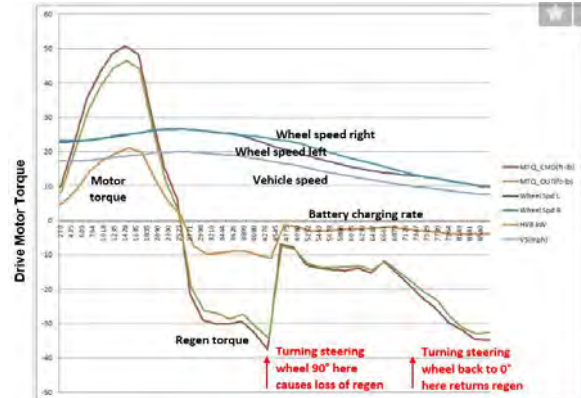
Figure 29. When the steering wheel is turned 90°, the wheel speeds change and regen is lost, causing a forward surge.⁴⁴

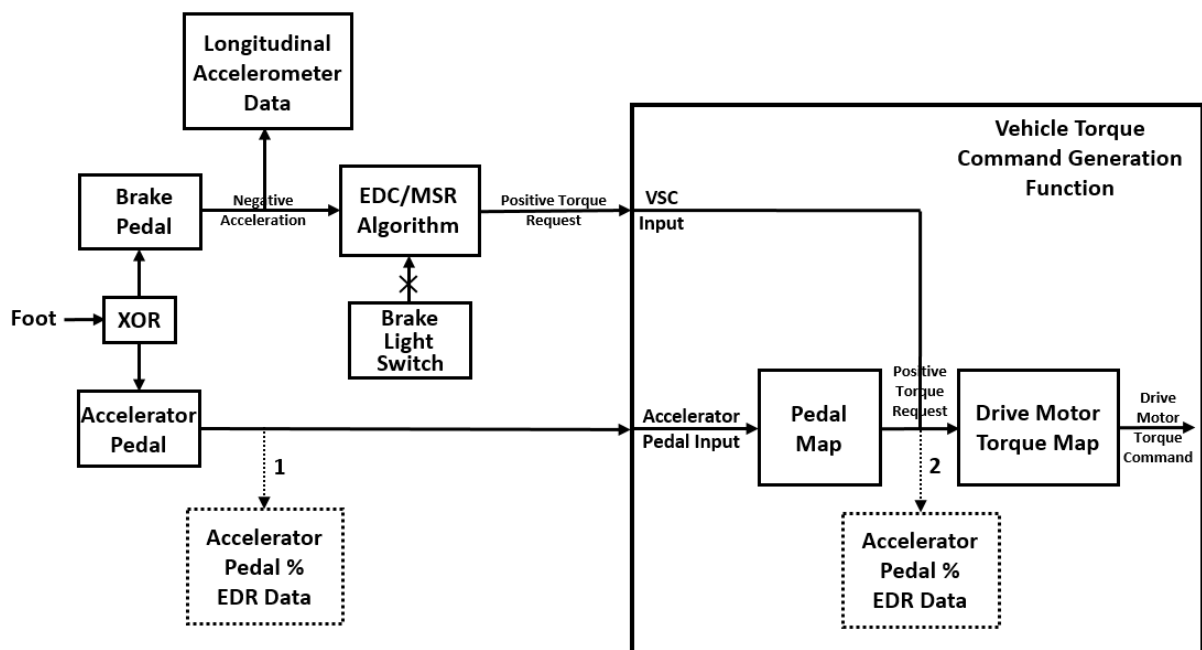
Answer: The vehicle steered to the left because the increase in vehicle speed during a right hand turn created an oversteer situation to the right that caused the electronic stability control (ESC) function in the ESP hev II module to activate. The function responded by braking the outside front wheel to produce a counter-torque to reduce the oversteer to the right. Since the outer front wheel in this case is the left front wheel, braking it caused the vehicle to turn to the left as the motor speed increased.

To answer **this question**, let's first clarify what was happening in greater detail. Figure 30 shows the sequence of events involved in this incident. **The driver's foot could either be on the brake pedal or the accelerator pedal, and not on both at the same time.** This explains the exclusive-OR (XOR) function in Figure 30. Pressing on the brake pedal produced a negative acceleration of 0.5 g's which was recorded by the longitudinal accelerometer. The EDC/MSR algorithm in the brake modulator also detected this negative acceleration, and after checking the defective brake light switch, it interpreted the negative acceleration as a drive motor drag torque. Therefore, it issued a request to the drive motor for a positive motor torque to offset the negative drag torque. This request went via a CAN bus to the VSC input of the Vehicle Torque Command Generation Function in the drive motor control system (Figure 16), where it became a positive torque request to the drive motor torque map.

Figure 30. Sequence of events involved in this incident

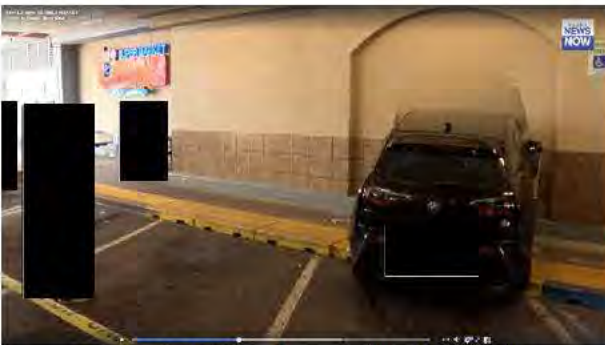
Figures 31 and 32 show a BMW i3 that has run into a wall.⁴⁷ This incident took place in the Kiamuki Shopping Center in an inner suburb of Honolulu on August 11, 2019. Although no driver's testimony is provided about the incident, it is clear from the photos what happened. The driver was trying to park in a perpendicular parking space in preparation for shopping in the Times supermarket. The parking space was near the entrance of the supermarket. As the driver was pulling into the parking space after making a 90° turn, the vehicle's drive motor revved up. The BMW i3 has a single rear drive motor just like many Tesla's. This incident is exactly like the 70 Tesla sudden acceleration incidents of Category A in Section 9, for which our explanation is valid.

Figure 31. BMW i3 after suddenly accelerating while pulling into a perpendicular parking space.⁴⁷

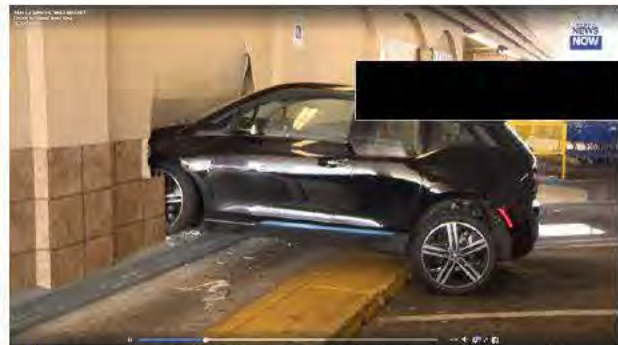
Figure 32. Side view showing damage to the wall behind the parking space. Store entrance is in the background.⁴⁷
