2020-09-10 Petitioner email  
attachment - Sixth Addendum  
to Motor Vehicle Defect  
Petition

**Sixth Addendum to Motor Vehicle Defect Petition:  
Petition to Recall Tesla Vehicles Due To SUA**

September 10, 2020

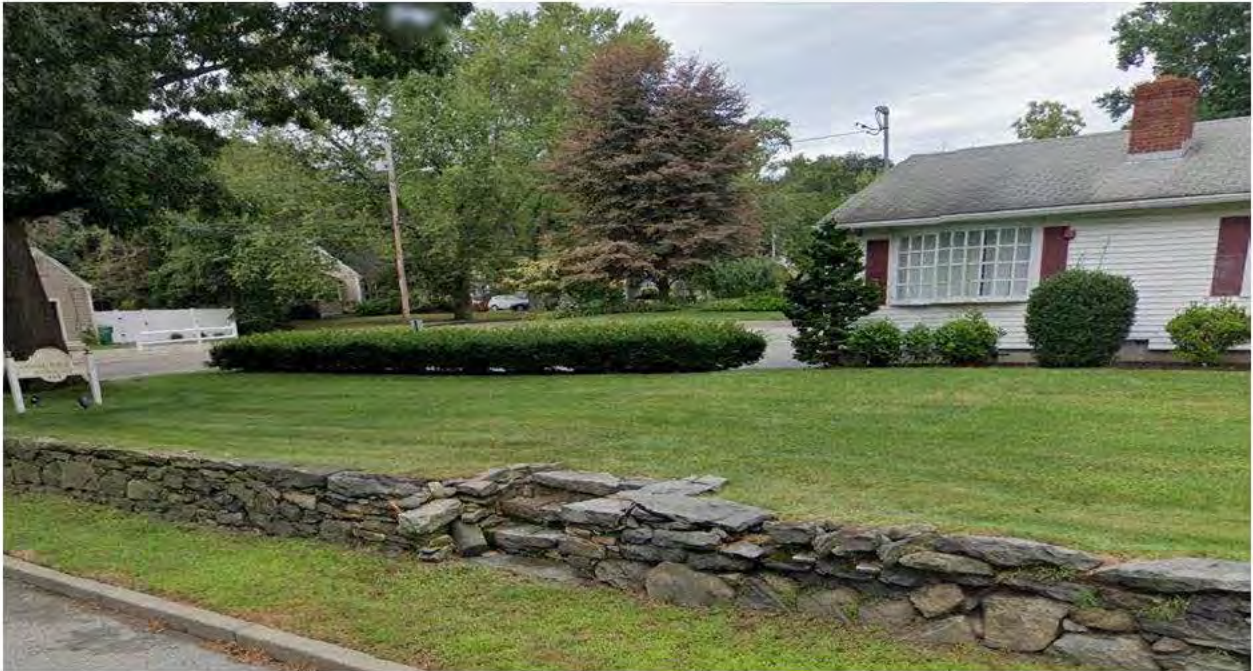
*I drove my car into the parking lot of 4519 Post Road (facing post road) and turned into the doctor's parking spot. The car had just about stopped and my foot was not yet off the brake when I suddenly felt the car accelerating.*

*It went right through the hedge in front (about 1 foot away)*

*Then went through the office marquee, over the stone wall and on to the street. My foot on the brake, I was trying frantically to stop.*

The above photo shows the doctor's office in question, including the hedge referenced by the complainant, and the marquee destroyed during the SUA incident.

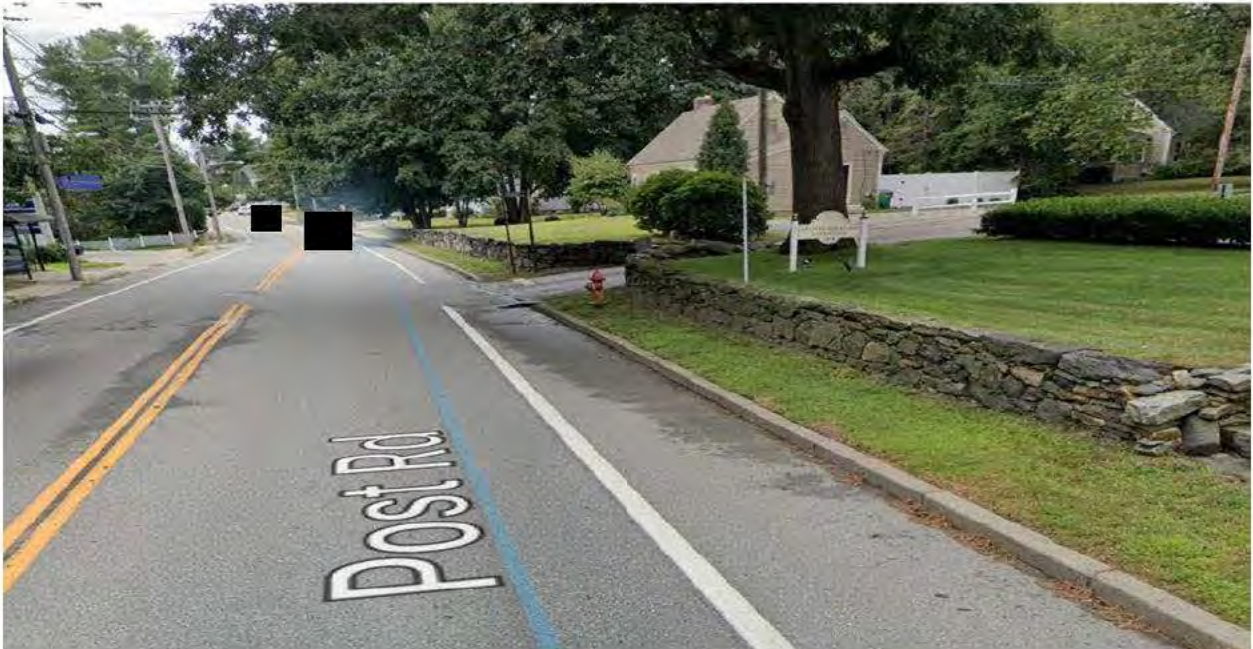
*The car stopped. Relieved, I thought I should quickly get out of the car. To my horror, it started accelerating again. In the next few seconds, it felt as though I was in a James Bond movie car chase.*

The above photo includes the hedge, marquee, and stone wall. The Tesla owner was initially able to stop the vehicle on the street but was unable to exit before the car resumed its acceleration toward the house pictured below where it hit a tree, according to the complaint.

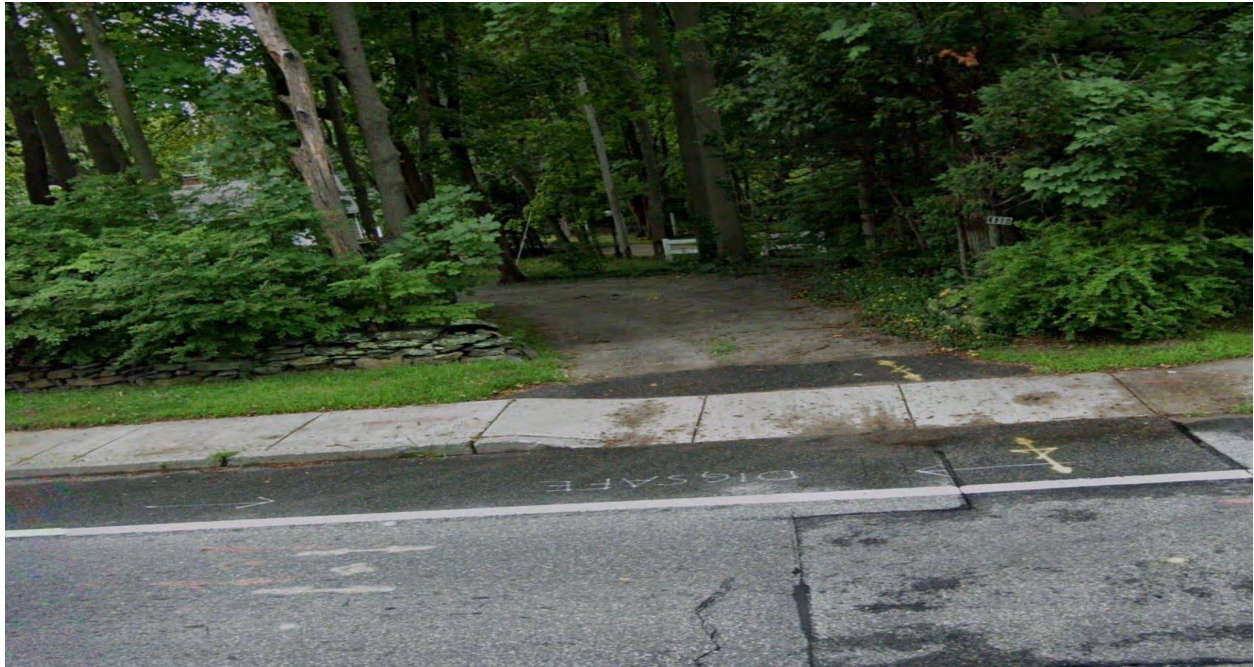
*The next thing I knew my car was tearing through the white fence of a house and then I remember trying to get out of the car. Which fortunately I was able to by opening the*

*driver-side door. Didn't know hit a tree inside breaking it into two. Found out later the yard was 4-6 feet below the street.*
