Recall Bulletin

PRODUCT SAFETY RECALL

SUBJECT: Safety Belt Lap Anchor Tensioner Cable

MODELS: 2011-2012 Chevrolet Malibu

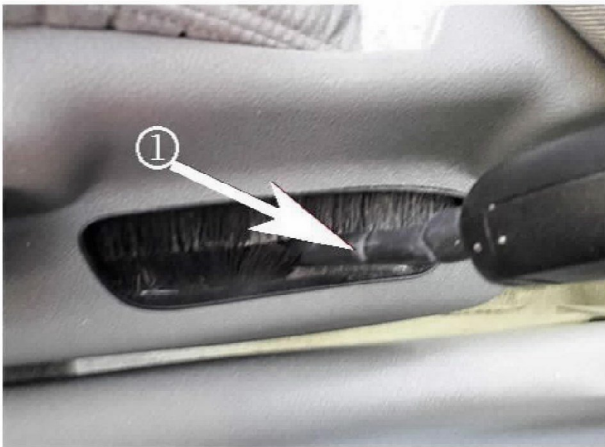
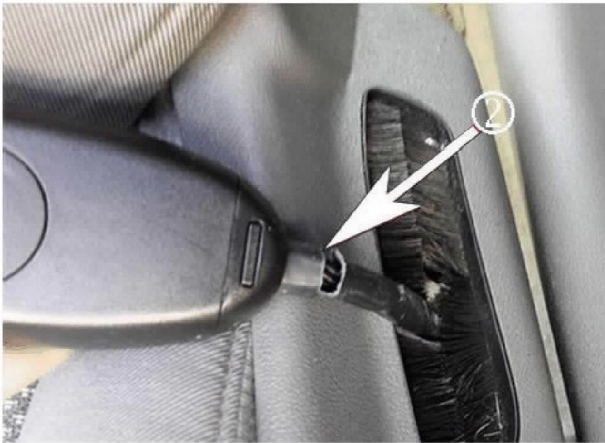
2. Inspect the safety belt shrink sleeve for any cuts or cracks. Bend the seat belt cable toward the inside (1) and outside (2) of the vehicle and carefully inspect for any cuts or cracks in the shrink sleeve.

3. If a sleeve is cut or cracked on the cable (1) or where the cable meets the buckle (2), replace the front seat belt anchor plate tensioner in step #10.
4. Remove the front seat belt anchor plate tensioner. Refer to *Front Seat Belt Anchor Plate Tensioner Replacement* in SI. If the shrink sleeve does not show any damage, it is not necessary to disconnect the anchor plate from the belt.

10. Reinstall the seat belt anchor plate tensioner. If the shrink sleeve was found to be damaged in step #2 above, replace the affected front seat belt anchor plate tensioner. Refer to *Front Seat Belt Anchor Plate Tensioner Replacement* in SI.
