Special Coverage Adjustment

N192289390 Seat Belt Anchor Pretensioner Cable

Release Date: June 2020

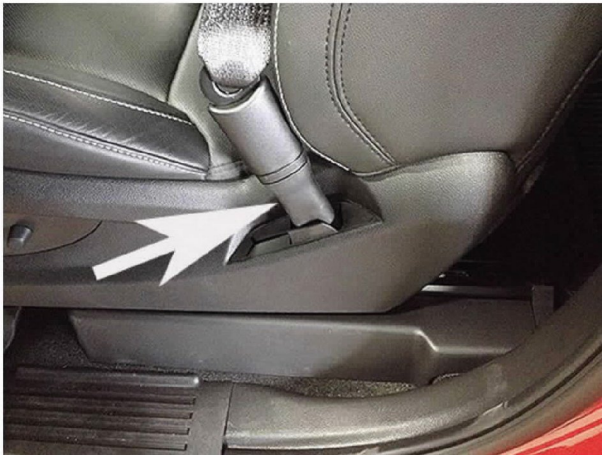
4522278

1. Move the driver seat to the full forward and full down position.

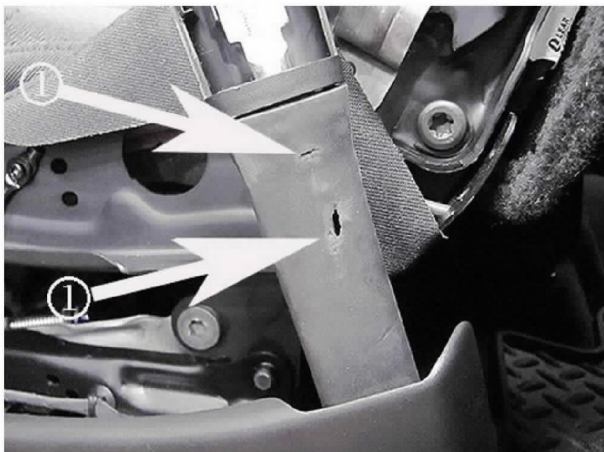
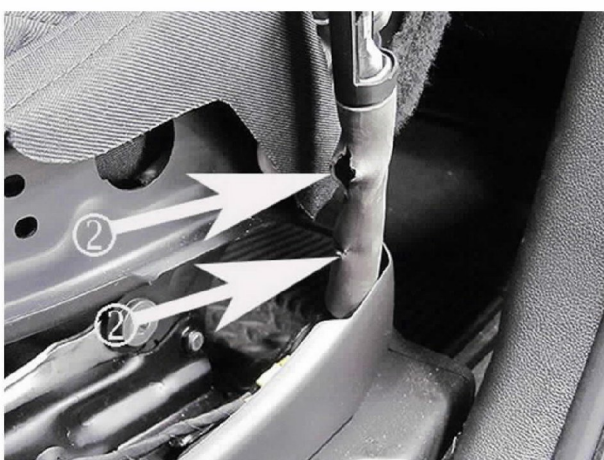
2. Inspect the seat belt tensioner cable cover for damage. Inspect the complete cable cover from the base of the cable to the buckle.

This damage will be in the form of holes (1) or splitting (2).

- If **any damage** is found, replace the driver side front seat belt anchor plate tensioner and the front seat cushion outer finish cover.
- If no damage is found, inform the customer that the special coverage condition is not present on their vehicle at this time.

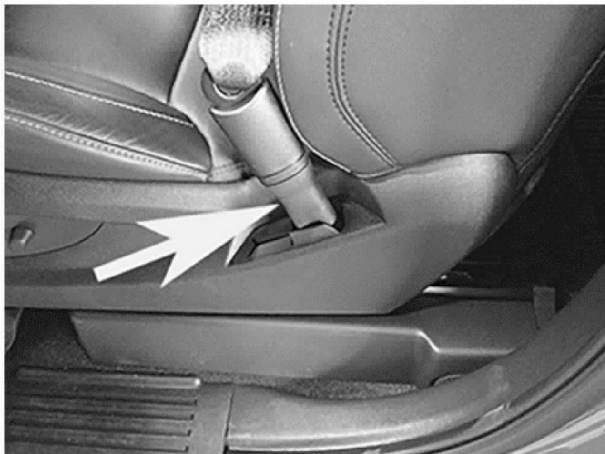
1. Move the driver seat to the full forward and full down position.

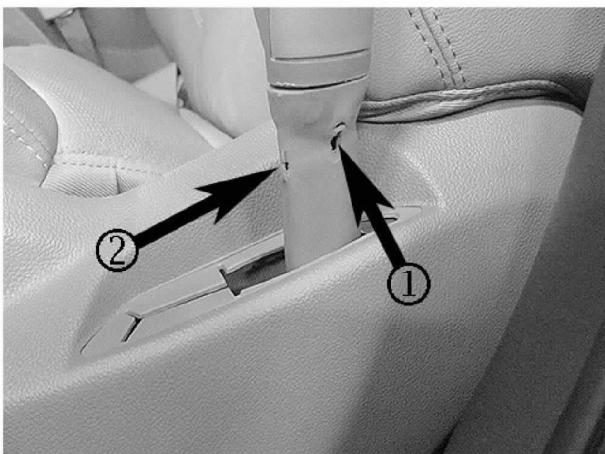
2. Inspect the seat belt tensioner cable cover for damage. Inspect the complete cable cover from the base of the cable to the buckle.

This damage will be in the form of holes (1) or splitting (2).

- If **any damage** is found, take the vehicle to the dealer for service.
- If no damage is found, the special coverage condition is not present on the vehicle at this time.
