# Special Coverage Adjustment

## N192219480 Drivers Front Seat Belt Lap Pretensioner

Release Date: June 2019

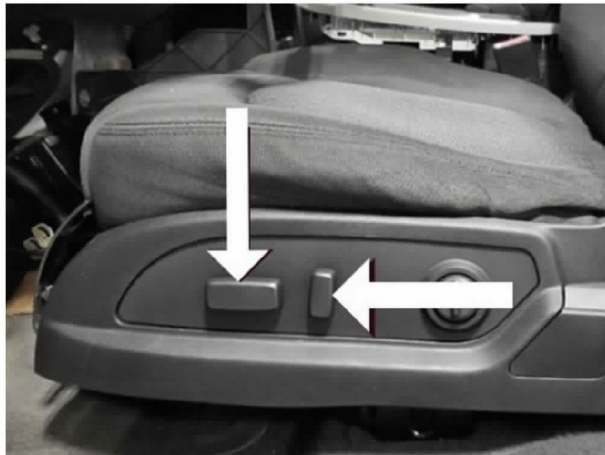
5357877

1. Move the driver seat to the full forward and full down position.

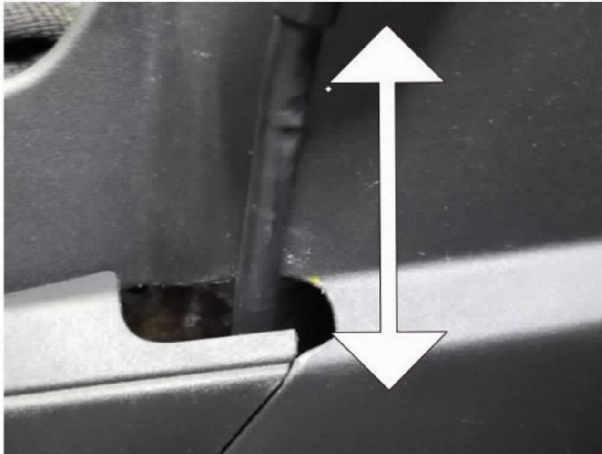
5357882

2. With the seat in the full forward and down position, inspect the seat belt tensioner cable cover for damage. Inspect the complete cable cover from the base of the cable to the latch. Damage includes any splits, holes or cracks.

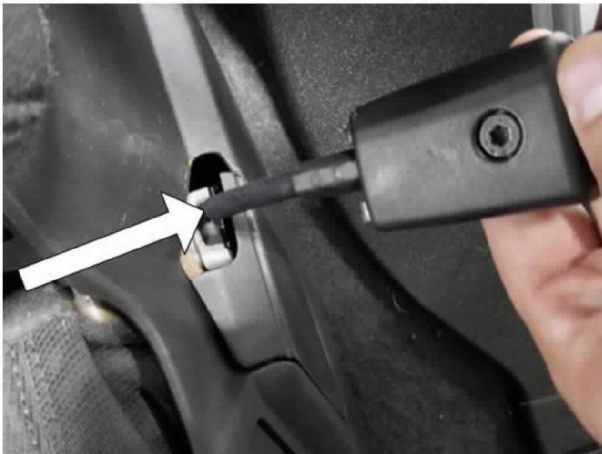
5357887

3. Flex the seat belt in an outboard direction and look on inboard side of driver seat seatbelt anchor cover for damage.

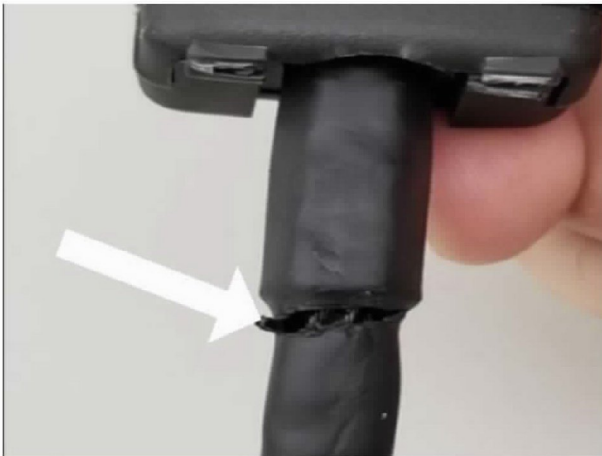
5357891

#### Damage Examples

4. If inspection finds cuts, splits, tears or cracks exposing the metal components underneath, replace the driver side front seat belt anchor plate tensioner. Refer to *Front Seat Belt Anchor Plate Tensioner Replacement* in SI.
5. If no damage is found, inform the customer that the special coverage condition is not present on their vehicle.

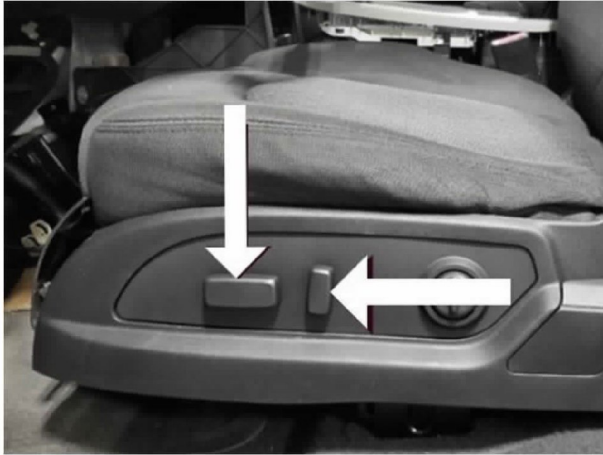
1. Move the driver seat to the full forward and full down position.

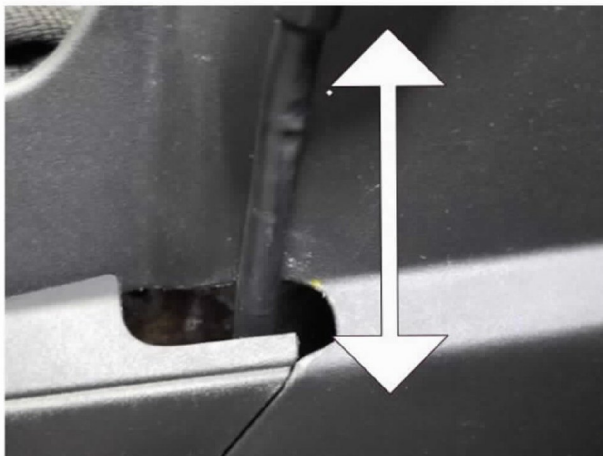
2. With the seat if the full forward and down position, inspect the seat belt tensioner cable cover for damage. Inspect the complete cable cover from the base of the cable to the latch. Damage includes any splits, holes or cracks.

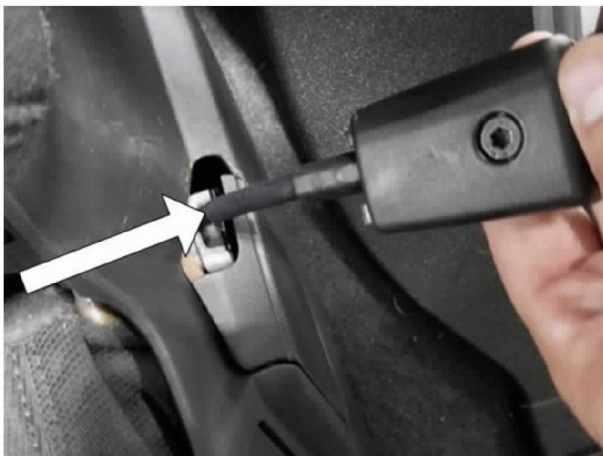
3. Flex the seat belt in an outboard direction and look on inboard side of driver seat seatbelt anchor cover for damage.
