Product Safety Recall

N202312100 Seat Belt Cable Separation – US Only

Release Date: November 2020

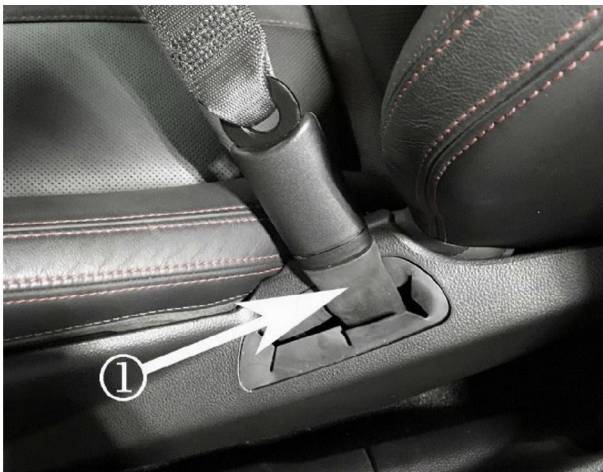
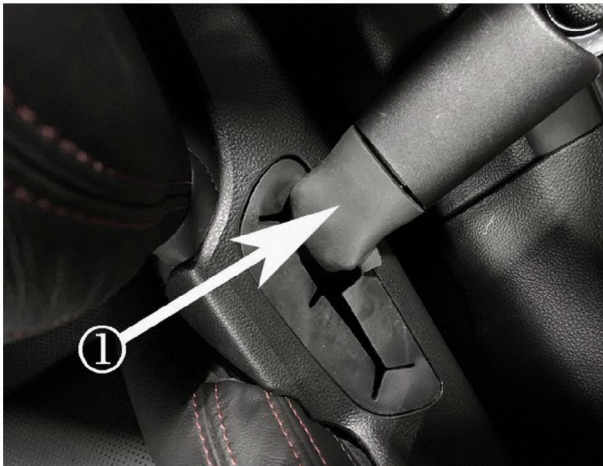
4593189

1. Using the seat adjustment switch, move the driver seat as far rearward and downward as possible. The front safety belt cable sleeve (hereinafter, “sleeve”) covers the flexible steel cable that connects the safety belt to the vehicle at the front outside seating position. The sleeve is covered by the seat trim and comes out of the slot on the side of the front seat.

2. Inspect the sleeve for any cuts or cracks. Bend the cable toward the inside and outside of the vehicle and inspect the area near arrows (1) above.

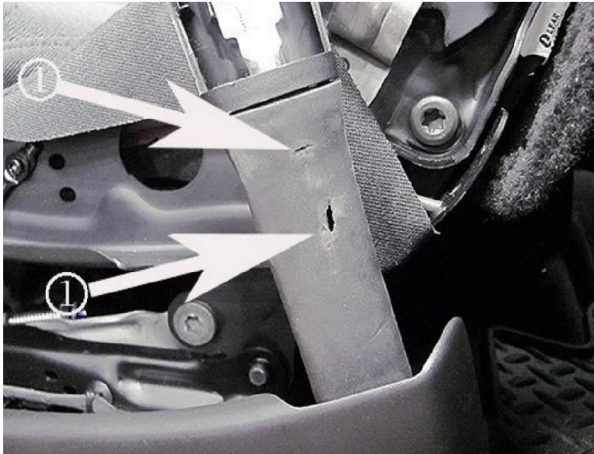
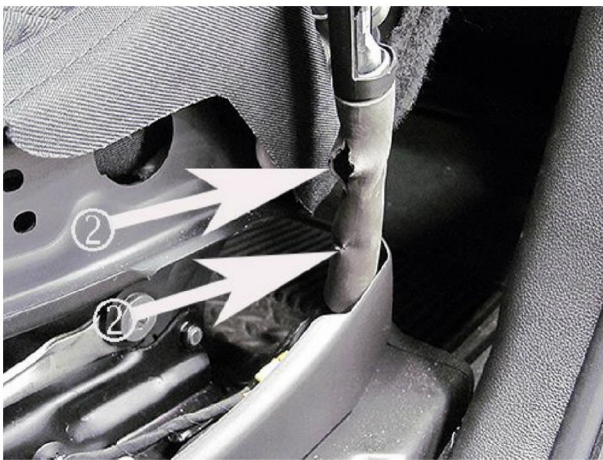
4522272

This damage will be in the form of holes (1) or splitting (2).

- If **any damage** is found, replace the tensioner and revised seat trim listed above. Refer to *Front Seat Belt Anchor Plate Tensioner Replacement* in SI.
- If no damage is found, only install the revised seat cushion outer finish cover.
