# Bulletin Summary - N192219480 Driver's Front Seat Belt Lap Pretensioner (Special Coverage)

# Special Coverage Adjustment

## N192289390 Seat Belt Anchor Pretensioner Cable

# Product Safety Recall

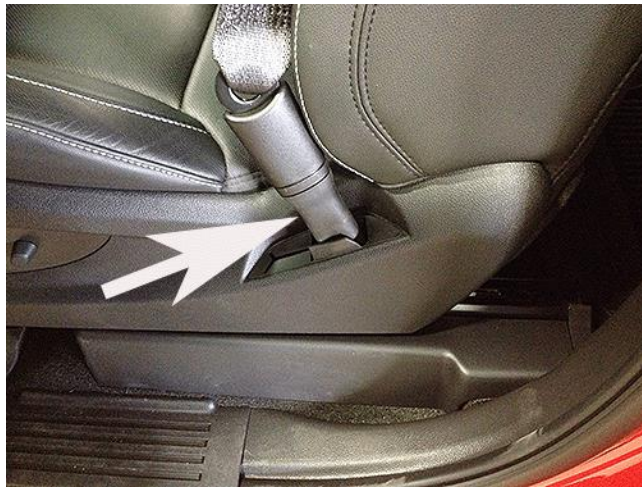
1. Move the driver seat to the full forward and full down position.

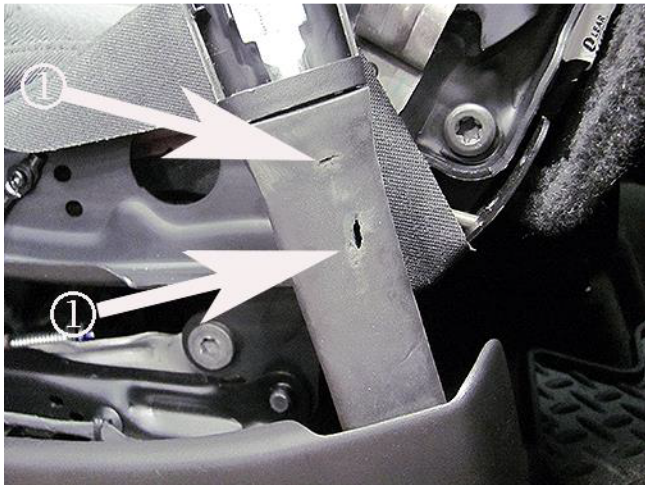
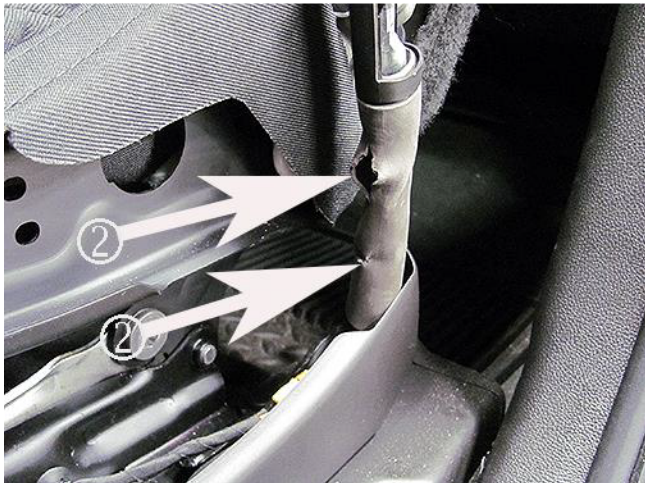
2. Inspect the seat belt tensioner cable cover for damage. Inspect the complete cable cover from the base of the cable to the buckle.

This damage will be in the form of holes (1) or splitting (2).

- If **any damage** is found, replace the driver side front seat belt anchor plate tensioner and the front seat cushion outer finish cover.
- If no damage is found, inform the customer that the special coverage condition is not present on their vehicle at this time.

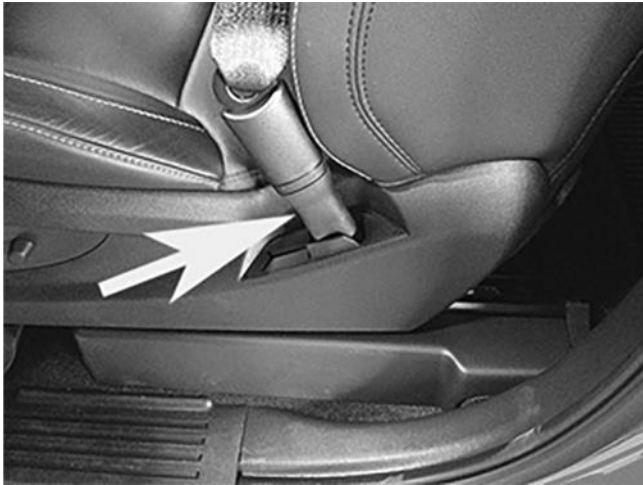
1. Move the driver seat to the full forward and full down position.

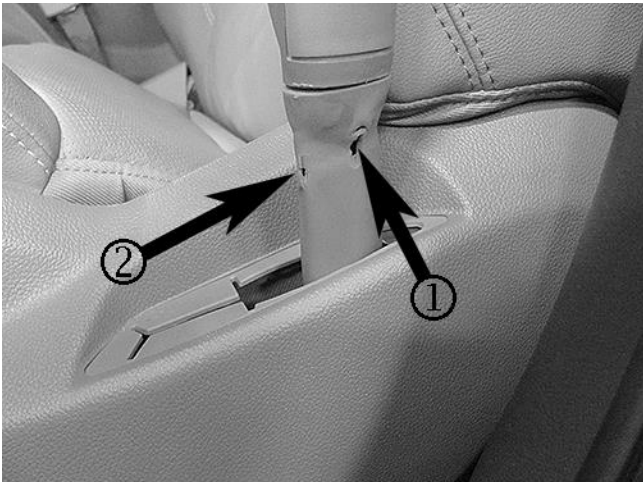
2. Inspect the seat belt tensioner cable cover for damage. Inspect the complete cable cover from the base of the cable to the buckle.

This damage will be in the form of holes (1) or splitting (2).

- If **any damage** is found, take the vehicle to the dealer for service.
- If no damage is found, the special coverage condition is not present on the vehicle at this time.

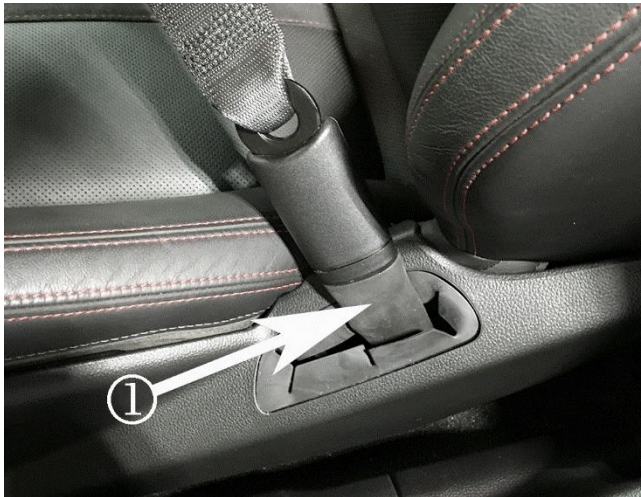
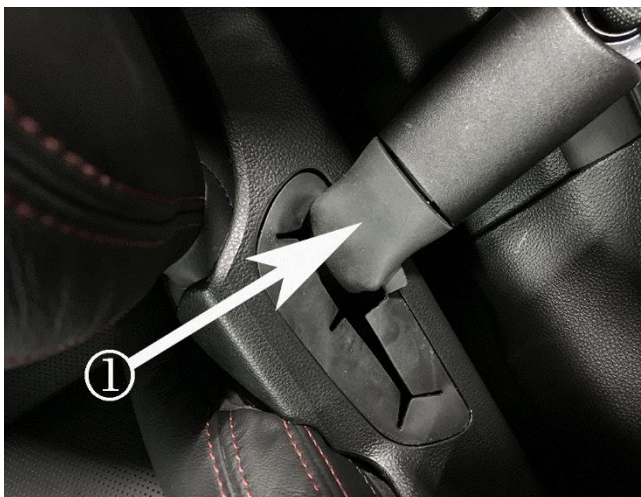
1. Using the seat adjustment switch, move the driver seat as far rearward and downward as possible. The front safety belt cable sleeve (hereinafter, “sleeve”) covers the flexible steel cable that connects the safety belt to the vehicle at the front outside seating position. The sleeve is covered by the seat trim and comes out of the slot on the side of the front seat.

2. Inspect the sleeve for any cuts or cracks. Bend the cable toward the inside and outside of the vehicle and inspect the area near arrows (1) above.

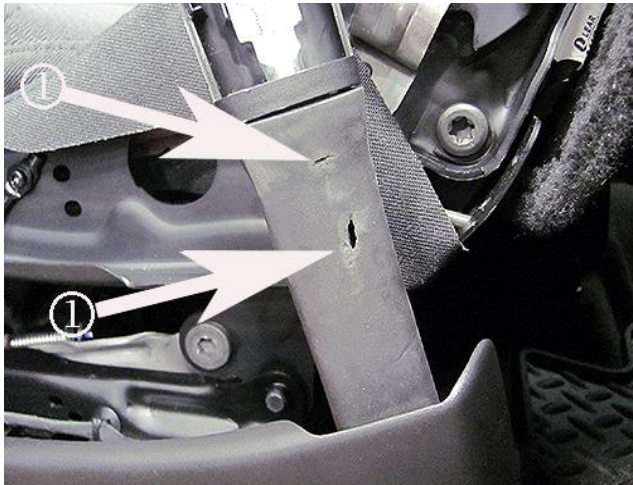
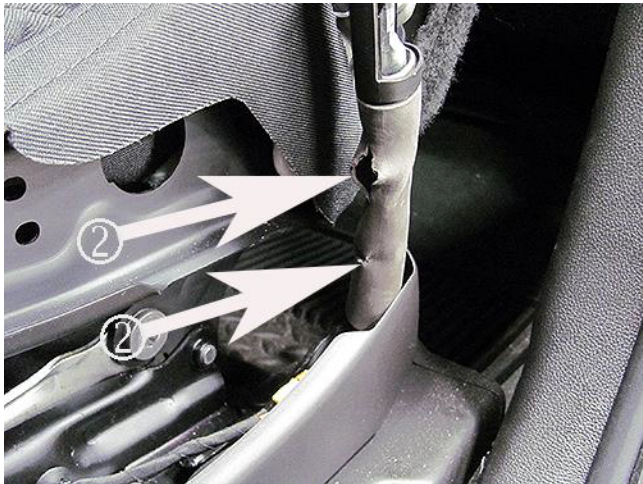
This damage will be in the form of holes (1) or splitting (2).

- If **any damage** is found, replace the tensioner and revised seat trim listed above. Refer to *Front Seat Belt Anchor Plate Tensioner Replacement* in SI.
- If no damage is found, only install the revised seat cushion outer finish cover.
