Special Coverage Adjustment

N192268380 Driver Seat Belt Anchor Pretensioner Cable

Release Date: August 2020

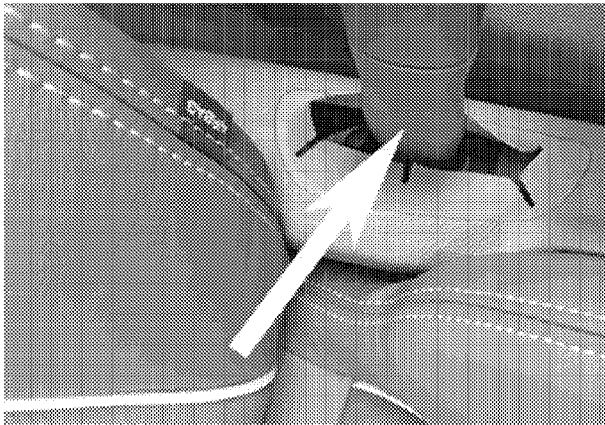
1. Move the driver seat to the full forward and full down position.
2. Inspect the seat belt pretensioner cable cover for damage. Inspect the complete cable cover from the base of the cable to the latch. Damage includes any splits, holes or cracks.

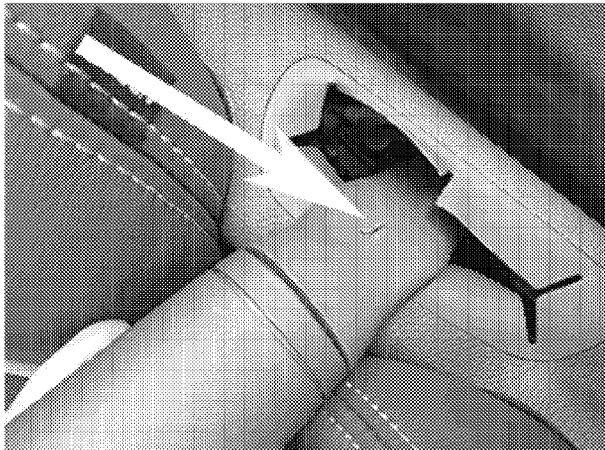
3. Flex the seat belt in an outboard direction and look on inboard side of driver seat seatbelt anchor cover for damage.

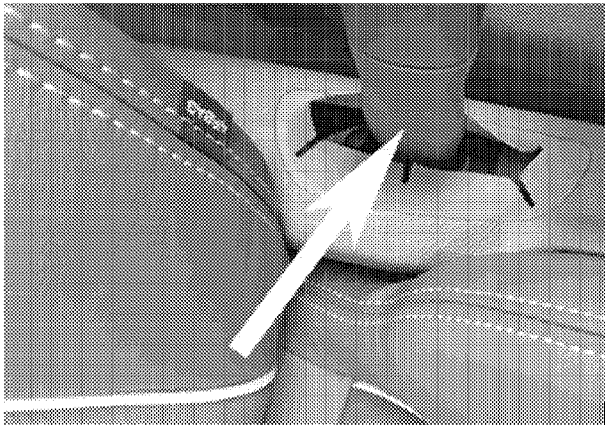
1. Move the driver seat to the full forward and full down position.
2. Inspect the seat belt pretensioner cable cover for damage. Inspect the complete cable cover from the base of the cable to the latch. Damage includes any splits, holes or cracks.

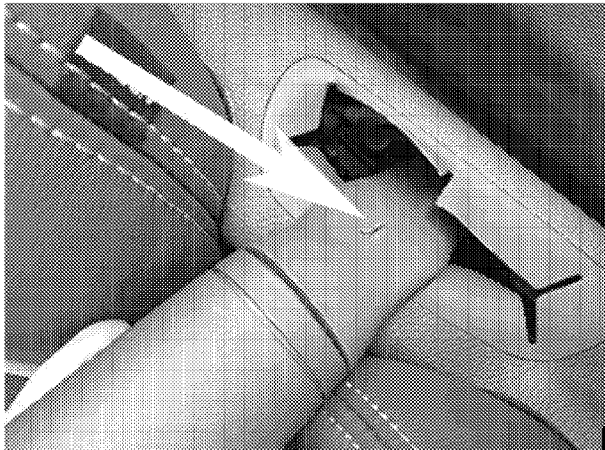
3. Flex the seat belt in an outboard direction and look on inboard side of driver seat seatbelt anchor cover for damage.

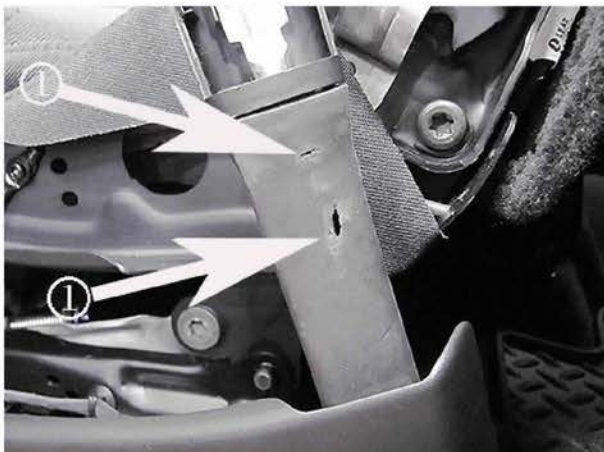
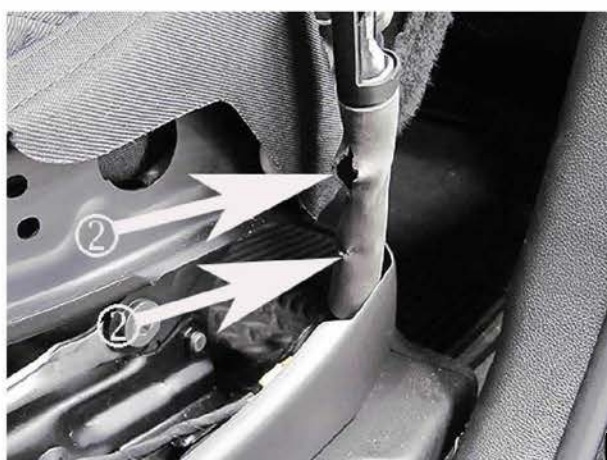
2. Inspect the seat belt tensioner cable cover for damage. Inspect the complete cable cover from the base of the cable to the buckle.

This damage will be in the form of holes (1) or splitting (2).

- If **any damage** is found, replace the driver side front seat belt anchor plate tensioner and the front seat cushion outer finish cover.
- If no damage is found, inform the customer that the special coverage condition is not present on their vehicle at this time.

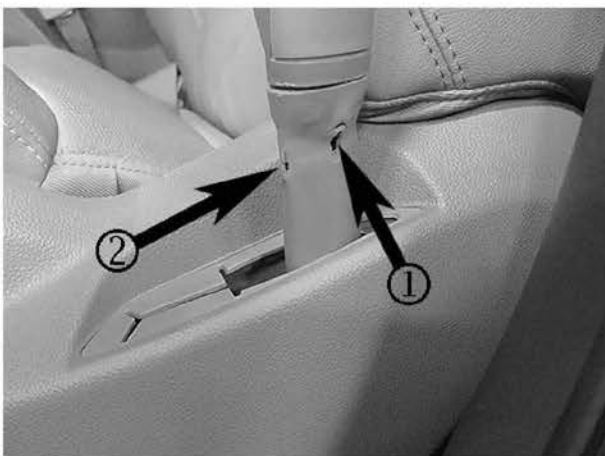
2. Inspect the seat belt tensioner cable cover for damage. Inspect the complete cable cover from the base of the cable to the buckle.

This damage will be in the form of holes (1) or splitting (2).

- If **any damage** is found, take the vehicle to the dealer for service.
- If no damage is found, the special coverage condition is not present on the vehicle at this time.

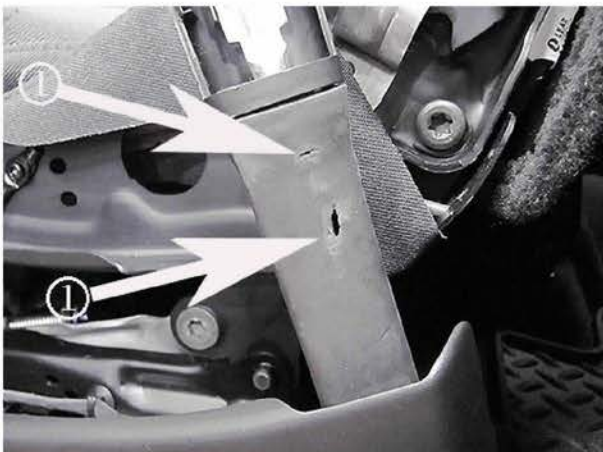
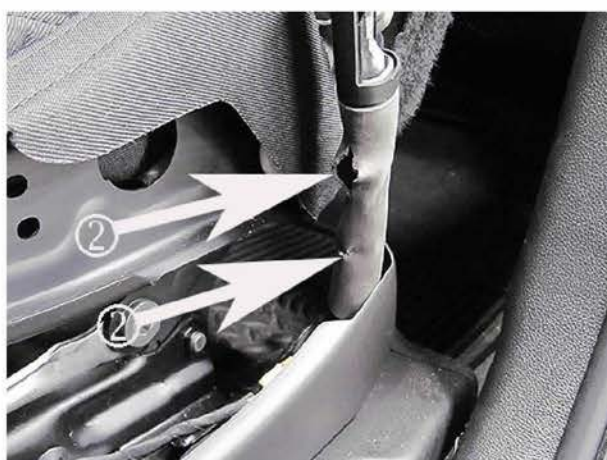
2. Inspect the seat belt tensioner cable cover for damage. Inspect the complete cable cover from the base of the cable to the buckle.

This damage will be in the form of holes (1) or splitting (2).

- If **any damage** is found, replace the driver side front seat belt anchor plate tensioner and the front seat cushion outer finish cover.
- If no damage is found, inform the customer that the special coverage condition is not present on their vehicle at this time.

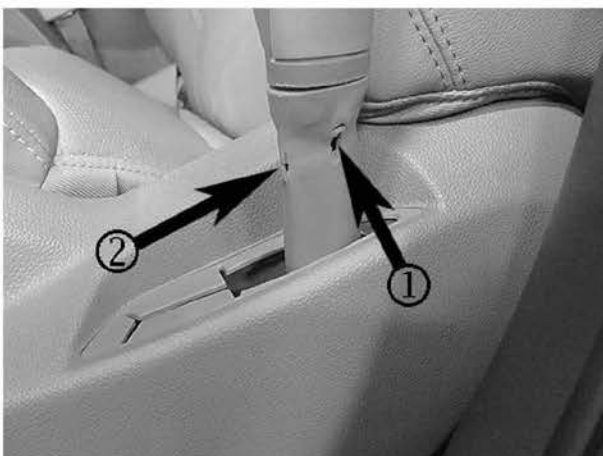
2. Inspect the seat belt tensioner cable cover for damage. Inspect the complete cable cover from the base of the cable to the buckle.

This damage will be in the form of holes (1) or splitting (2).

- If **any damage** is found, take the vehicle to the dealer for service.
- If no damage is found, the special coverage condition is not present on the vehicle at this time.
