SERVICE PROCEDURE

CONDITION

General Motors has decided that a defect which relates to motor vehicle safety exists in **certain** 2014-2015 model year Chevrolet Silverado 1500 Series and GMC Sierra 1500 Series vehicles. Some of these vehicles have a condition in which the flexible steel cable that connects the driver’s seat belt to the outboard side of the seat (the “tensioner cable”) can fatigue and separate over time as a result of occupant movement into the driver’s seat. In a crash, a fatigued tensioner

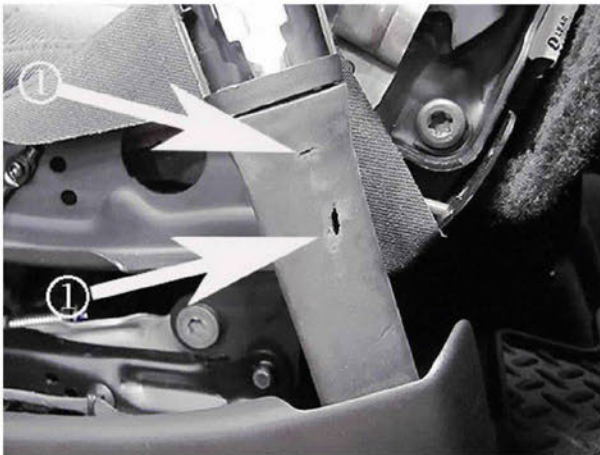
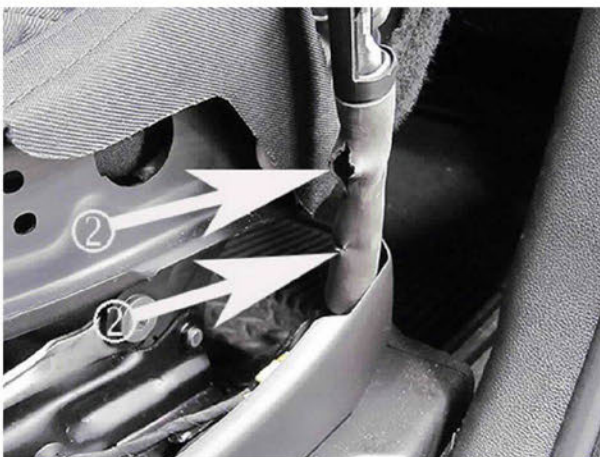
2. Inspect the tensioner cable cover for damage. Inspect the complete cable from the base of the cable to the buckle.

This damage will be in the form of holes (1) or splitting (2).

- If **any damage** is found, replace the tensioner while performing the bracket installation.
- If no damage is found, install the seat tensioner bracket using the existing tensioner.

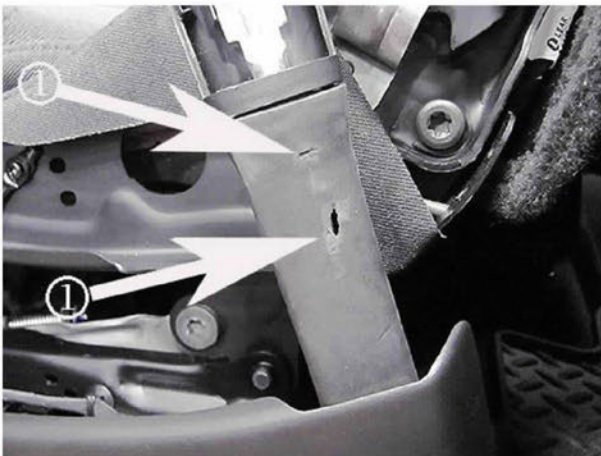
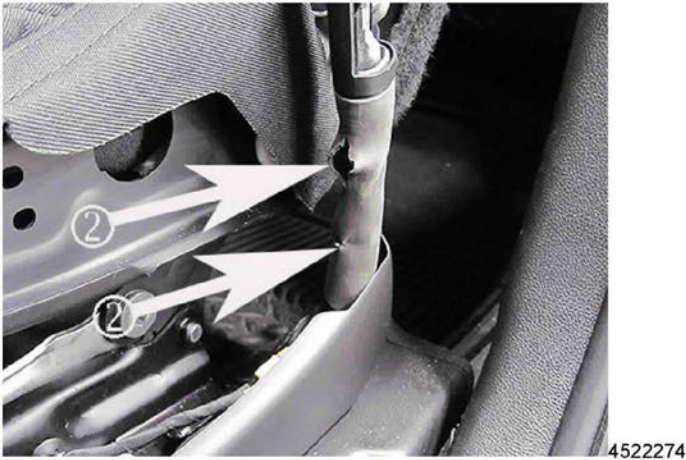
2. Inspect the tensioner cable cover for damage over its entire length.

This damage will be in the form of holes (1) or splitting (2).

- If **any damage** is found, replace the tensioner kit. Refer to *Front Seat Belt Anchor Plate Tensioner Replacement* in SI.
- If no damage is found, no further repair is required until a final remedy is available.

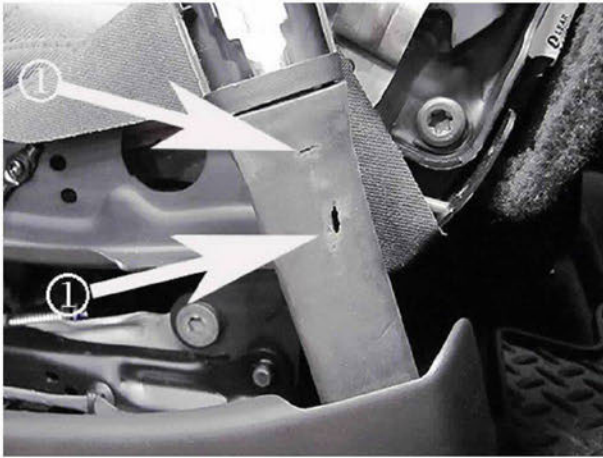
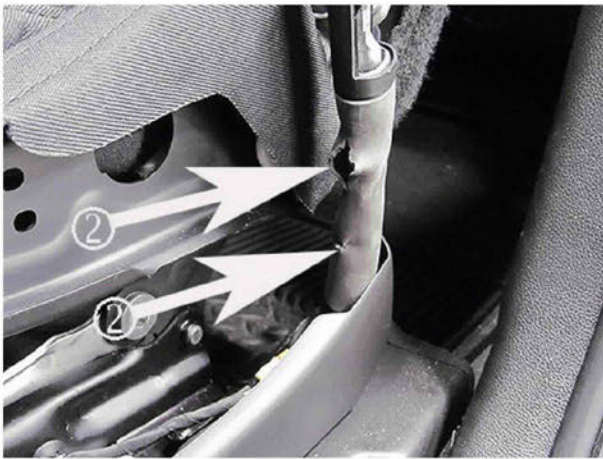
2. Inspect the tensioner cable cover for damage. Inspect the complete cable from the base of the cable to the buckle.

This damage will be in the form of holes (1) or splitting (2).

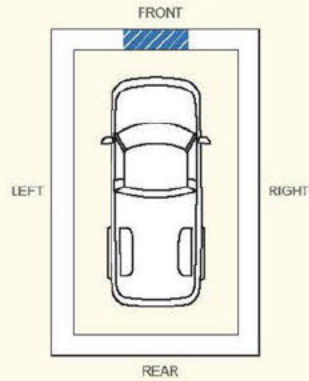
Damage Location

11/05/2015 Ohio Damage Report Damage reported Damage to front Damage to right front
