Special Coverage Adjustment

N192289390 Seat Belt Anchor Pretensioner Cable

Release Date: June 2020

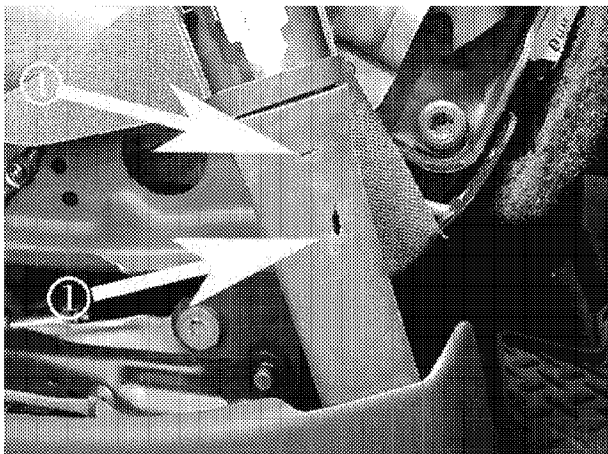
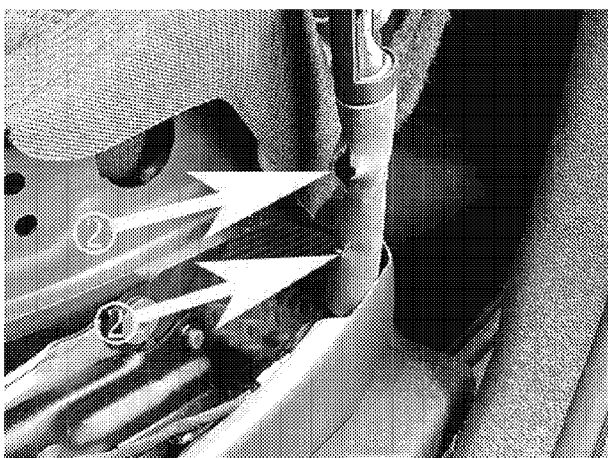
2. Inspect the seat belt tensioner cable cover for damage. Inspect the complete cable cover from the base of the cable to the buckle.

This damage will be in the form of holes (1) or splitting (2).

- If **any damage** is found, replace the driver side front seat belt anchor plate tensioner and the front seat cushion outer finish cover.
- If no damage is found, inform the customer that the special coverage condition is not present on their vehicle at this time.

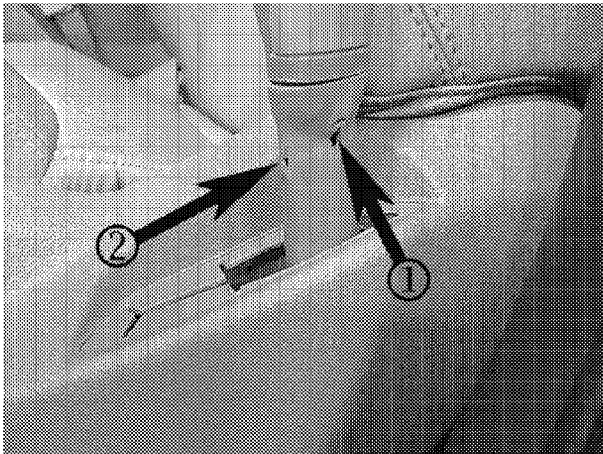
This damage will be in the form of holes (1) or splitting (2).

- If **any damage** is found, take the vehicle to the dealer for service.
- If no damage is found, the special coverage condition is not present on the vehicle at this time.

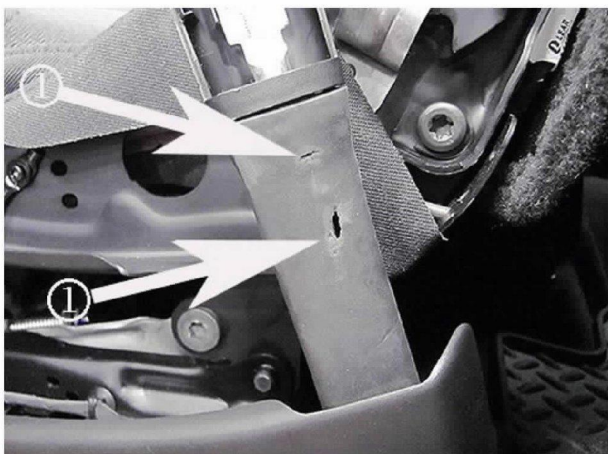
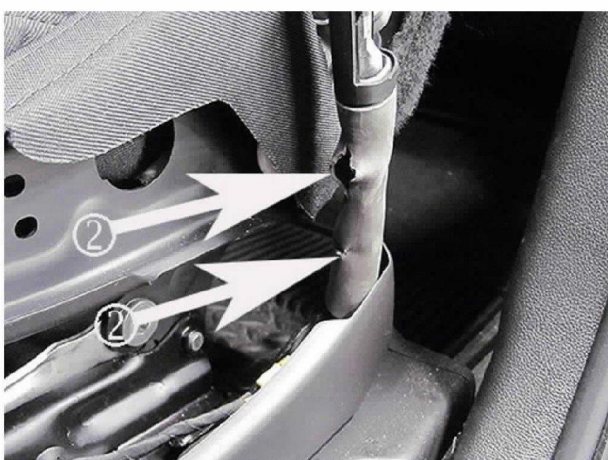
This damage will be in the form of holes (1) or splitting (2).

- If **any damage** is found, replace the driver side front seat belt anchor plate tensioner and the front seat cushion outer finish cover.
- If no damage is found, inform the customer that the special coverage condition is not present on their vehicle at this time.

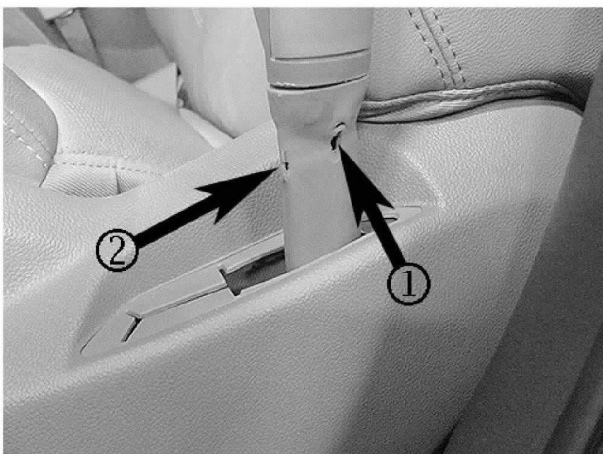
This damage will be in the form of holes (1) or splitting (2).

- If **any damage** is found, take the vehicle to the dealer for service.
- If no damage is found, the special coverage condition is not present on the vehicle at this time.

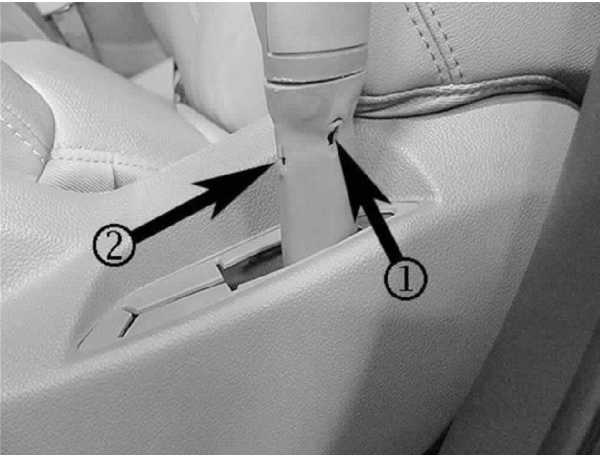
This damage will be in the form of holes (1) or splitting (2).

- If **any damage** is found, take the vehicle to the dealer for service.
- If no damage is found, the special coverage condition is not present on the vehicle at this time.

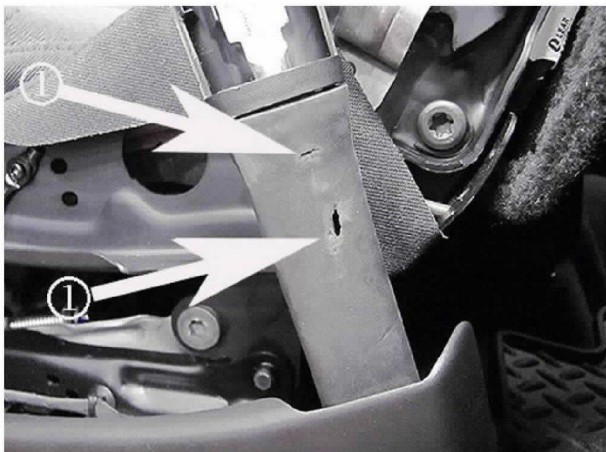
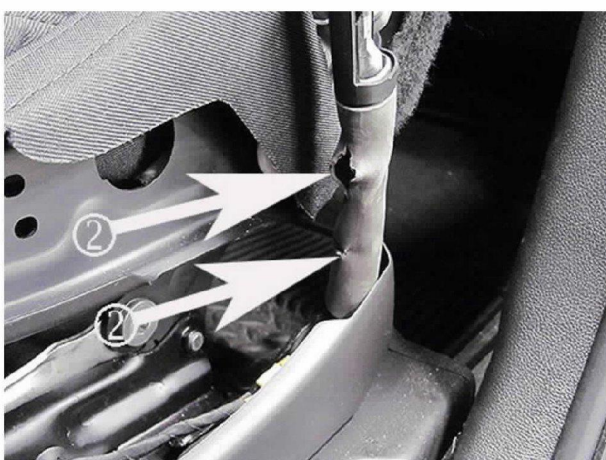
This damage will be in the form of holes (1) or splitting (2).

- If **any damage** is found, replace the driver side front seat belt anchor plate tensioner and the front seat cushion outer finish cover.
- If no damage is found, inform the customer that the special coverage condition is not present on their vehicle at this time.

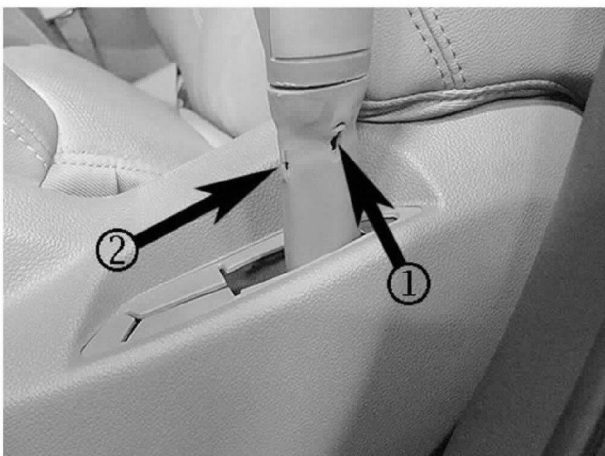
This damage will be in the form of holes (1) or splitting (2).

- If **any damage** is found, take the vehicle to the dealer for service.
- If no damage is found, the special coverage condition is not present on the vehicle at this time.

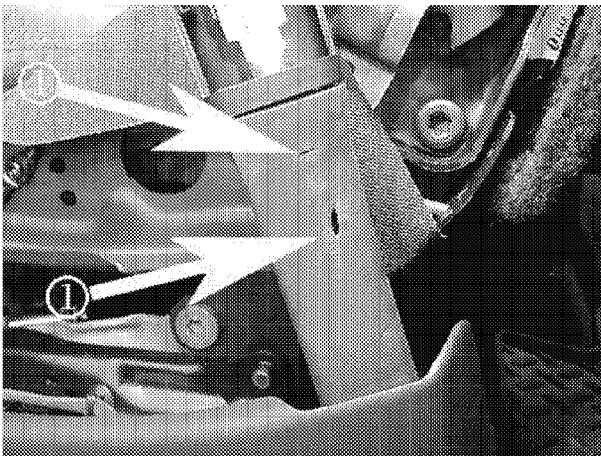
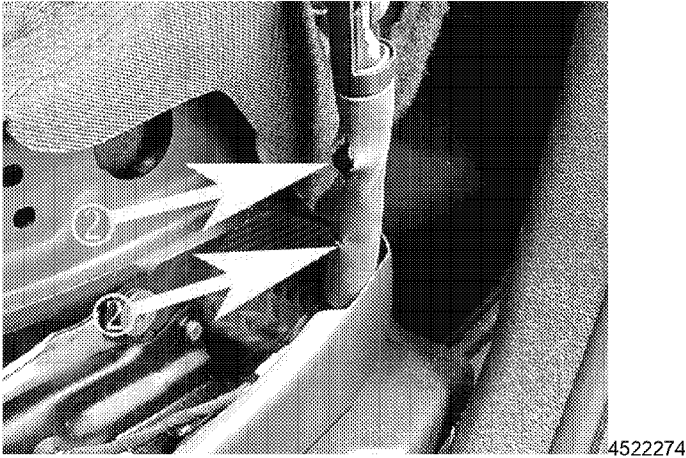
2. Inspect the tensioner cable cover for damage over its entire length.

This damage will be in the form of holes (1) or splitting (2).

- If **any damage** is found, replace the tensioner kit. Refer to *Front Seat Belt Anchor Plate Tensioner Replacement* in SI.
- If no damage is found, no further repair is required until a final remedy is available.

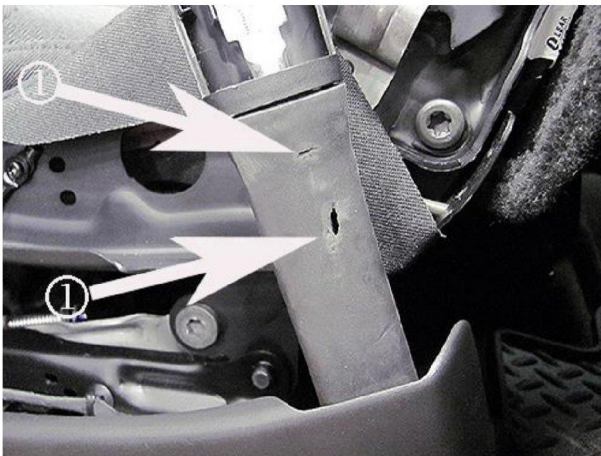
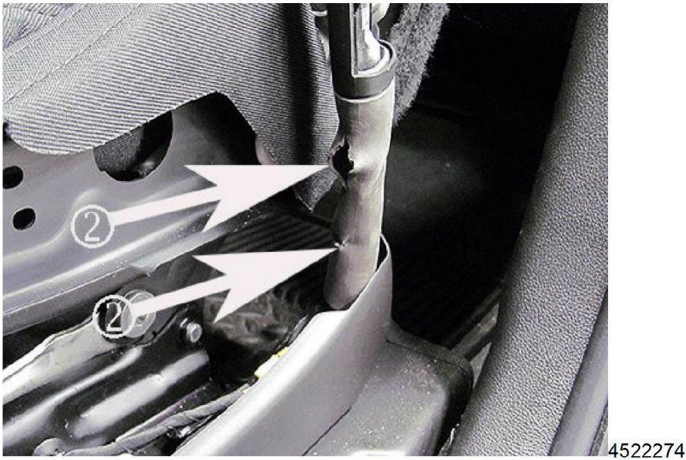
2. Inspect the tensioner cable cover for damage over its entire length.

This damage will be in the form of holes (1) or splitting (2).

- If **any damage** is found, replace the tensioner kit. Refer to *Front Seat Belt Anchor Plate Tensioner Replacement* in SI.
- If no damage is found, no further repair is required until a final remedy is available.

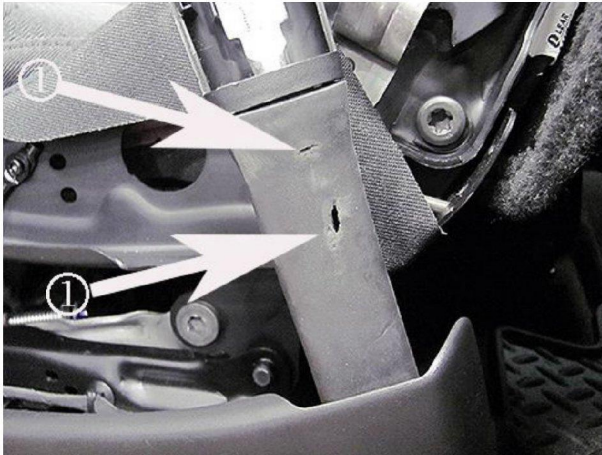
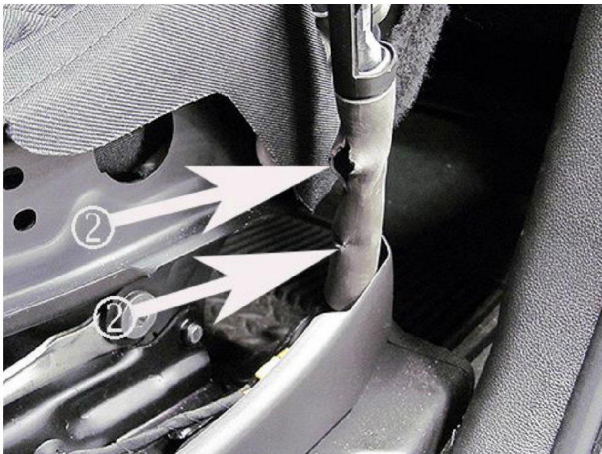
2. Inspect the tensioner cable cover for damage. Inspect the complete cable from the base of the cable to the buckle.

This damage will be in the form of holes (1) or splitting (2).
