## Product Safety Recall

### N202312100 Seat Belt Cable Separation – US Only

<b>Condition</b>	General Motors has decided that a defect which relates to motor vehicle safety exists in certain 2014-2016 model year Chevrolet Caprice Police Pursuit Vehicles (PPVs) and Chevrolet SS vehicles that were subject to NHTSA Recall No. 16V518 and may not have received a complete repair under the recall. The flexible steel cable that connects the safety belt to the vehicle at the outside of the front driver seat can fatigue and separate over time if the driver's movement into the seat repeatedly bends the steel seat belt cable down against the seat edge. The covering on the cable may show visible signs, including tears, holes, or wear marks. In a crash, a fatigued cable could break, reducing the effectiveness of the vehicle's safety belts and increasing the risk of injury to the occupant. <b>As part of the remedy under NHTSA Recall No. 16V518 (bulletin 31340), dealers were instructed to install a new seat trim piece with a redesigned opening for improved cable routing. In some of the vehicles repaired under that recall, dealers did not replace the seat trim as specified.</b>

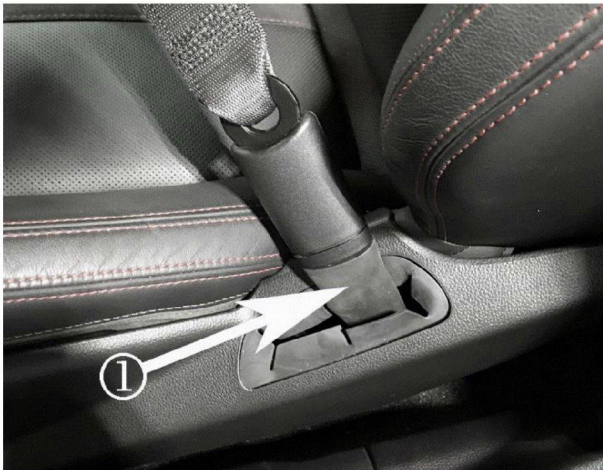
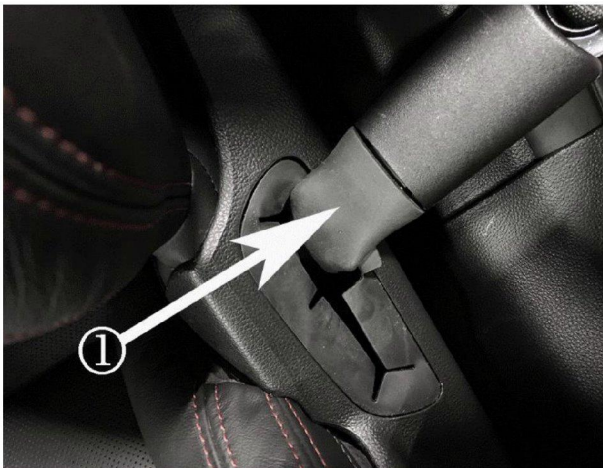
2. Inspect the sleeve for any cuts or cracks. Bend the cable toward the inside and outside of the vehicle and inspect the area near arrows (1) above.

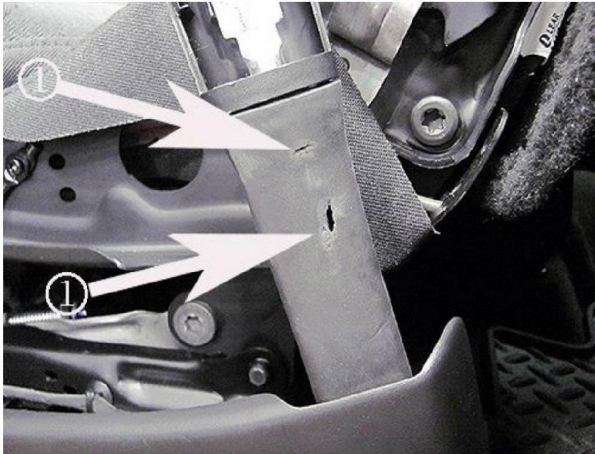
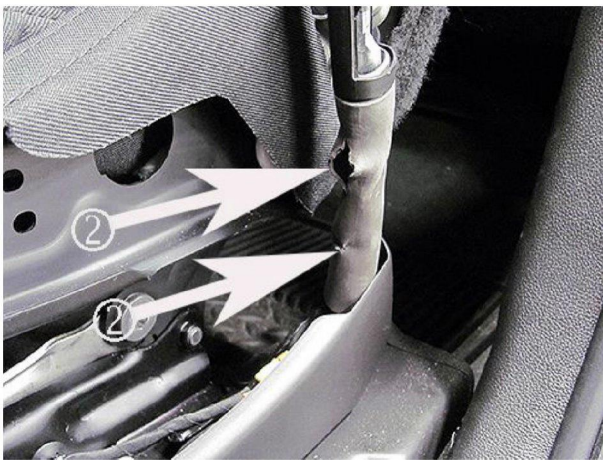
This damage will be in the form of holes (1) or splitting (2).

- If **any damage** is found, replace the tensioner and revised seat trim listed above. Refer to *Front Seat Belt Anchor Plate Tensioner Replacement* in SI.
- If no damage is found, only install the revised seat cushion outer finish cover.

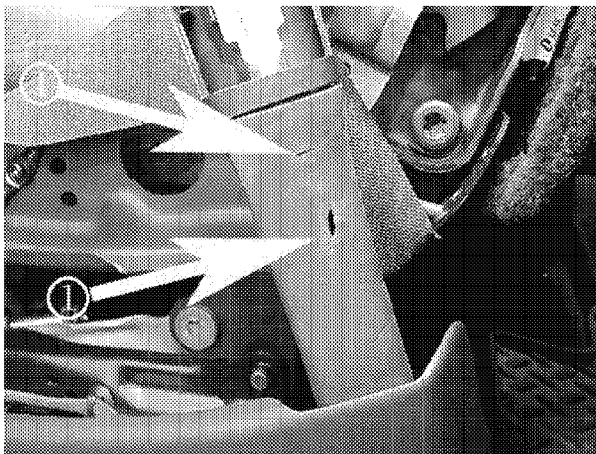
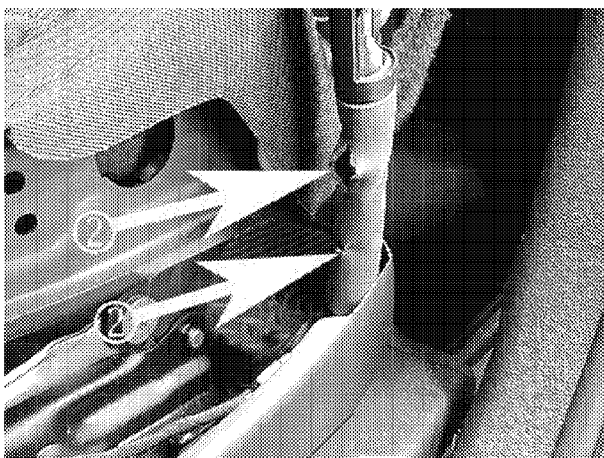
This damage will be in the form of holes (1) or splitting (2).

- If **any damage** is found, replace the tensioner and revised seat trim listed above. Refer to *Front Seat Belt Anchor Plate Tensioner Replacement* in SI.
- If no damage is found, only install the revised seat cushion outer finish cover.

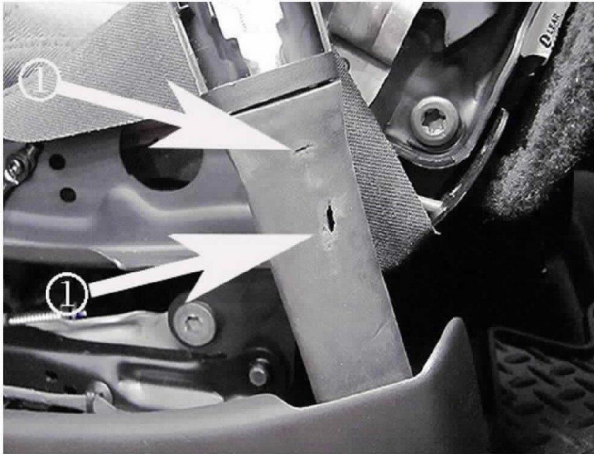
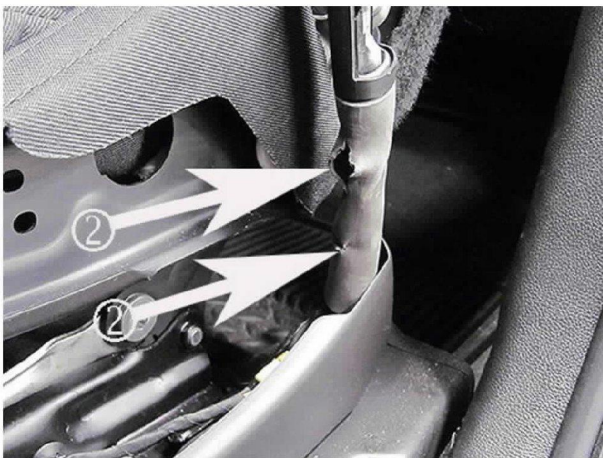
This damage will be in the form of holes (1) or splitting (2).

- If **any damage** is found, replace the tensioner and revised seat trim listed above. Refer to *Front Seat Belt Anchor Plate Tensioner Replacement* in SI.
- If no damage is found, only install the revised seat cushion outer finish cover.

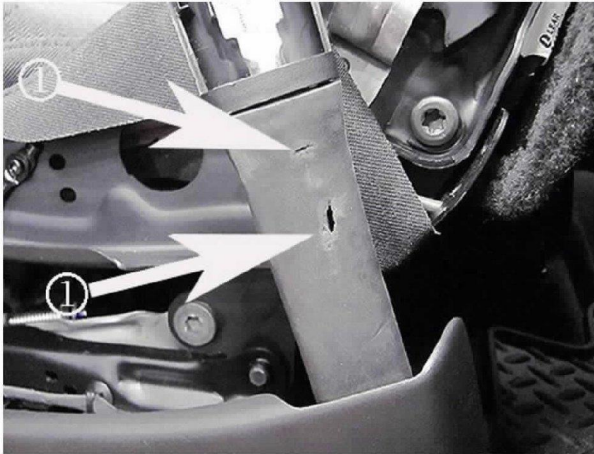
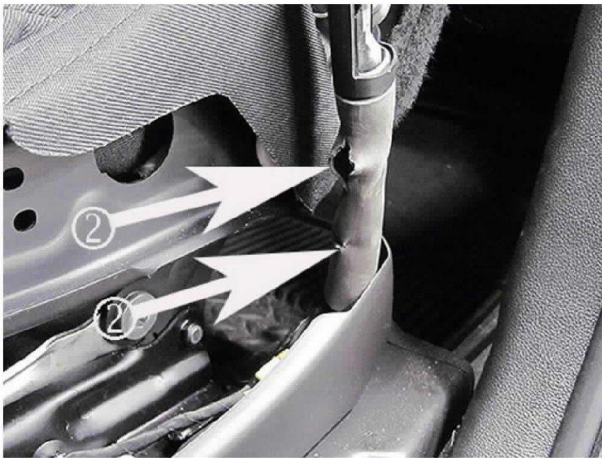
This damage will be in the form of holes (1) or splitting (2).

- If **any damage** is found, replace the tensioner and revised seat trim listed above. Refer to *Front Seat Belt Anchor Plate Tensioner Replacement* in SI.
- If no damage is found, only install the revised seat cushion outer finish cover.

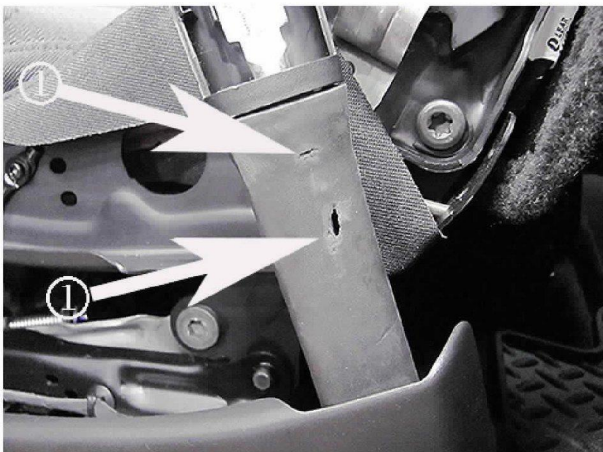
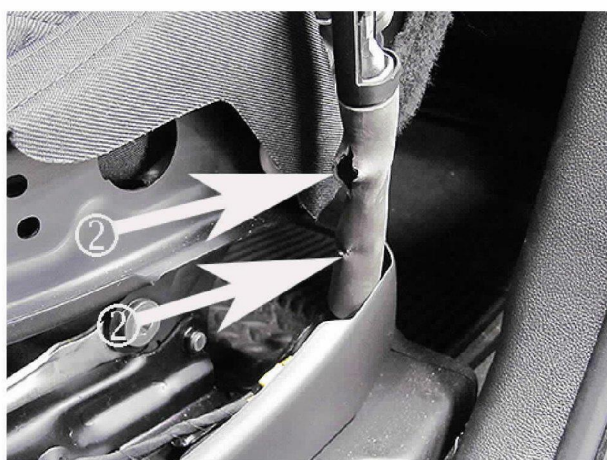
This damage will be in the form of holes (1) or splitting (2).

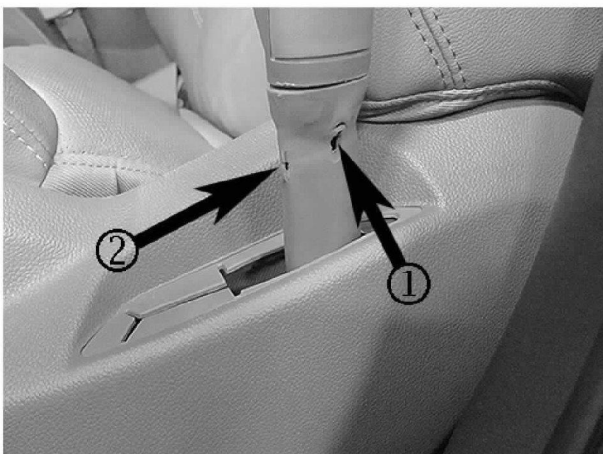
This damage will be in the form of holes (1) or splitting (2).

- If **any damage** is found, take the vehicle to the dealer for service.
- If no damage is found, the special coverage condition is not present on the vehicle at this time.

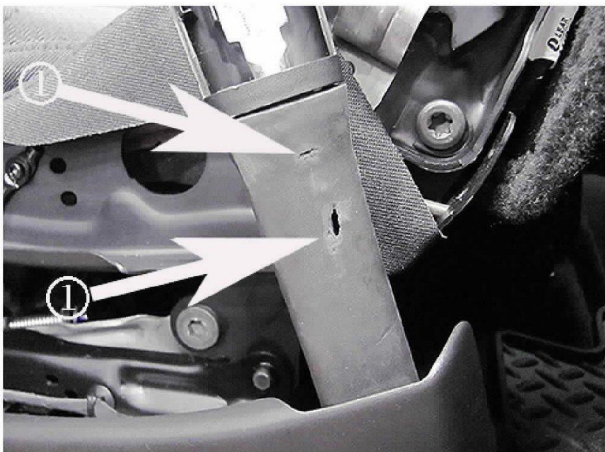
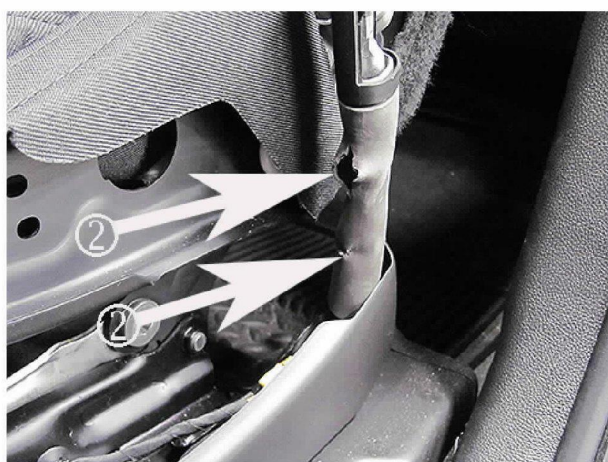
This damage will be in the form of holes (1) or splitting (2).

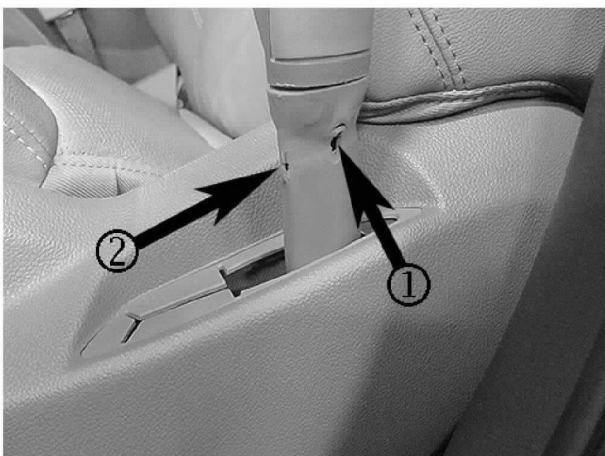
This damage will be in the form of holes (1) or splitting (2).

- If **any damage** is found, take the vehicle to the dealer for service.
- If no damage is found, the special coverage condition is not present on the vehicle at this time.

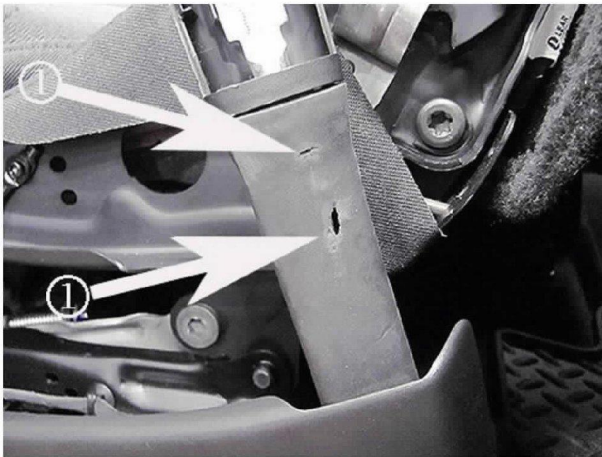
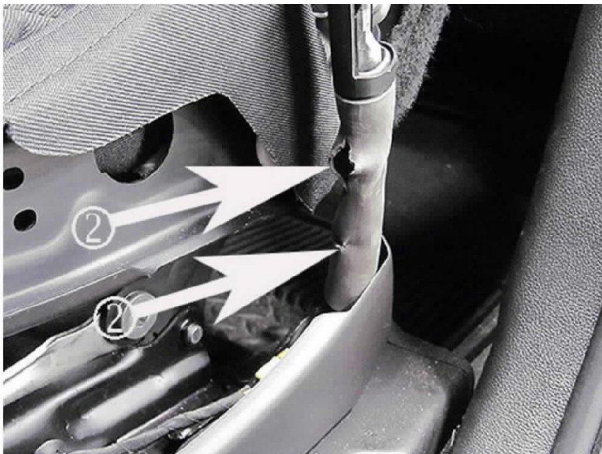
This damage will be in the form of holes (1) or splitting (2).
