IMPORTANT SAFETY RECALL

General Motors has decided that a defect, which relates to motor vehicle safety, exists in certain 2014-2015 model year Chevrolet Silverado Series 1500 and GMC Sierra Series 1500 vehicles. As a result, GM is conducting a safety recall. We apologize for this inconvenience. However, we are concerned about your safety and continued satisfaction with our products.

General Motors has decided that a defect which relates to motor vehicle safety exists in **certain** 2014-2015 model year Chevrolet Silverado 1500 Series and GMC Sierra 1500 Series vehicles. Some of these vehicles have a condition in which the flexible steel cable that connects the driver’s seat belt to the outboard side of the seat (the “tensioner cable”) can fatigue and separate over time as a result of occupant movement into the driver’s seat. In a crash, a fatigued tensioner

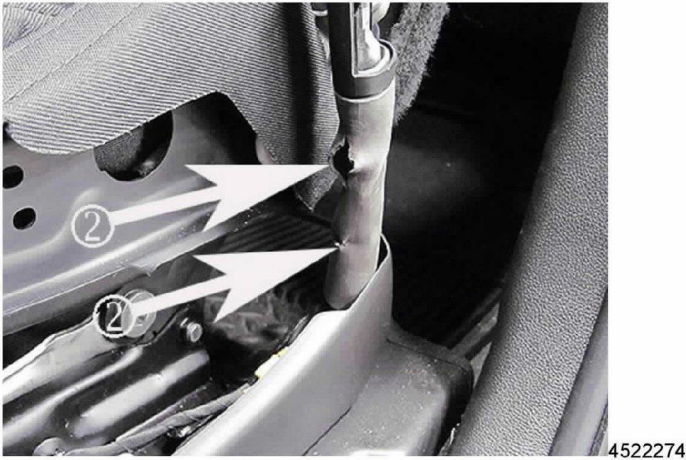
This damage will be in the form of holes (1) or splitting (2).

- If **any damage** is found, replace the tensioner kit. Refer to *Front Seat Belt Anchor Plate Tensioner Replacement* in SI.
- If no damage is found, no further repair is required until a final remedy is available.

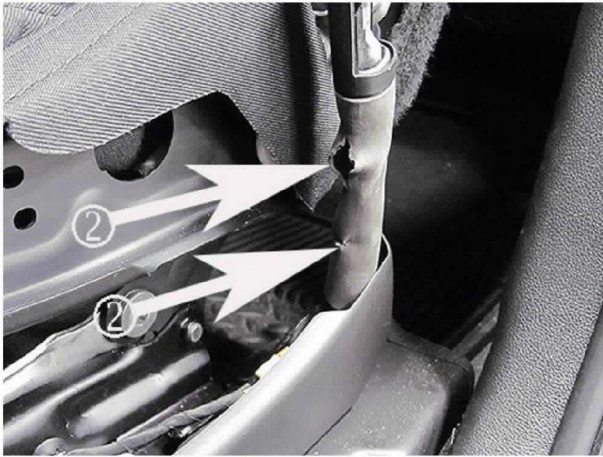
4522274

This damage will be in the form of holes (1) or splitting (2).

- If **any damage** is found, replace the tensioner while performing the bracket installation.
- If no damage is found, install the seat tensioner bracket using the existing tensioner.

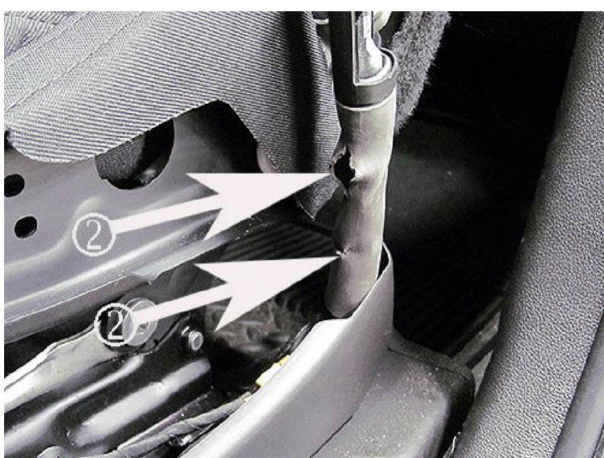
4522274

This damage will be in the form of holes (1) or splitting (2).

- If **any damage** is found, replace the driver side front seat belt anchor plate tensioner and the front seat cushion outer finish cover.
- If no damage is found, inform the customer that the special coverage condition is not present on their vehicle at this time.

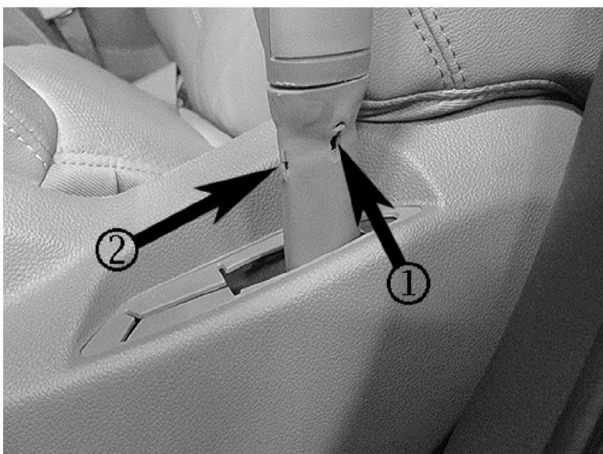
This damage will be in the form of holes (1) or splitting (2).

- If **any damage** is found, take the vehicle to the dealer for service.
- If no damage is found, the special coverage condition is not present on the vehicle at this time.
