# Product Safety Recall

## N202312100 Seat Belt Cable Separation – US Only

**Release Date:** November 2020

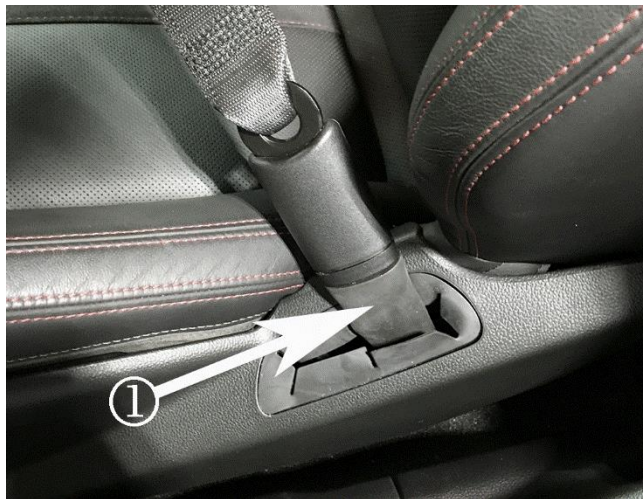
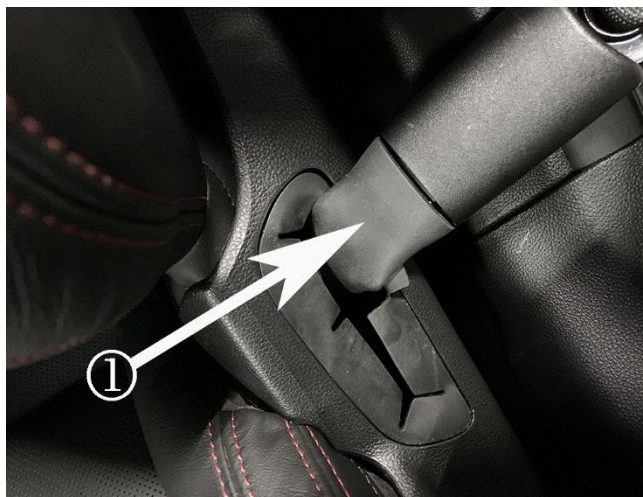
1. Using the seat adjustment switch, move the driver seat as far rearward and downward as possible. The front safety belt cable sleeve (hereinafter, “sleeve”) covers the flexible steel cable that connects the safety belt to the vehicle at the front outside seating position. The sleeve is covered by the seat trim and comes out of the slot on the side of the front seat.

2. Inspect the sleeve for any cuts or cracks. Bend the cable toward the inside and outside of the vehicle and inspect the area near arrows (1) above.
