Special Coverage Adjustment

N192289390 Seat Belt Anchor Pretensioner Cable

Release Date: June 2020

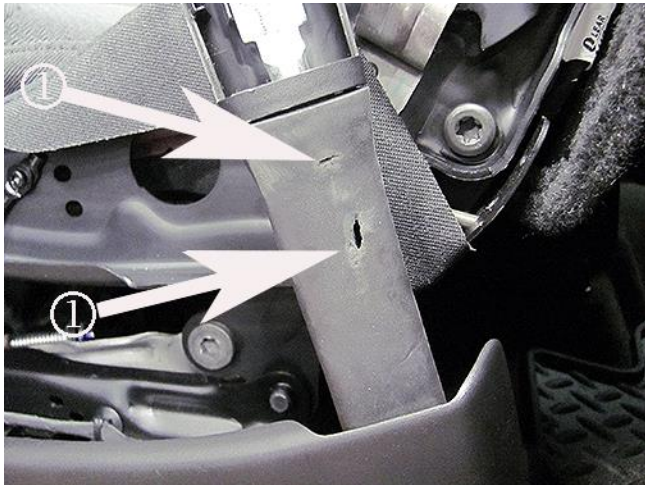
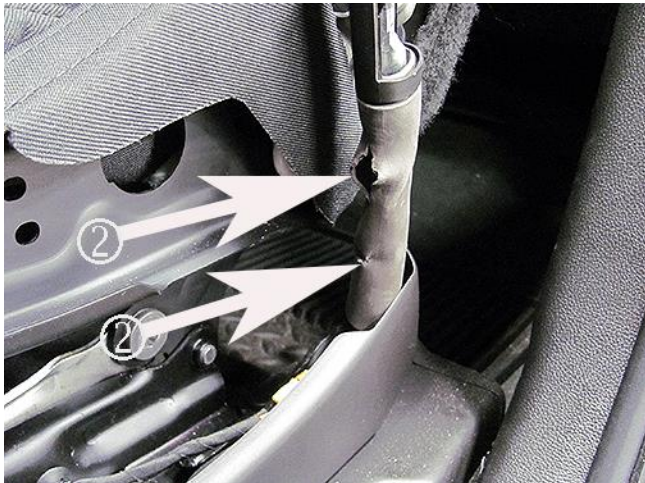
Condition	If a driver repeatedly sits on the seat belt cable cover located at the base of the driver's seat when entering the vehicle, it may cause the seat belt pretensioner to bend sharply over the seat side shield. If this continues to occur over an extended period of time, which is very rare, the seat belt pretensioner cable may fatigue and eventually separate, which could reduce the effectiveness of the vehicle's seat belts. Before any damage occurs to the pretensioner cable itself, signs of wear will be visible on the pretensioner cable cover where it has been repeatedly bent over the seat side shield. The condition described may exist in the following models and model years: 2014-2016 Chevrolet Silverado LD and GMC Sierra LD trucks, limited 2017 Chevrolet Silverado LD and GMC Sierra LD trucks, and limited 2016 Chevrolet Silverado HD and GMC Sierra HD trucks.
Special Coverage Adjustment	<p>This special coverage covers the condition described above for a period of 12 years or 180,000 miles (290,000 km), whichever occurs first, from the date the vehicle was originally placed in service, regardless of ownership.</p> <p>For vehicles covered by Vehicle Service Contracts, all eligible claims with repair orders on or after June 2, 2020, are covered by this special coverage and must be submitted using the labor operation codes provided with this bulletin. Claims with repair orders prior to June 2, 2020, must be submitted to the Service Contract provider.</p> <p>Vehicle owners or lessees who paid for repairs referenced in this Special Coverage ("Customers") are eligible for reimbursement of their reasonable and customary expenses in accordance with the procedures specified below. The conditional right to reimbursement is provided by GM solely in the interest of customer satisfaction and is personal to Customers. <i>Customers may not assign and GM does not consent to any assignment of any Customer's right to submit reimbursement claims, or to receive reimbursement, or any other rights granted by this Special Coverage to any third party, including but not limited to service contract providers, and this Special Coverage is not intended to and does not confer any third party beneficiary, subrogation or contribution rights, or any other rights to reimbursement, against GM, whether in law, equity or otherwise, on any third parties.</i></p>

This damage will be in the form of holes (1) or splitting (2).

Correction	Dealers are to replace the pretensioner and side shield for all customers that experience a broken pretensioner cable or come to a dealership with excessive wear on the cable sleeve. The repairs will be made at no charge to the customer.

- If **any damage** is found, replace the driver side front seat belt anchor plate tensioner and the front seat cushion outer finish cover.
- If no damage is found, inform the customer that the special coverage condition is not present on their vehicle at this time.
