REQUEST 8 - MCI
RESPONSE TO ODI PE20-001

3_Radiator_External_Corrosion
_Summary_161011

To: Shannon Groen
 Cc:
 From: Tom Burrows
 Date: 13 February 2017
 Subject: Radiator Failure

MCI Returned Hose Failure Analysis Part 16-11-1970 REV B

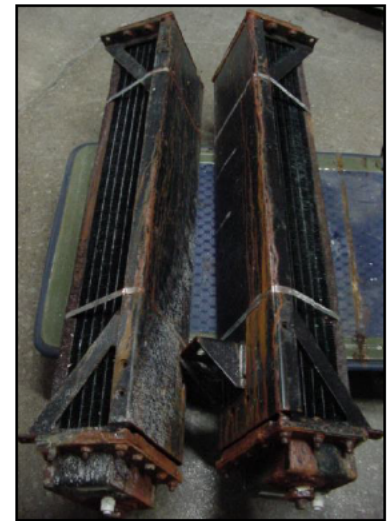
Copper Brass Radiator samples leak checked during SWAAT Test

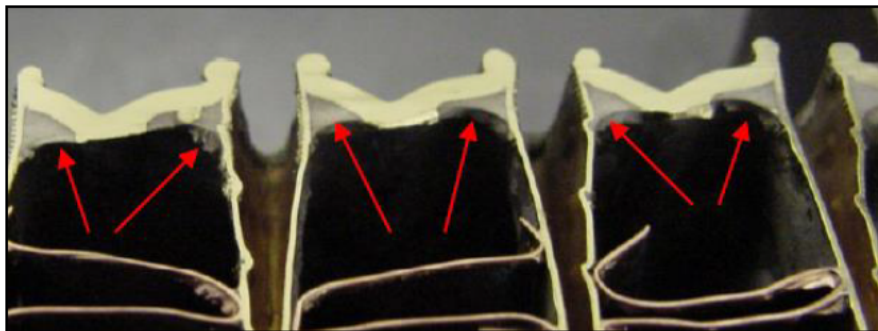
Cross Section of Copper Brass Radiator with Degradation of Backsolder during SWAAT Test

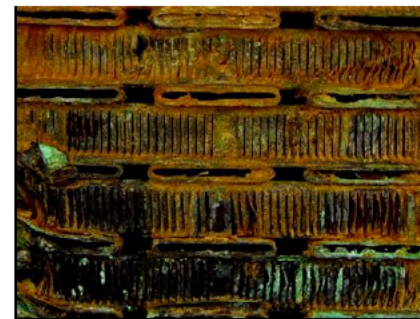
Copper Brass Air Fin Degradation during SWAAT Test

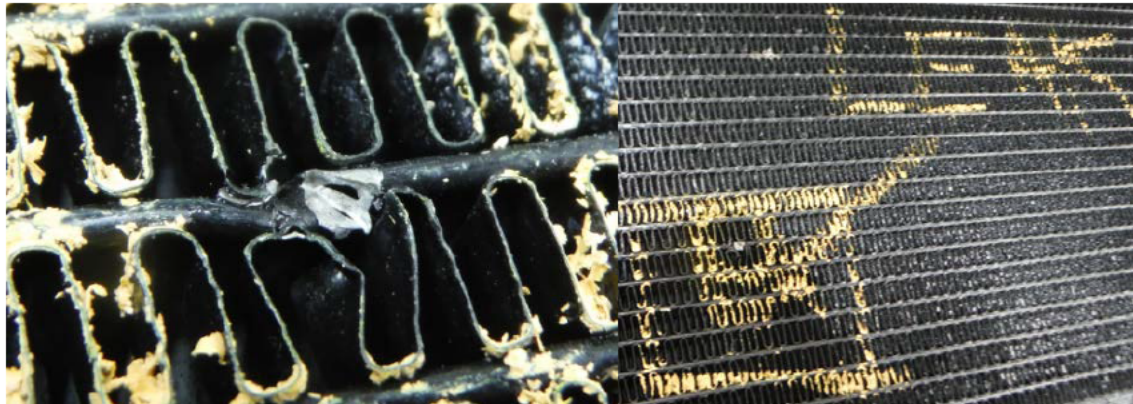
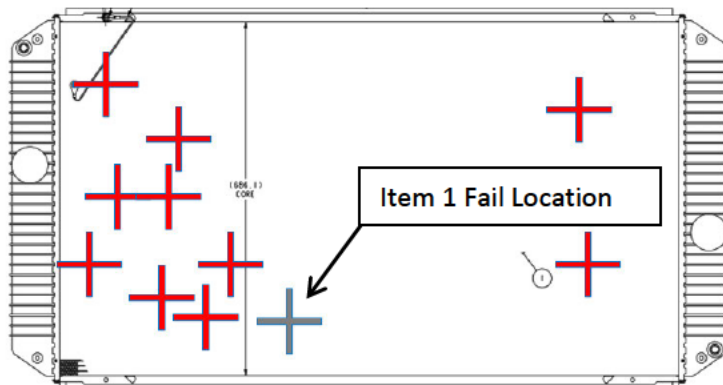
Modine Test Results: Inspection of radiator found exterior core tube damage where customer marked it (fan side of core).

Modine Claim Disposition: No defects in material or workmanship found. Reject

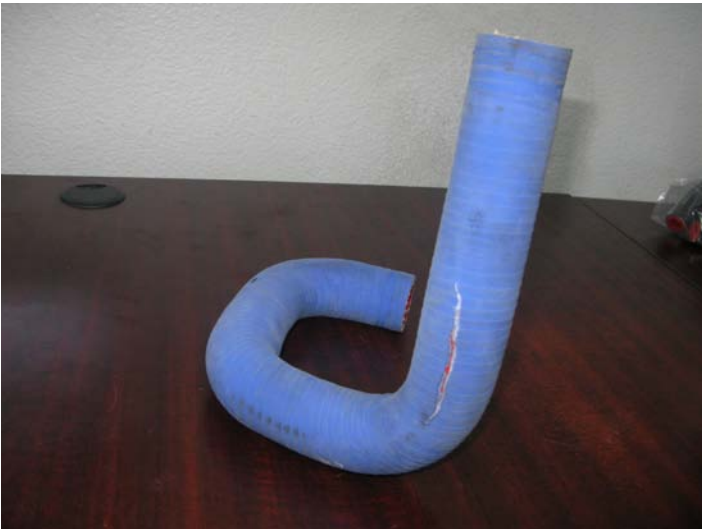
Upon initial examination of the exterior of the hose there was clear evidence of hose wall rupture. The hose was cut in half to fully expose all of the inside surface. The liner material thickness throughout the entire length of the hose was consistent. In the middle of the hose along the seam line material separation of the edges of the seam were visible at two locations. At one of the separation points fluid contamination was detected in the cavity of the separation point. It is plausible to deduce that the liner seam did not fully fuse together along the entire length of the seam during the curing cycle. With this condition the application of fluid, temperature, and constant over pressure and under pressure the structural integrity of the hose was adversely affected with fluid wicking through the reinforcement fibers until full wall rupture occurred.

HOSE AS RECEIVED

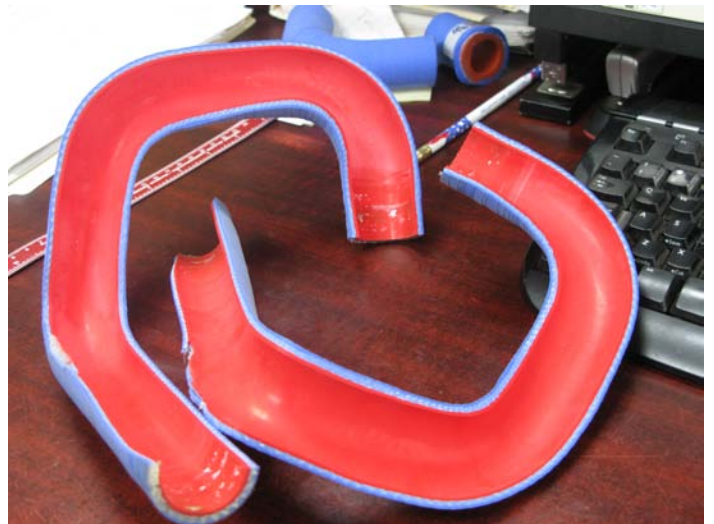
CUT SECTION VIEW

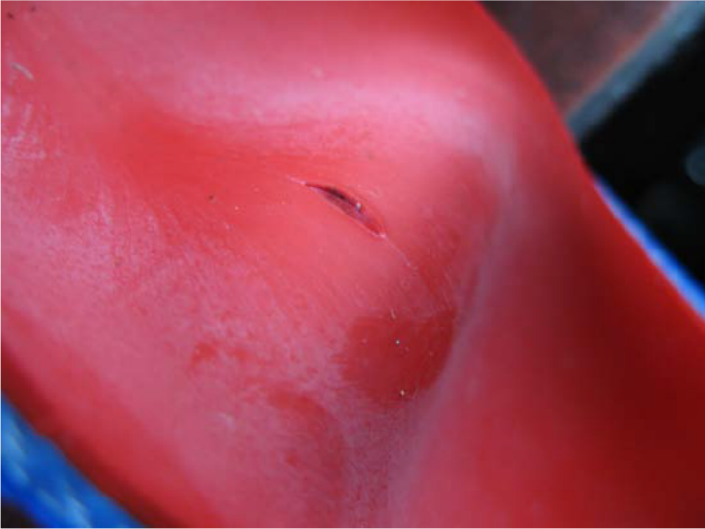
LINER BREACH POINT WITH CONTAMINATION

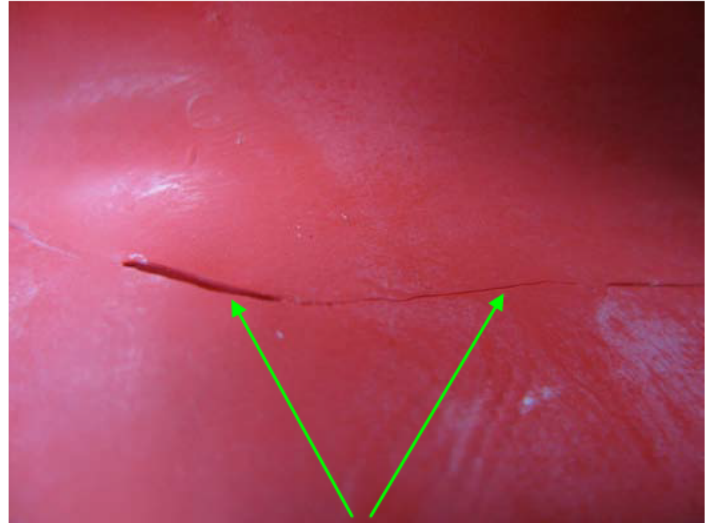
LINER SEAM SEPARATION

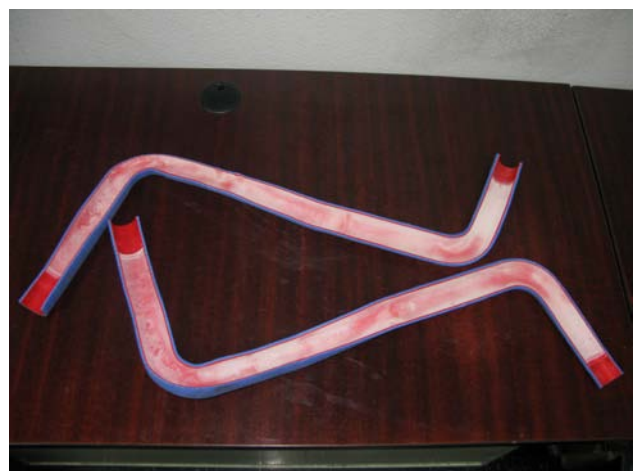
Upon initial examination of the exterior of the hose there was no evidence of damage or rupture. The hose was positioned in a hydrostatic chamber and water pressurized to 35 PSI and held at that pressure for 30 minutes. No evidence of leaking or wicking was visible. The hose was then cut in half exposing entire interior surface area. The liner thickness within specification and was consistent throughout the length of the hose. There was no evidence of thin liner condition or liner breach. From the pressure test and review of the inside of this hose all characteristics indicate the sample was in conformity to specification.

CUT SECTION VIEW
