Front brake caliper leaking

K50/11 K51/11 K52 K67

# LOW PRESSURE LEAKAGE FRONT BRAKE CALIPER HAYES. ROOT CAUSE AND MEASURE

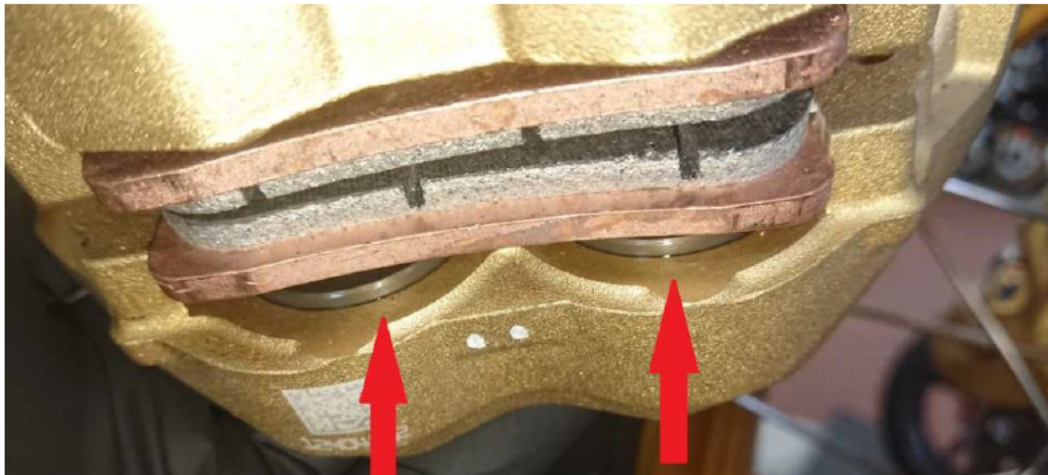
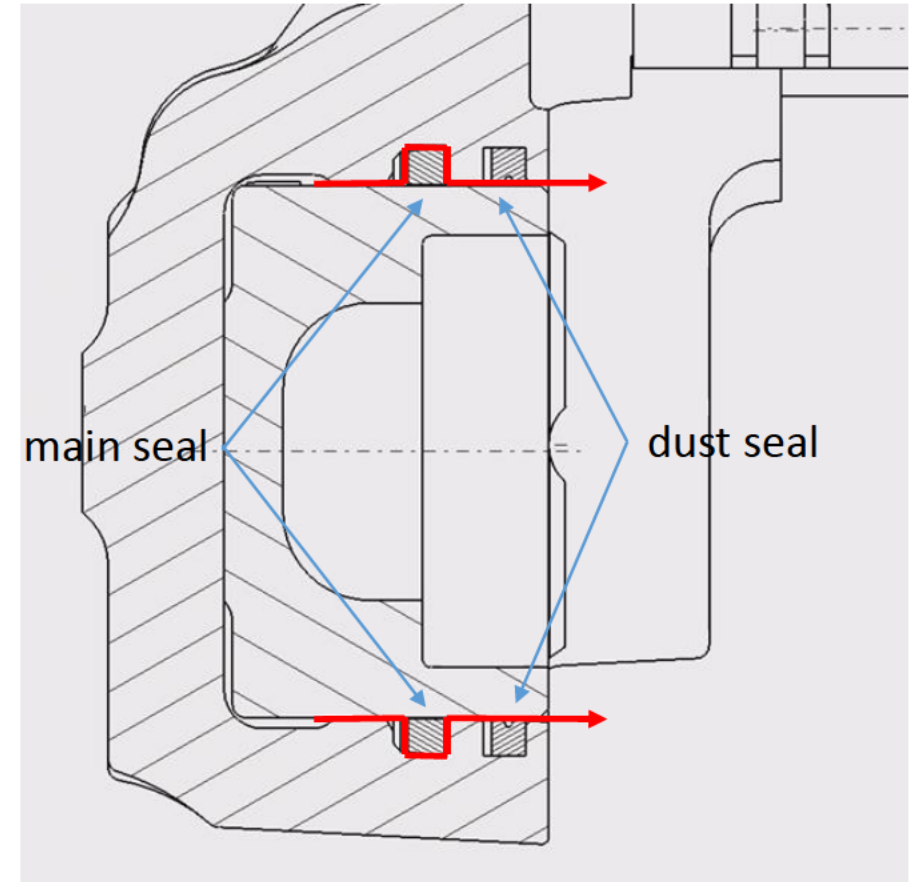
- **Core reason:**

Capillary effect between caliper body and primary seal due to too high finish roughness before launching the vehicle.

1. housing end : variation of finish roughness in the groove caused by the anodizing process
2. seal end : finish roughness due to production process (grinding)

- **Corrective actions in vehicle production:**

**Sept. 02nd 2019:** conditioning of the brake calipers before vehicle assembly (simulation of driving cycles; brake in process); → work off the rough tops

**Sept. 27th 2019 :** Lowering the roughness values of the caliper body by modification of the process

**cw 51/2019:** Lowering the roughness values of the seal outer surface by reducing the forward feed rate while grinding

**cw 03/2020 :** Change of the production process of the seal to casting process
