Front brake caliper weeping when parked

E series

K50/11 K51/11 K52 K67 K69

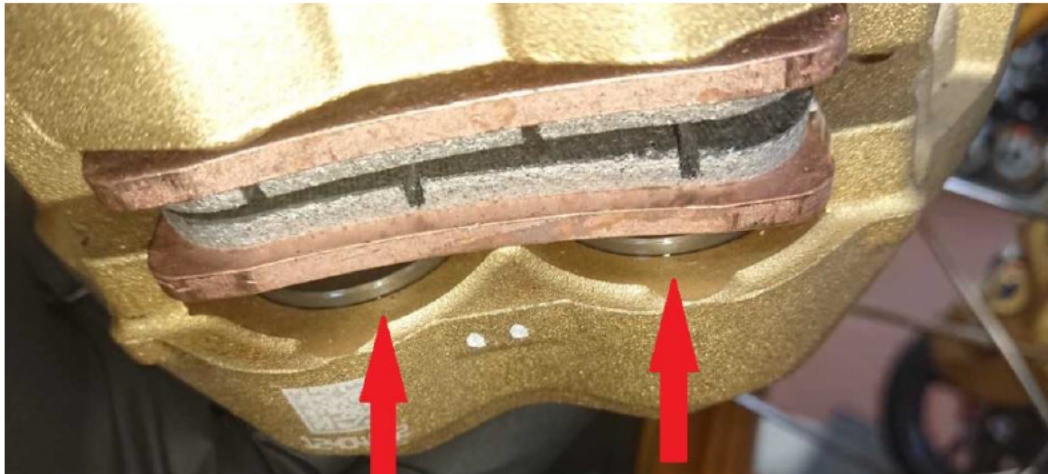
LOW PRESSURE WEEPING FRONT BRAKE CALIPER HAYES. ROOT CAUSE AND MEASURE

Capillary effect between caliper body and primary seal due to too high finish roughness before launching the vehicle.

1. housing end : variation of finish roughness in the groove caused by the anodizing process
2. seal end : finish roughness due to production process (grinding)

- **Corrective actions in vehicle production:**

Sept. 02nd 2019: conditioning of the brake calipers before vehicle assembly (simulation of driving cycles; brake in process); → work off the rough tops

Sept. 27th 2019 : Lowering the roughness values of the caliper body by modification of the process

cw 51/2019: Lowering the roughness values of the seal outer surface by reducing the forward feed rate while grinding

cw 03/2020 : Change of the production process of the seal to casting process
