SIB 34 01 20

2020-03-24

FRONT BRAKE CALIPER WEEPAGE WHEN PARKED

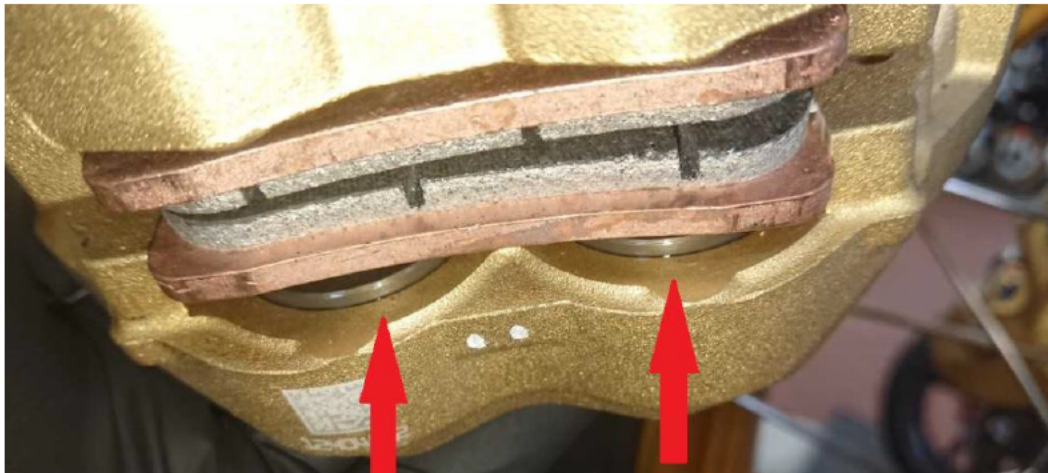
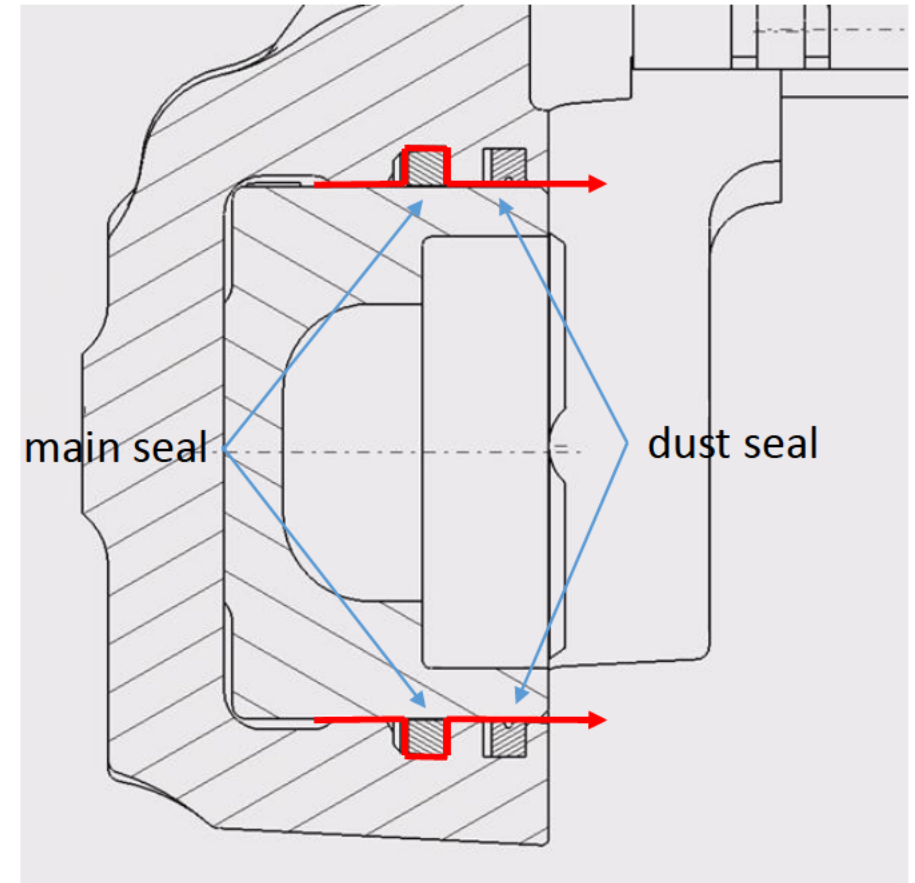
Capillary effect between caliper body and primary seal due to too high finish roughness before launching the vehicle.

1. housing end : variation of finish roughness in the groove caused by the anodizing process
2. seal end : finish roughness due to production process (grinding)

Sept. 02nd 2019: conditioning of the brake calipers before vehicle assembly (simulation of driving cycles; brake in process); → work off the rough tops

Sept. 27th 2019 : Lowering the roughness values of the caliper body by modification of the process

cw 51/2019: Lowering the roughness values of the seal outer surface by reducing the forward feed rate while grinding

cw 03/2020 : Change of the production process of the seal to casting process
