## **\*\* Tech Tip \*\* - TT-019-2016 Automated Manual Transmission ( AMT ) Bearing And Gear Shaft Inspection**

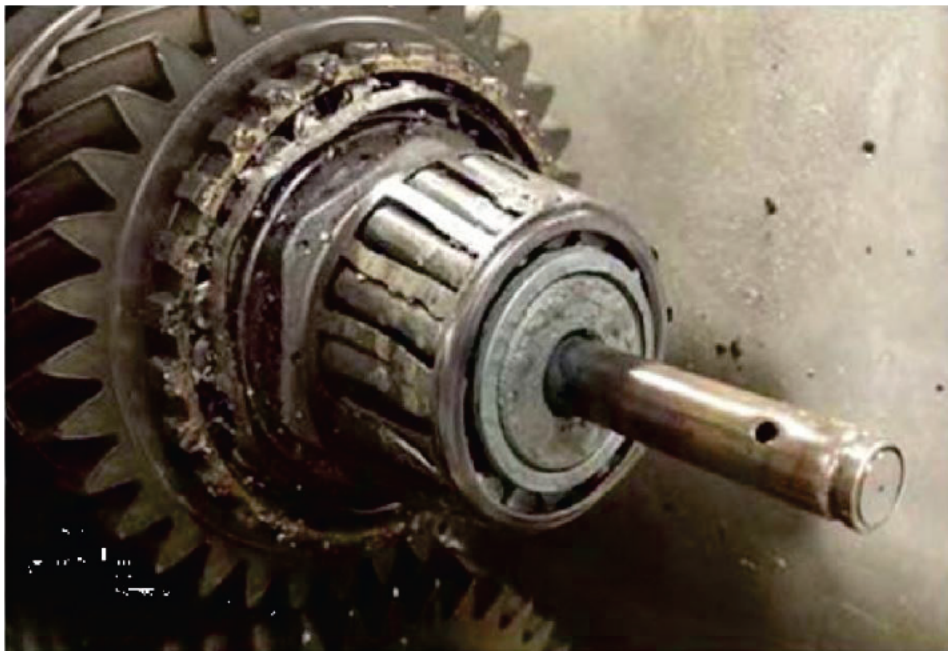
**Towing Related Failure (Image 1)**

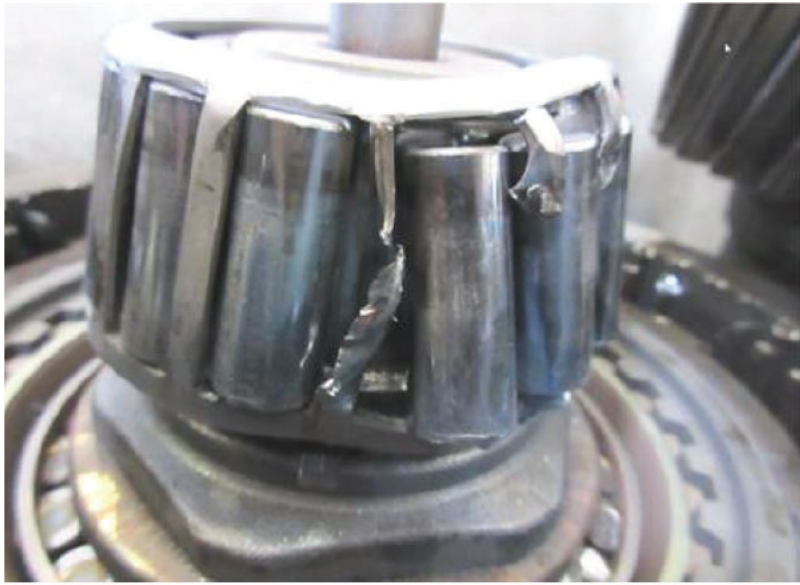
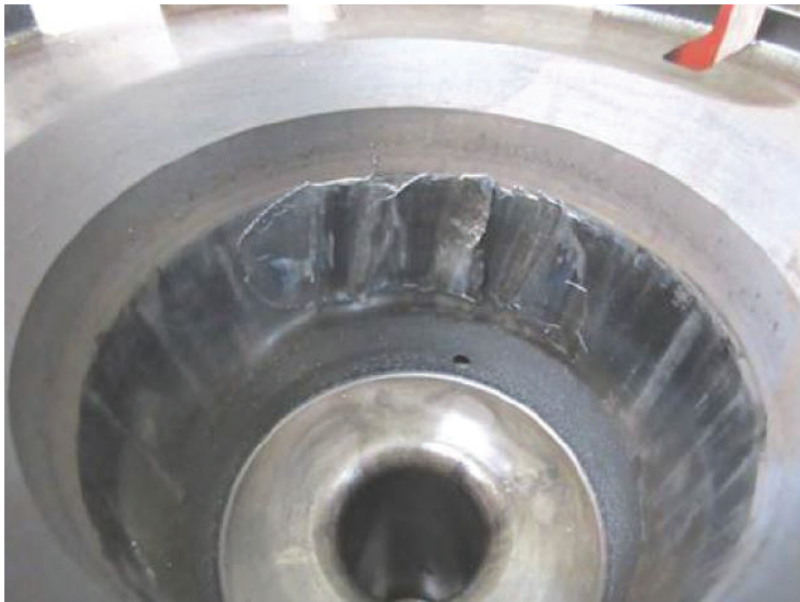
**Towing Related Failure (Image 2)**

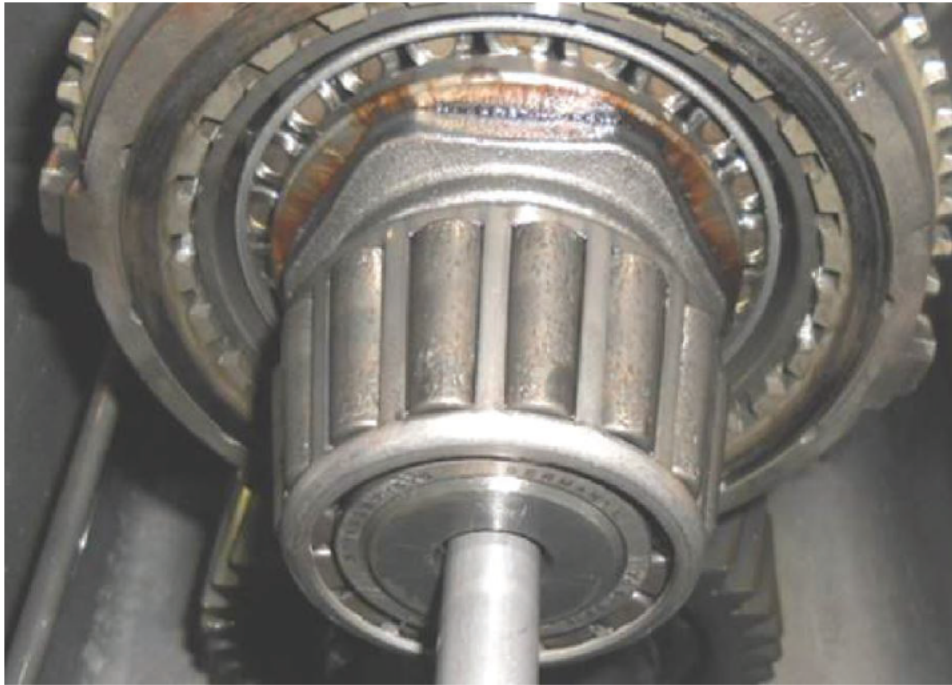
**Spalled bearing failure (Image 3)**

1. The ridge in the input shaft. This is similar to what is seen in the spalled spigot bearing failure **image 3**.
2. The DTC readout, as in the example below. The vehicle clock is incorrect however you can assume that the "Last Occurrence" has to be close to the readout day. In this example you can see that there had been main shaft codes for ~2 mo and split shift codes for ~3mo

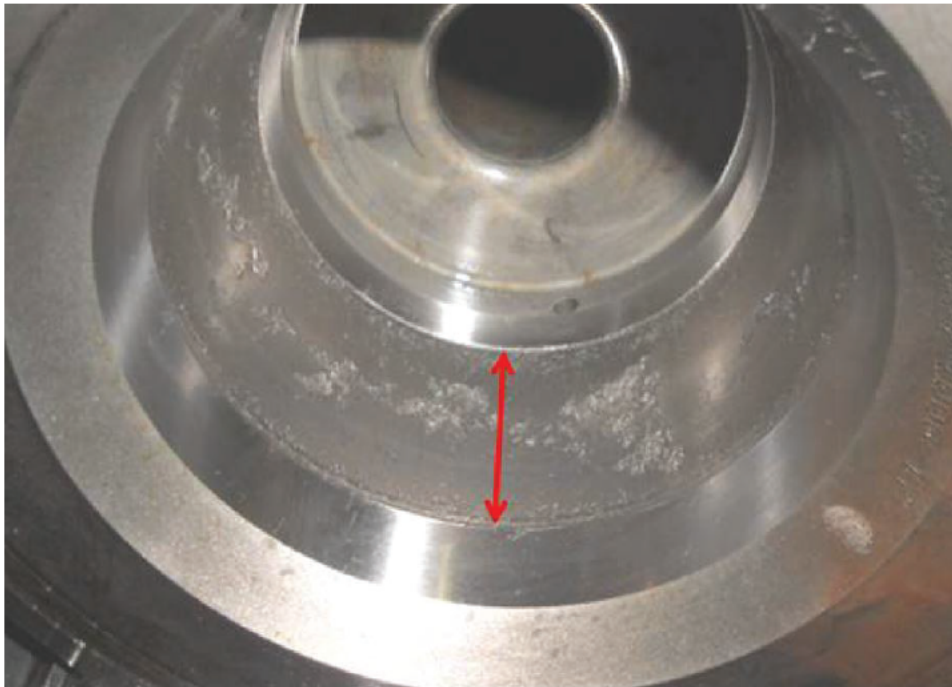
**Spalled bearing race (Image 4)**

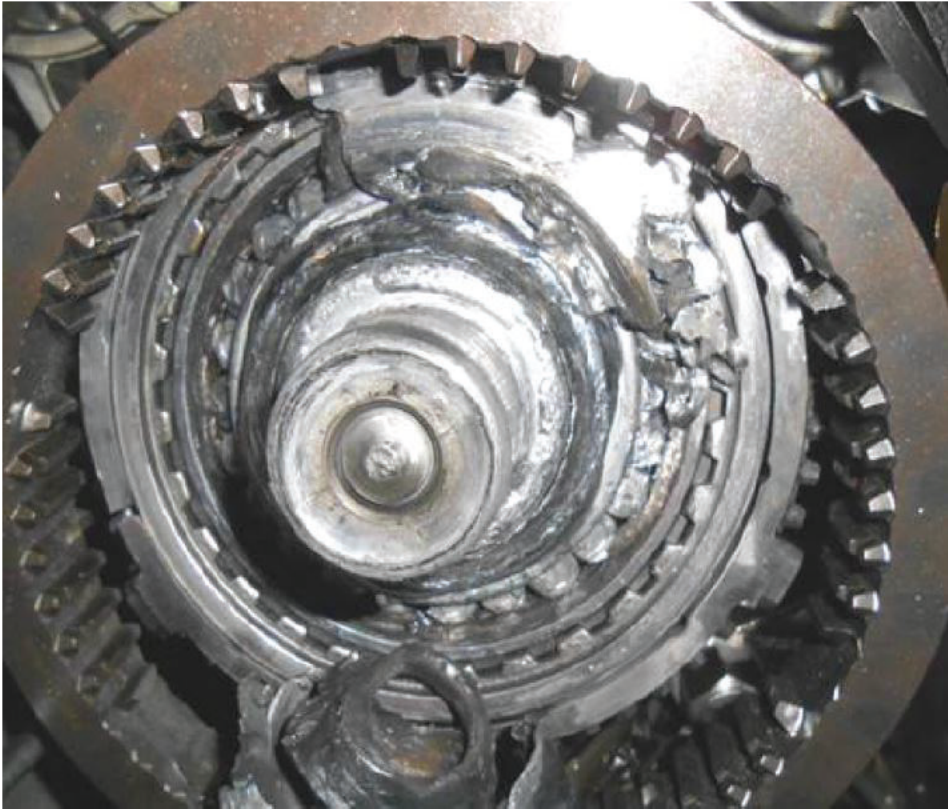
**Spalled Bearing Failure (Image 5)**

**These images (5 & 6) represent a failure that went ignored for some time.**

While the main shaft does not have evidence of heat as in the towing example (image 1), there are additional parts that have been affected:

- Contact with the main shaft nut
- Rollers missing and race worn down
- Oil distribution tube twisted off and closed
- P1 bearing damaged
- Split synchro ring broken

Clues that this may have been a spalled, or otherwise damaged, spigot bearing is:

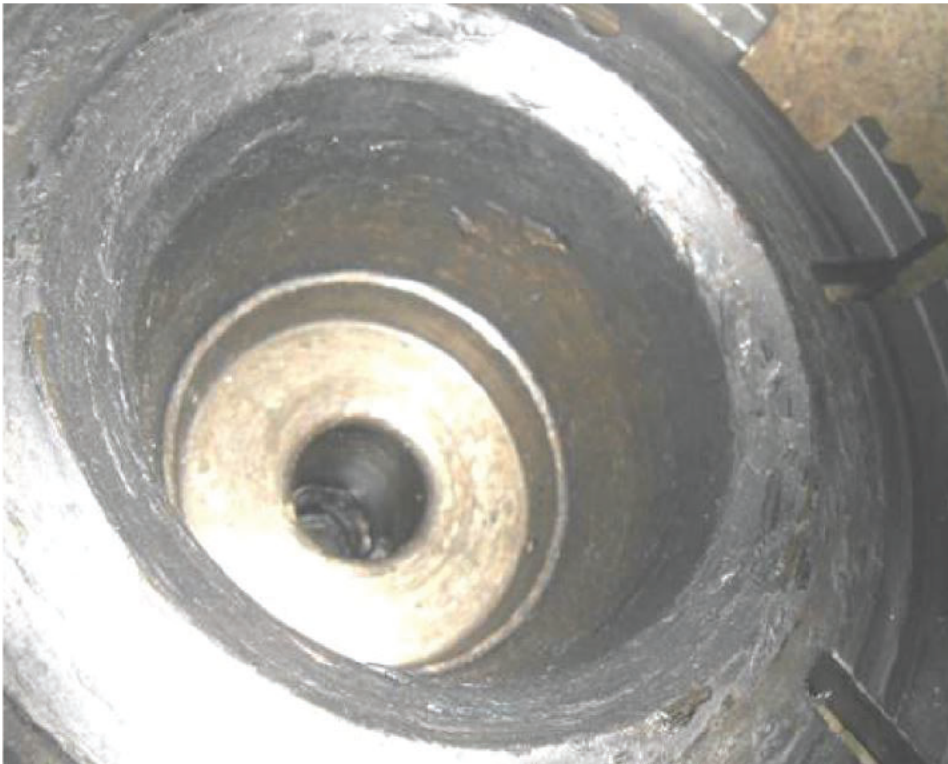
**Spalled Bearing Race (Image 6)**
