## Automated Manual Transmission (AMT) Concentric Clutch Actuator (CCA), Diagnostic guidance for P107538

### Fault Tracing Requirements and Criteria

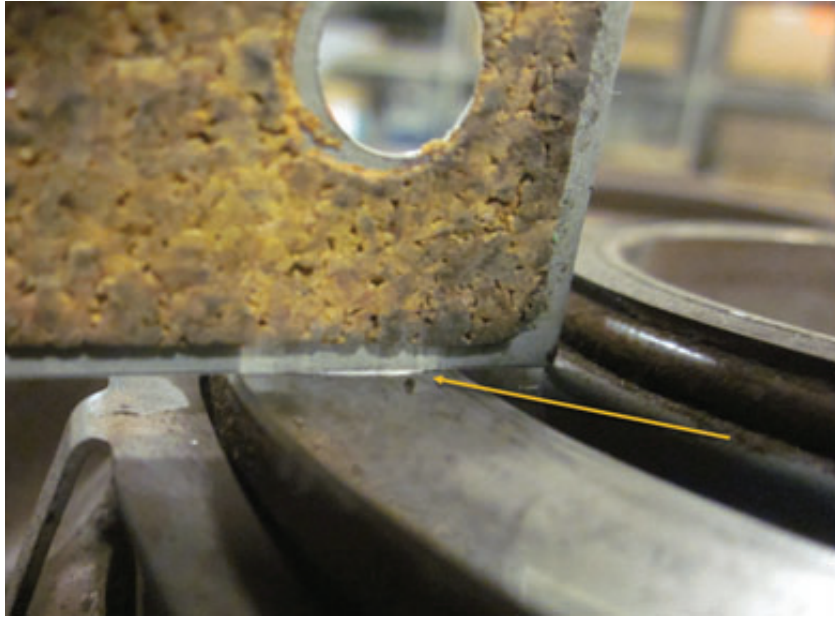
- The example below shows a bearing face with normal wear, caused by the movement between the clutch fingers and the bearing face.

- CCAs with wear greater than shown above do not cause a functional issue. The bearing should be reused if nothing else is found wrong.

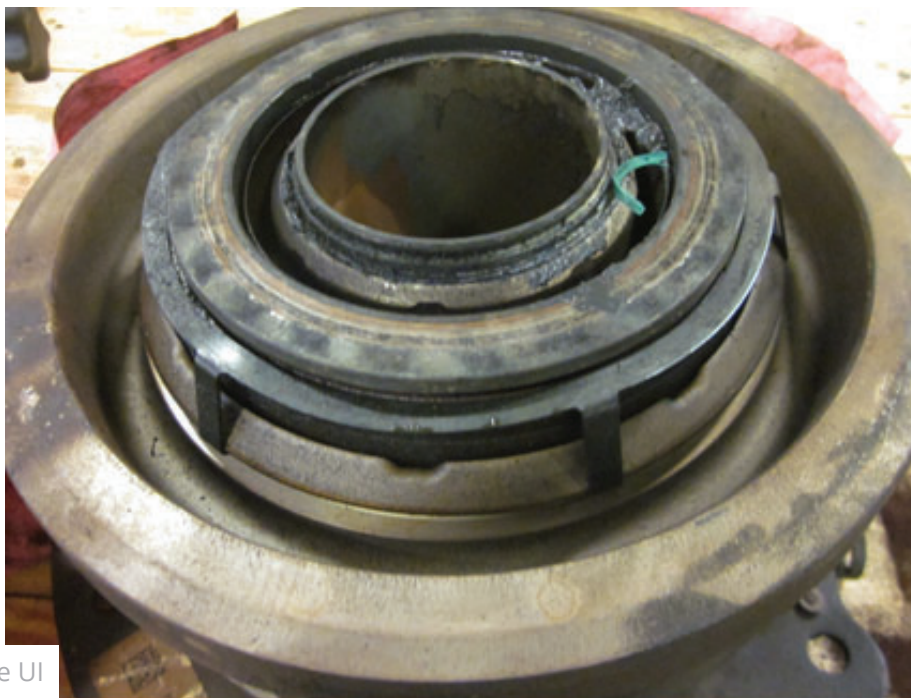
- A CCA that has had a clutch failure with extreme heat should be inspected. A melted, extremely worn or missing dust boot should be replaced.

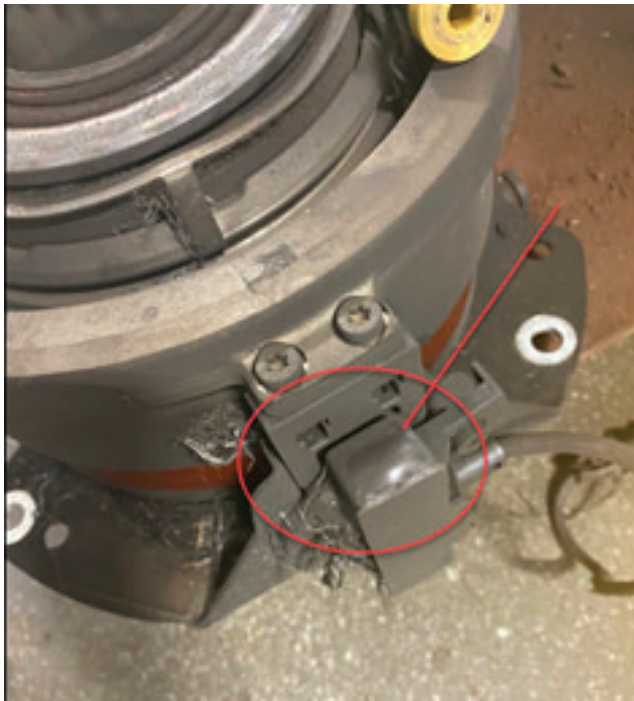
- A CCA that passes all of the evaluations but has a melted position sensor can be reused and the sensor replaced separately. An example is shown below:

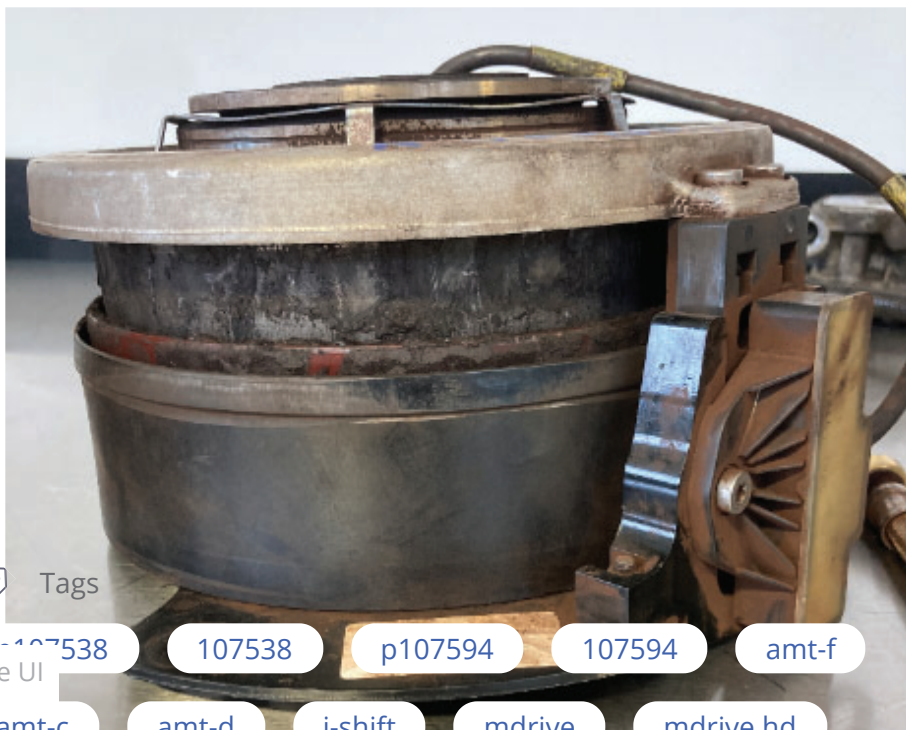
- Check the outer dust skirt as shown in the picture below. If the outer dust skirt is out of place, replace the CCA.
