# Product Safety Recall

## N202311730 High Voltage Battery May Melt or Burn

Release Date: November 2020

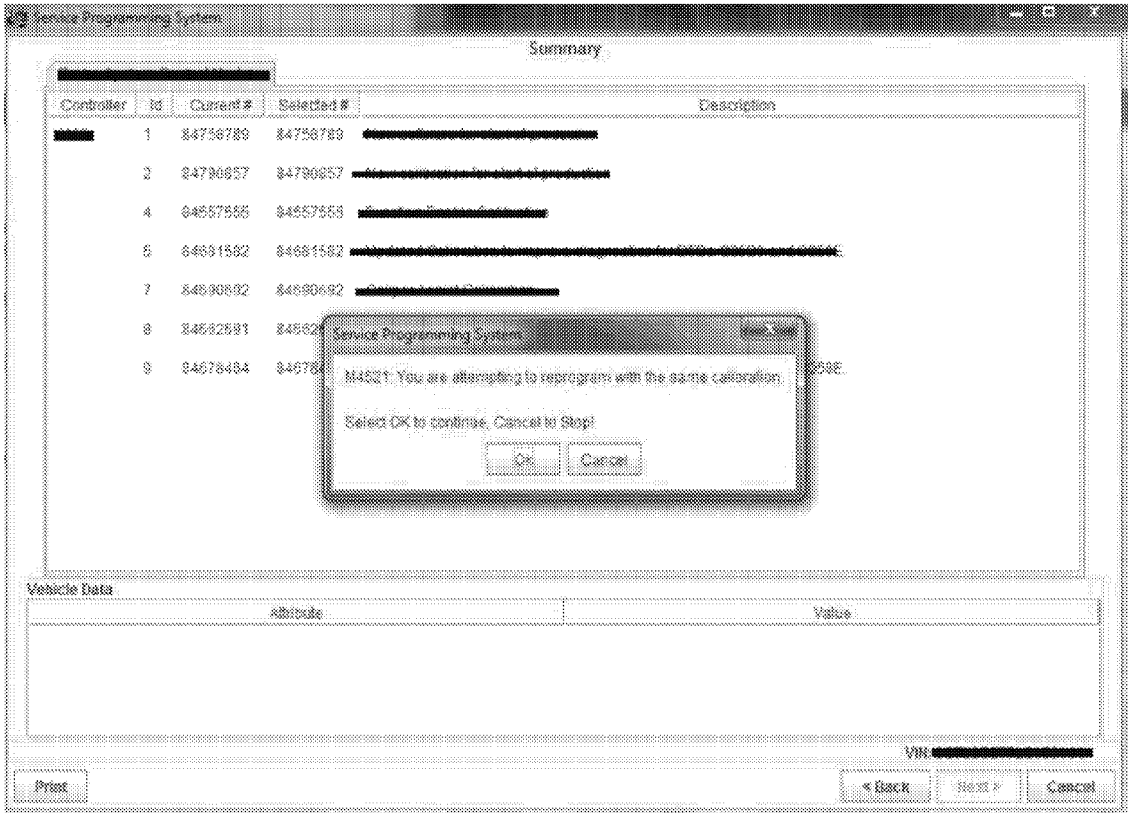
5431207

**Important:** Techline Connect and TIS2WEB screens shown above.

**Important:** If the same calibration/software warning is noted on the TLC or SPS Summary screen, select OK and follow screen instructions. After a successful programming event, the WCC is located in the Service Programming System dialogue box of the SPS Summary screen. No further action is required. Refer to the Warranty section of the bulletin.

- 1.Reprogram the K114B Hybrid/EV Powertrain Control Module 2. Refer to *K114B Hybrid/EV Powertrain Control Module 2: Programming and Setup* in SI.

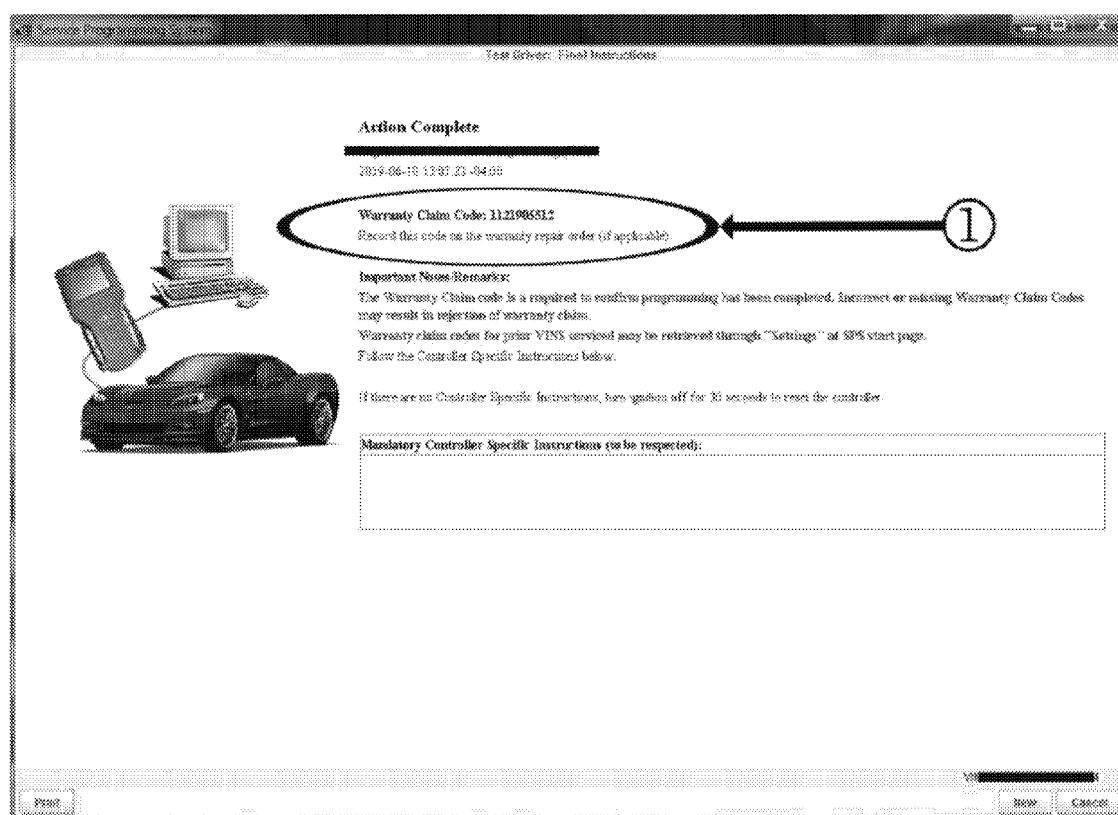
5431209

**Note:** The screenshots above are an example of module programming and may not be indicative of the specific module that is being programmed. Module selection and VIN information have been blacked out.

**Important:** To avoid warranty transaction rejections, you **MUST** record the warranty claim code provided on the Warranty Claim Code (WCC) screen shown above on the job card. Refer to callout 1 above for the location of the WCC on the screen.

2. Record SPS Warranty Claim Code on job card for warranty transaction submission.
