# Recall Bulletin

## PRODUCT SAFETY RECALL

**SUBJECT:** Rear Toe Link Adjuster Lock Nut Torque

**MODELS:** 2010-2015 Cadillac SRX  
2011-2012 Saab 9-4X

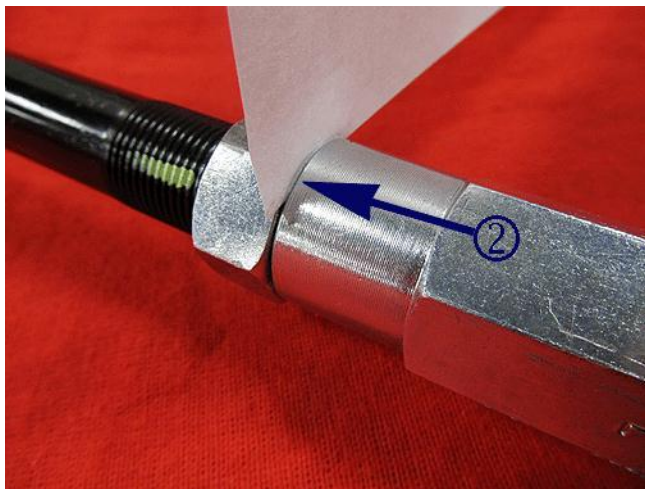
3980942

(1) Paper does NOT fit between jam nut and rear suspension adjustment link. (2) Paper fits between jam nut and rear suspension adjustment link.

- Inspect the toe link assembly for loosened jam nuts. Use a piece of paper to determine if there is a gap between the jam nut and the adjustment collar.
5. If the adjustment link fails any of the above tests, replace the adjustment link assembly. Refer to *Adjust Link Replacement* in SI.

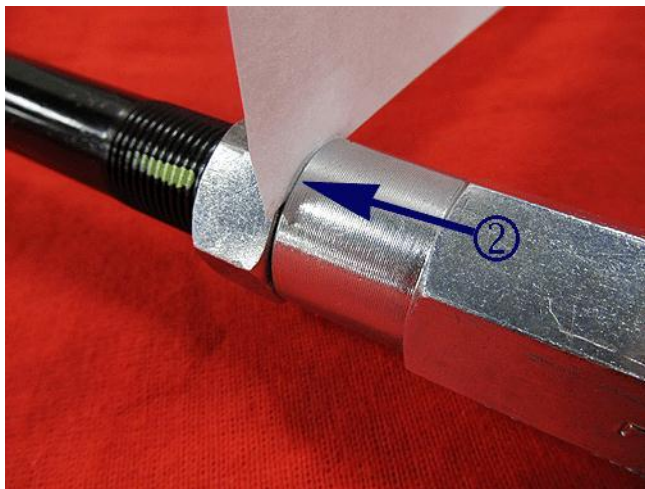
3980942

(1) Paper does NOT fit between jam nut and rear suspension adjustment link. (2) Paper fits between jam nut and rear suspension adjustment link.

- Inspect the toe link assembly for loosened jam nuts. Use a piece of paper to determine if there is a gap between the jam nut and the adjustment collar.
5. If the adjustment link fails any of the above tests, replace the adjustment link assembly. Refer to *Adjust Link Replacement* in SI.

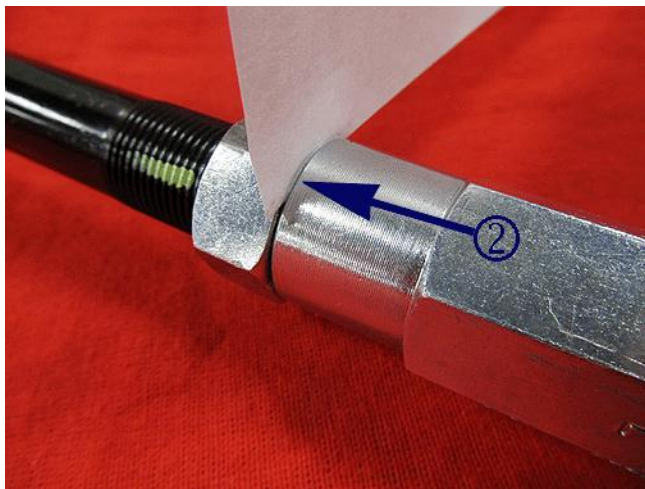
3980942

(1) Paper does NOT fit between jam nut and rear suspension adjustment link. (2) Paper fits between jam nut and rear suspension adjustment link.

- Inspect the toe link assembly for loosened jam nuts. Use a piece of paper to determine if there is a gap between the jam nut and the adjustment collar.
5. If the adjustment link fails any of the above tests, replace the adjustment link assembly. Refer to *Adjust Link Replacement* in SI.

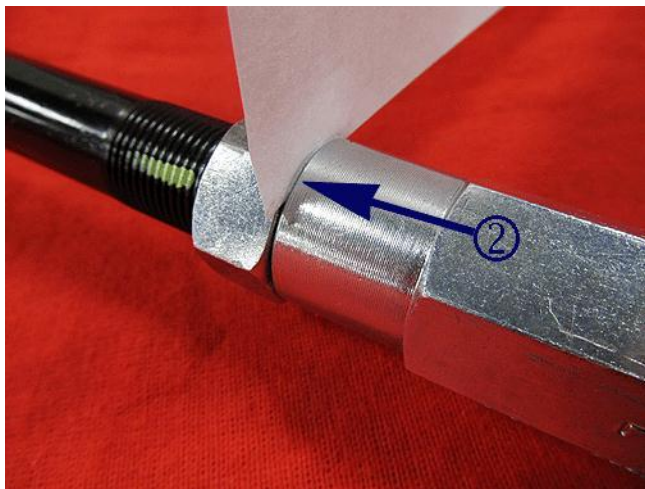
3980942

(1) Paper does NOT fit between jam nut and rear suspension adjustment link. (2) Paper fits between jam nut and rear suspension adjustment link.

- Inspect the toe link assembly for loosened jam nuts. Use a piece of paper to determine if there is a gap between the jam nut and the adjustment collar.
4. If the adjustment link fails any of the above tests, replace the adjustment link assembly. Refer to *Adjust Link Replacement* in SI.
