File Name: LAS\_REVIEWED\_2010-2015 SRX REAR SUSPENSION  
VOQS 3\_20\_2015.XLSM

### CONDITION

General Motors has decided that a defect which relates to motor vehicle safety exists in certain 2010-2015 model year Cadillac SRX vehicles and 2011-2012 Saab 9-4X vehicles. On some of these vehicles, the jam nut in the rear suspension toe adjuster link may not be torqued to the proper specification. A loose toe adjuster link can cause the vehicle to sway or wander at highway speed, activate the vehicle's electronic stability control system, and cause excessive wear to the threads in the link. Additionally, the rear suspension may make loud metallic noises, particularly when the vehicle is travelling over bumps or potholes. If the threads in the link become worn, the link may separate. If separation occurs while the vehicle is being driven, it would create sudden vehicle instability, increasing the risk of a crash.

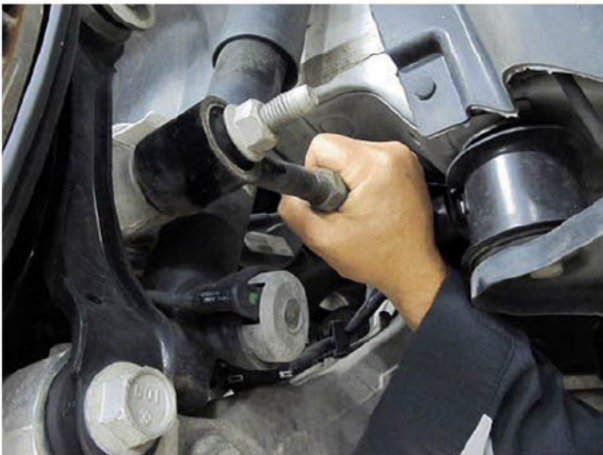
3979306

- Grasp the adjustment collar and push up and pull down firmly, note any movement in the link assembly components (the ends are rubber mounted and will have some movement)

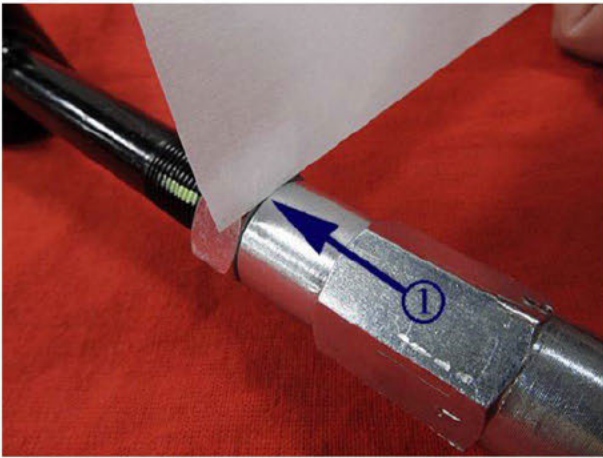
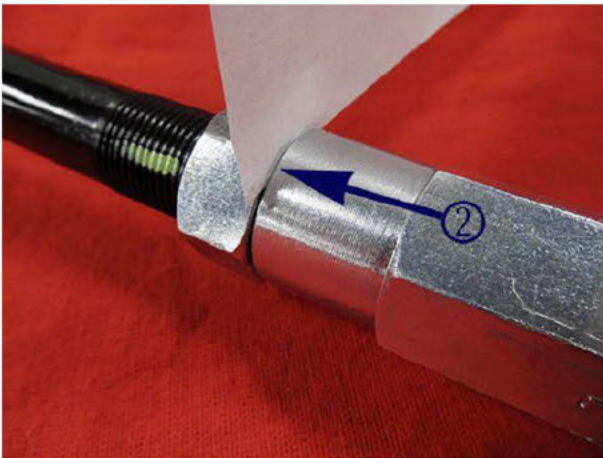
(1) Paper does NOT fit between jam nut and rear suspension adjustment link. (2) Paper fits between jam nut and rear suspension adjustment link.

- Inspect the toe link assembly for loosened jam nuts. Use a piece of paper to determine if there is a gap between the jam nut and the adjustment collar.
5. If the adjustment link fails any of the above tests, replace the adjustment link assembly. Refer to *Adjust Link Replacement* in SI.

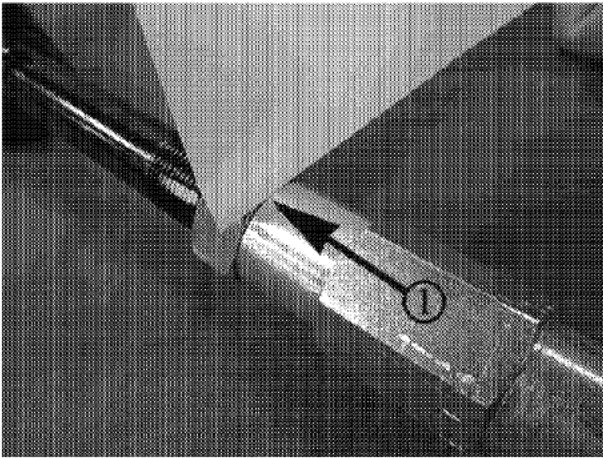
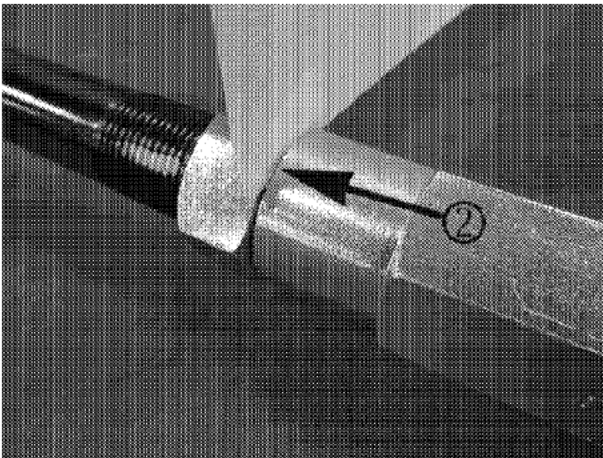
(1) Paper does NOT fit between jam nut and rear suspension adjustment link. (2) Paper fits between jam nut and rear suspension adjustment link.

- Inspect the toe link assembly for loosened jam nuts. Use a piece of paper to determine if there is a gap between the jam nut and the adjustment collar.
4. If the adjustment link fails any of the above tests, replace the adjustment link assembly. Refer to *Adjust Link Replacement* in SI.

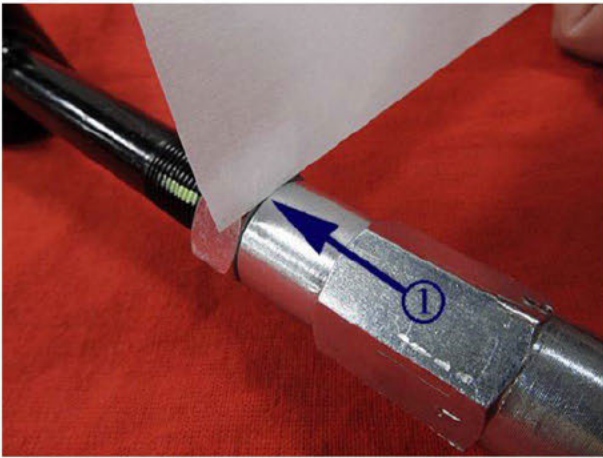
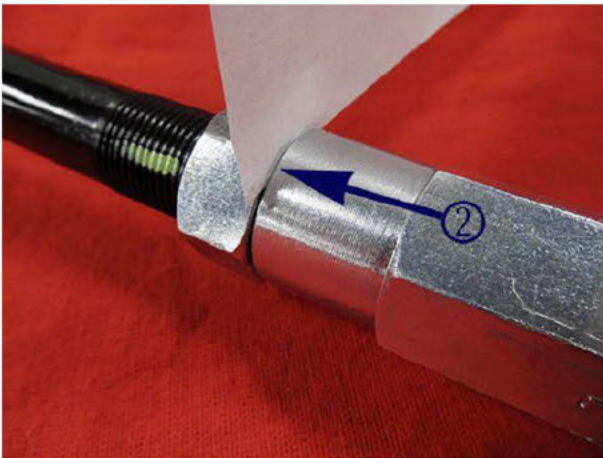
(1) Paper does NOT fit between jam nut and rear suspension adjustment link. (2) Paper fits between jam nut and rear suspension adjustment link.

- Inspect the toe link assembly for loosened jam nuts. Use a piece of paper to determine if there is a gap between the jam nut and the adjustment collar.
4. If the adjustment link fails any of the above tests, replace the adjustment link assembly. Refer to *Adjust Link Replacement* in SI.
