This file represents a consolidation of multiple files sent by the manufacturer. Please use the bookmarks to navigate to each file. (Each bookmark label is the name of the original file.)

### CONDITION

General Motors has decided that a defect which relates to motor vehicle safety exists in certain 2010-2015 model year Cadillac SRX vehicles and 2011-2012 Saab 9-4X vehicles. On some of these vehicles, the jam nut in the rear suspension toe adjuster link may not be torqued to the proper specification. A loose toe adjuster link can cause the vehicle to sway or wander at highway speed, activate the vehicle's electronic stability control system, and cause excessive wear to the threads in the link. Additionally, the rear suspension may make loud metallic noises, particularly when the vehicle is travelling over bumps or potholes. If the threads in the link become worn, the link may separate. If separation occurs while the vehicle is being driven, it would create sudden vehicle instability, increasing the risk of a crash.

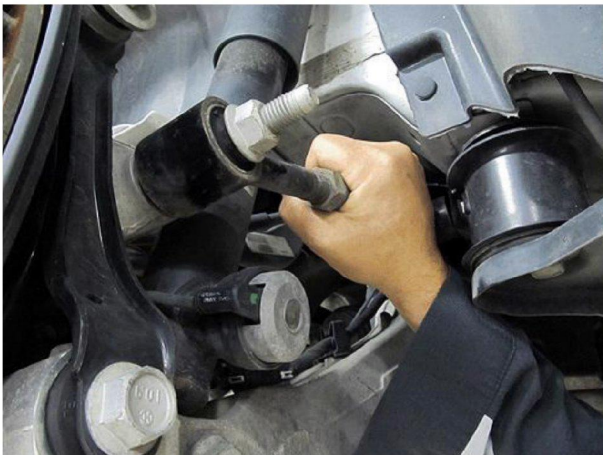
3979306

- Grasp the adjustment collar and push up and pull down firmly, note any movement in the link assembly components (the ends are rubber mounted and will have some movement)

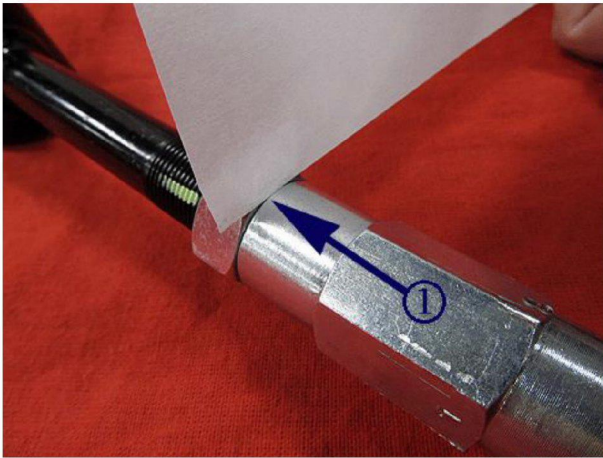
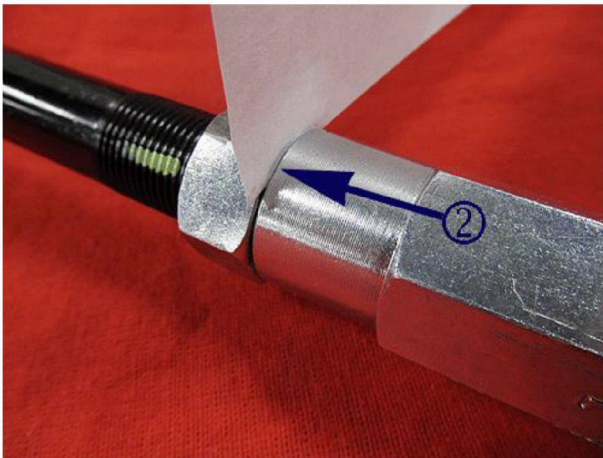
(1) Paper does NOT fit between jam nut and rear suspension adjustment link. (2) Paper fits between jam nut and rear suspension adjustment link.

- Inspect the toe link assembly for loosened jam nuts. Use a piece of paper to determine if there is a gap between the jam nut and the adjustment collar.
5. If the adjustment link fails any of the above tests, replace the adjustment link assembly. Refer to *Adjust Link Replacement* in SI.

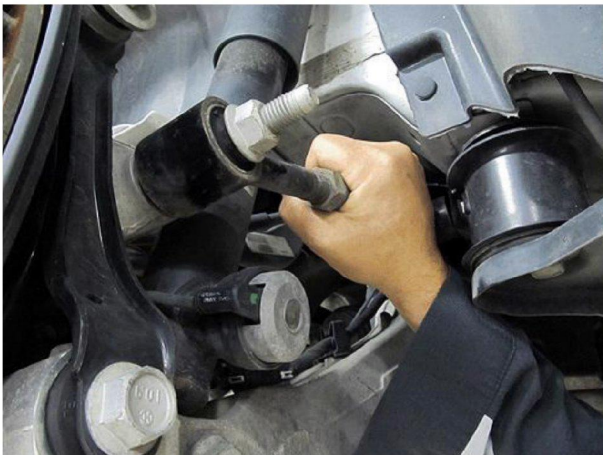
3979306

- Grasp the adjustment collar and push up and pull down firmly, note any movement in the link assembly components (the ends are rubber mounted and will have some movement)

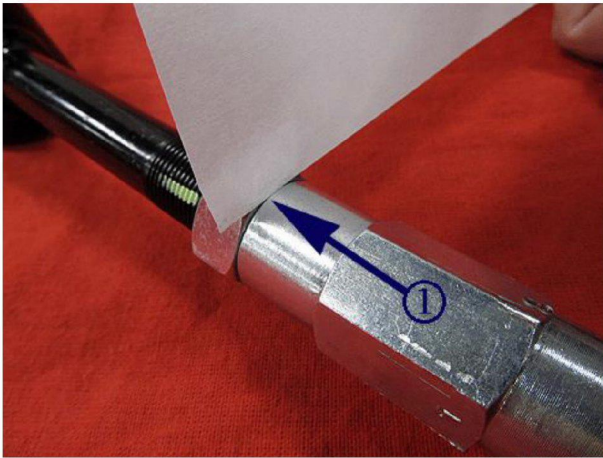
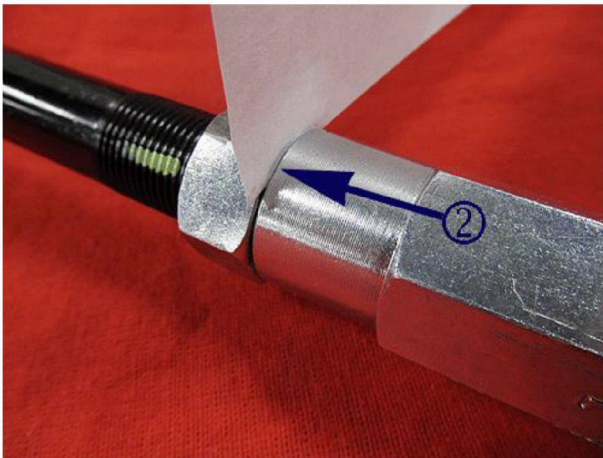
(1) Paper does NOT fit between jam nut and rear suspension adjustment link. (2) Paper fits between jam nut and rear suspension adjustment link.

- Inspect the toe link assembly for loosened jam nuts. Use a piece of paper to determine if there is a gap between the jam nut and the adjustment collar.
4. If the adjustment link fails any of the above tests, replace the adjustment link assembly. Refer to *Adjust Link Replacement* in SI.
