TriMark 060-1650 Motor Home Entrance Door Hardware

March. 12, 2021

Failure Detail

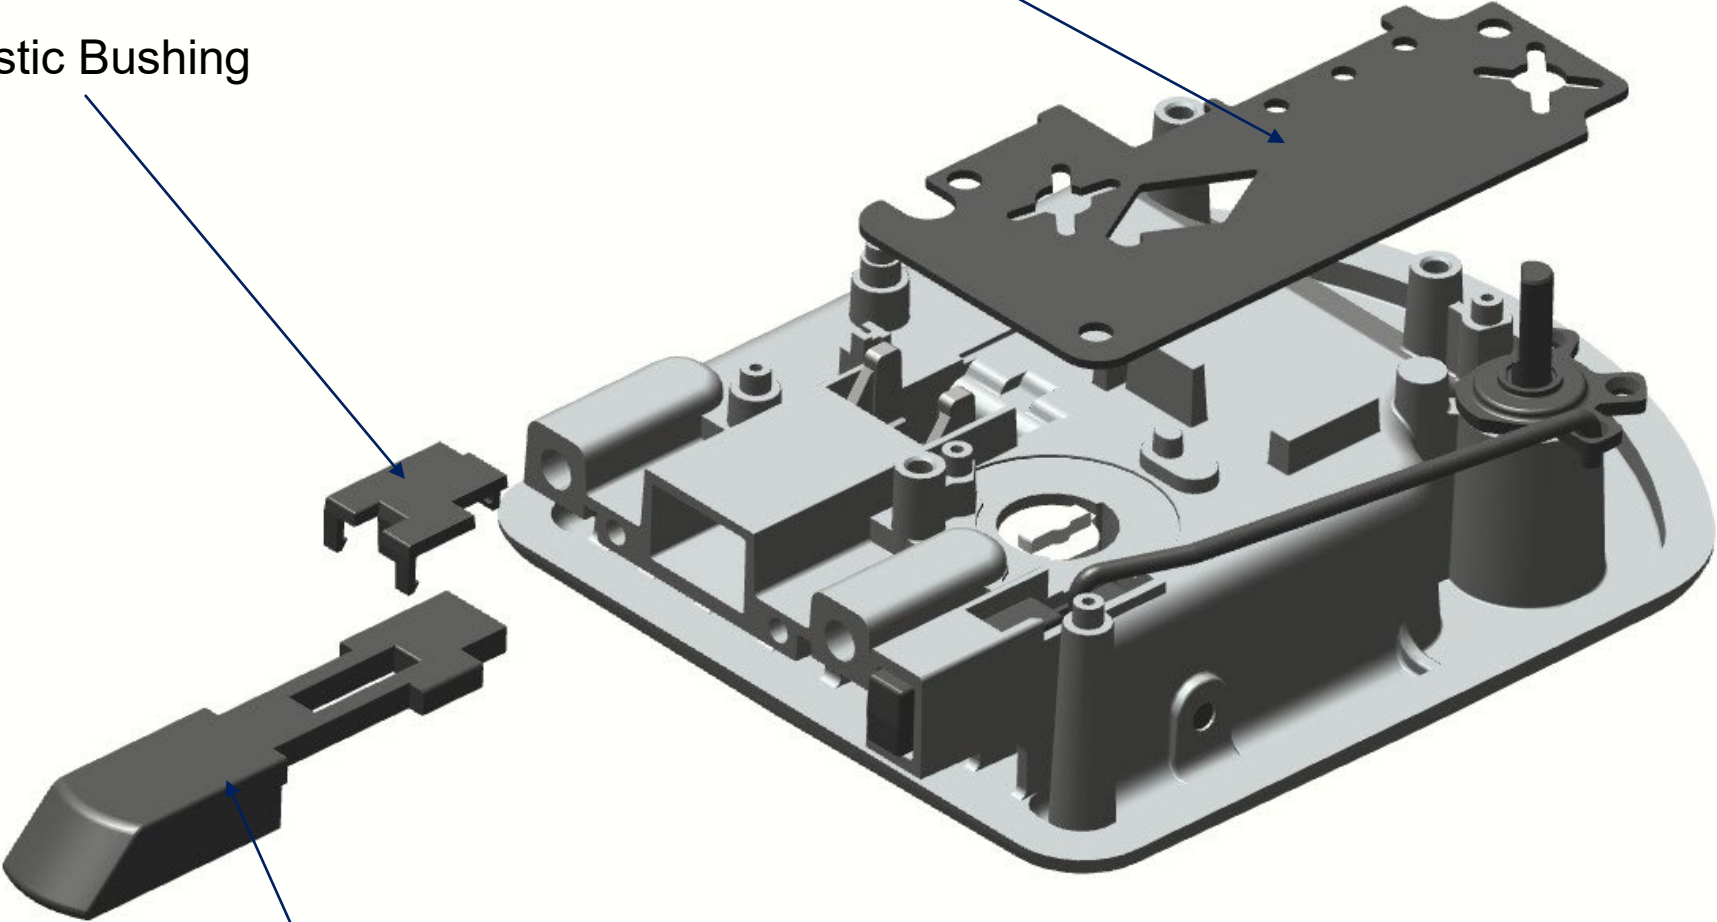
- **We know that we have had some lock-ins/lock-outs relative to the Product**
 - **First knowledge was 4/28/16 - Customer called-in (not sure make/model)**
 - **First OEM – 10/14/16 – 2 units – 1 had both a broken plunger and a fractured plastic bushing (Challenger Door - not sure make/model)**
- **TriMark has identified 3 potential causes for lock-in/lock-out**
 - **Plunger bolt failure**
 - **Broken/fractured plastic bushing**
 - **Insufficient staking of the deadbolt plate**

Deadbolt Plate

Plastic Bushing

Plunger Bolt

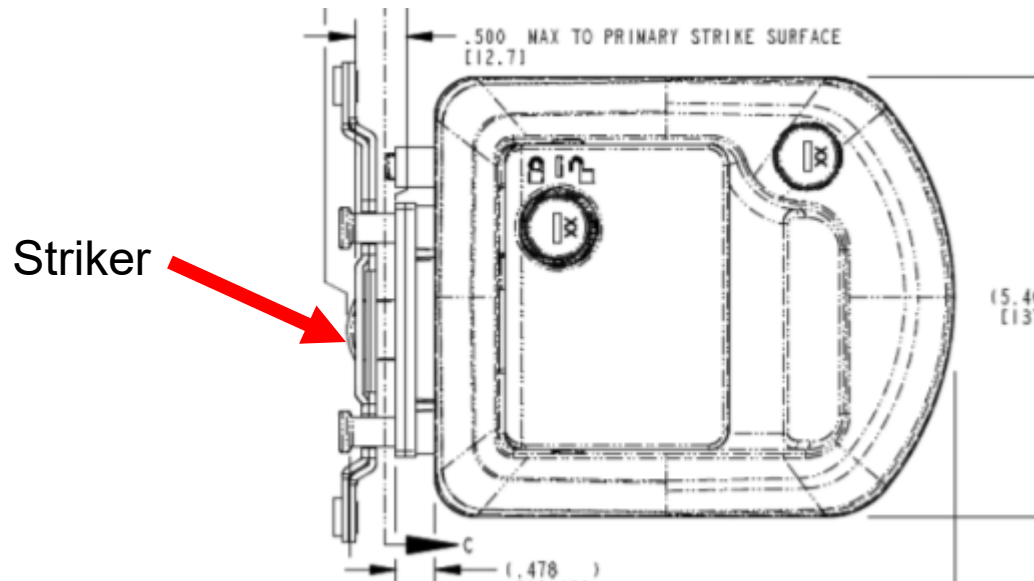
- **Plunger bolt failure**

- In extreme conditions with strike plate angularity and high door seal, the strike plate can cut a groove into the zinc plunger causing excessive force required to retract the plunger and potentially stress the plunger in the retraction mode causing plunger failure

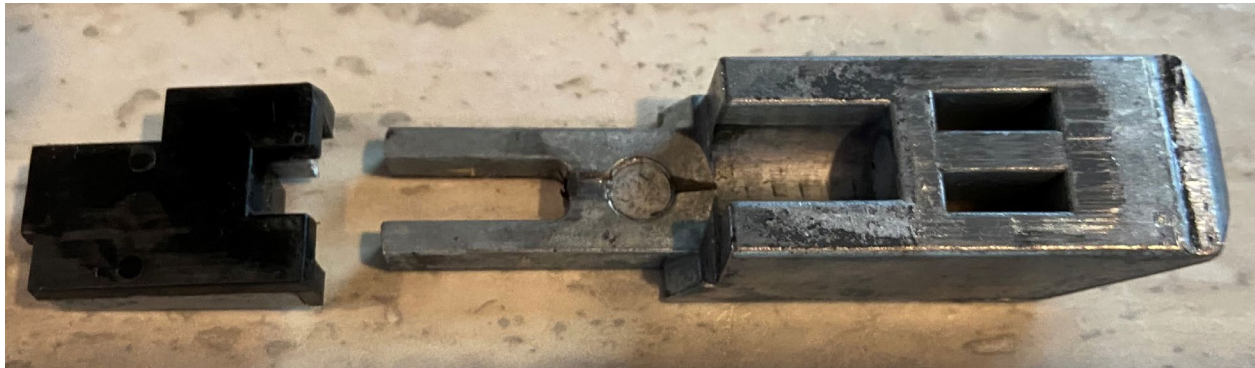
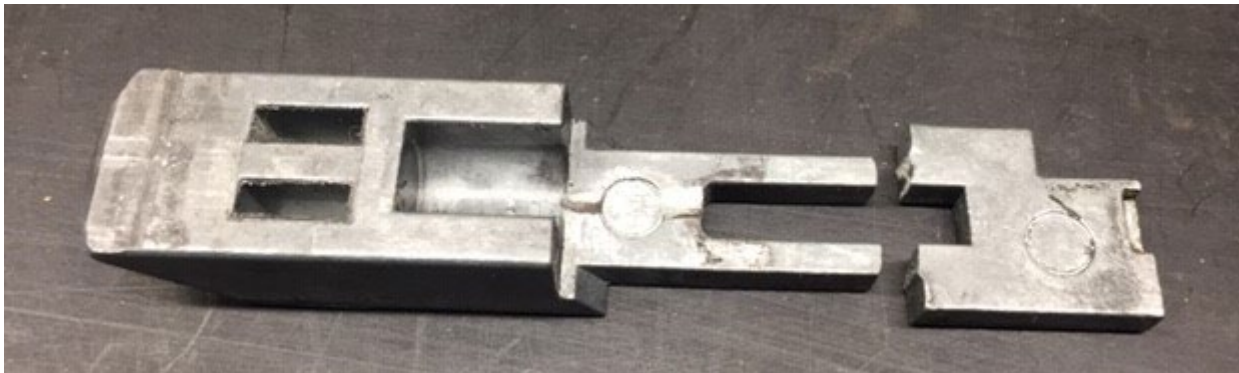
- **Plunger bolt failure**
 - Photographs of groove from striker bolt load

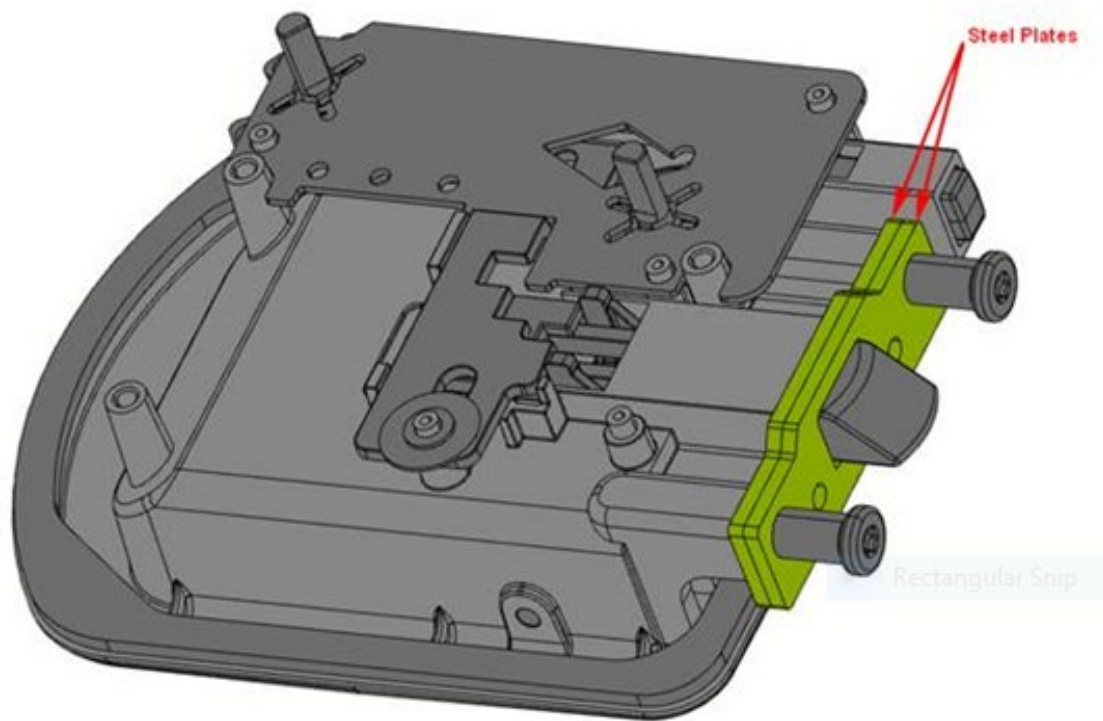
- **Plunger bolt failure**
 - Excessive striker bolt loads also causes a groove(s) to be worn on the back side of the plunger as well

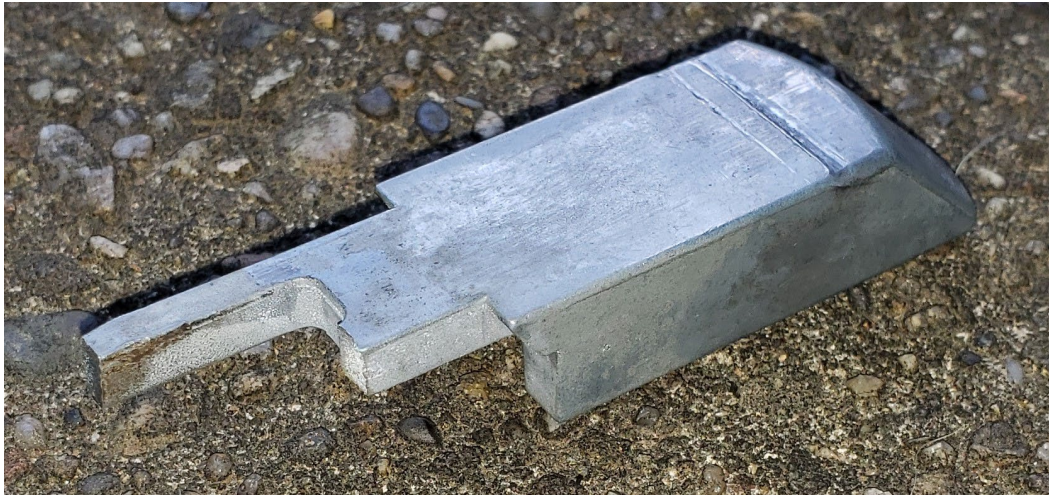
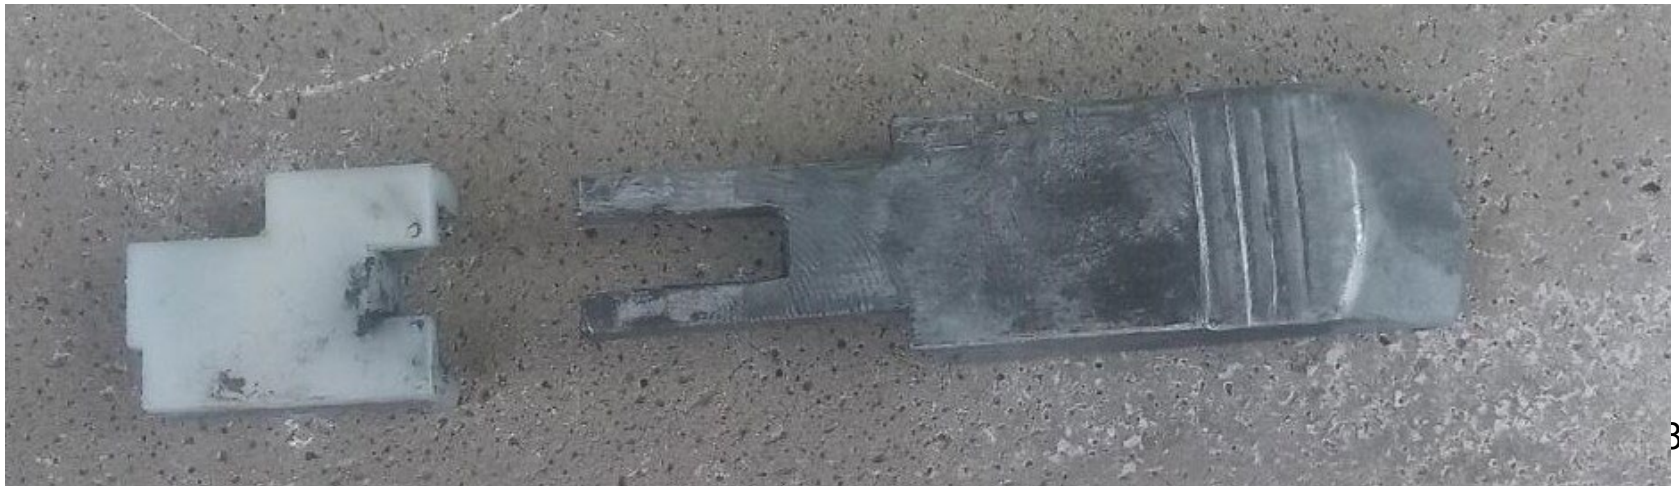
- **Plunger bolt failure**
 - Photographs – back side
