March 2009  
FL545A-C  
NHTSA #09V-024  
REVISED NOTICE

## Subject: Cascadia Cab and Chassis SAMs

**Models Affected: Specific Freightliner Cascadia vehicles manufactured with signal-detect and activation modules (SAMs) between February 20, 2006, and December 15, 2008**

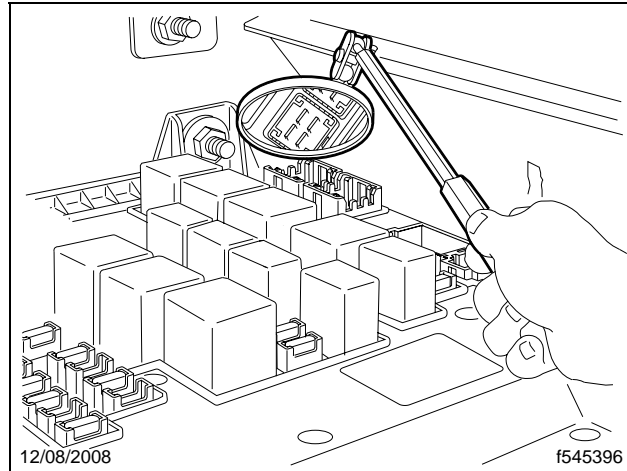
**Fig. 2, Corrosion Inspection**

8. Disconnect the four large, multi-pin connectors from the right side of the SAM Cab. Using an inspection mirror, check for extensive corrosion or evidence of excessive moisture in the connection insertion points on the SAM Cab. See **Fig. 2**. Check all the connections in the SAM Cab for extensive corrosion or evidence of moisture (whitish deposits). If extensive corrosion is found, or the module is not functioning correctly, replace the SAM Cab, following the instructions in step 9, below. To determine if the SAM Cab is functioning correctly, refer to section **G02.04** in the *Cascadia Troubleshooting Manual*.

If the connector terminals on the four wiring harnesses are damaged by extensive corrosion, replace the affected wiring ends, terminals, and connectors. If replacing the terminals, use the standard splicing technique and the butt splice connectors from Kit ESY ES 66 404. Refer to **Parts Bulletin 54-075** to identify the part numbers for the replacement connectors and terminals.
