INDICATIONS OF WATER INTRUSION WHICH COULD AFFECT THE SAMS

FL545 RECALL CAMPAIGN

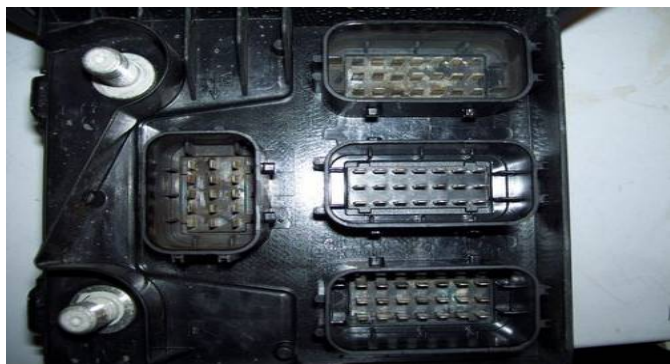
SAM Cab:

Corrosion on SAM connectors

Sealed connectors (outside)

If extensive corrosion and electrical malfunctions are present, a module may need to be replaced. If the module is dry, fully functional, and only exhibiting minor corrosion, replacement is not necessary.

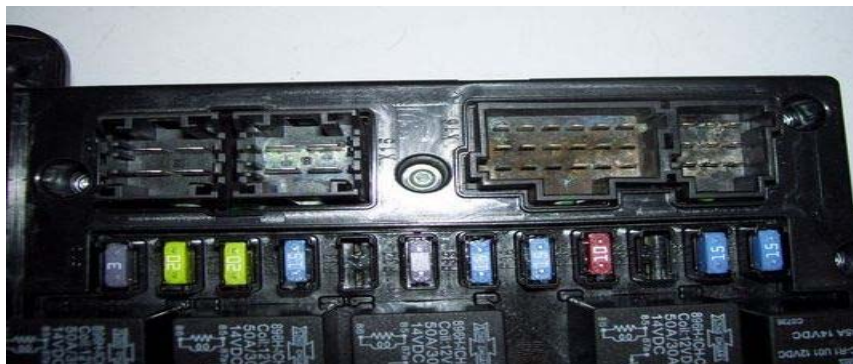
Interior connectors

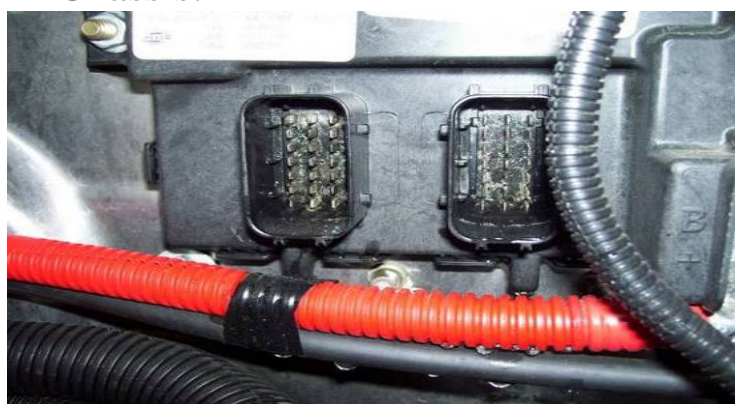
SAM Chassis:

Sealed connectors (outside)

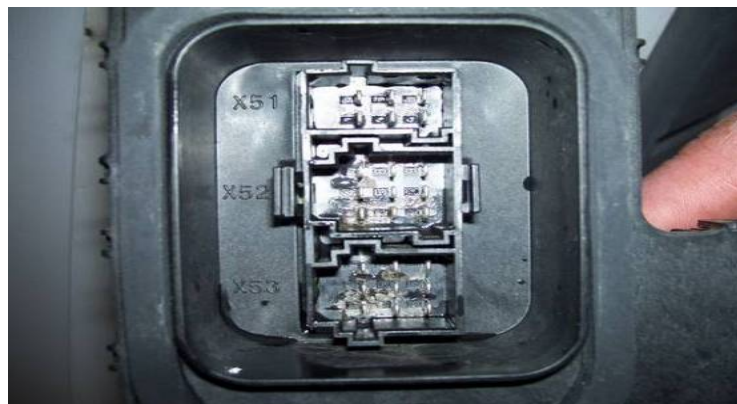
Interior connectors

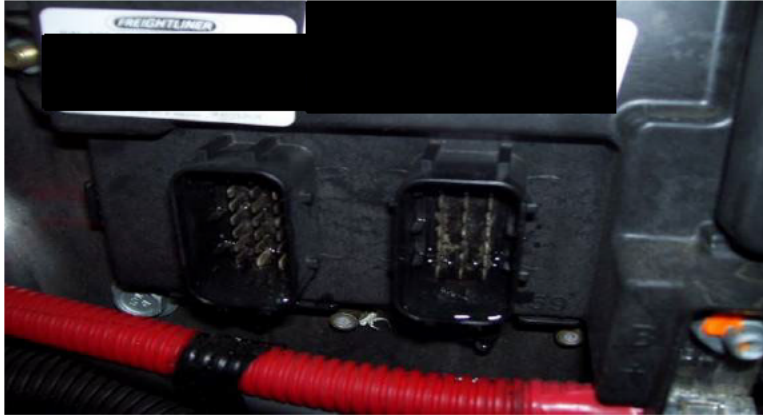
Water inside sealed connections

If water is found at any of the sealed (outside) connectors, water has entered the module. If the module is not damaged and has not exhibited any malfunctions, it should be removed, drained, dried, and reinstalled. The SAM Chassis should be drilled per the FL545 Recall Work Instructions, to allow drainage in the event of future water intrusion.

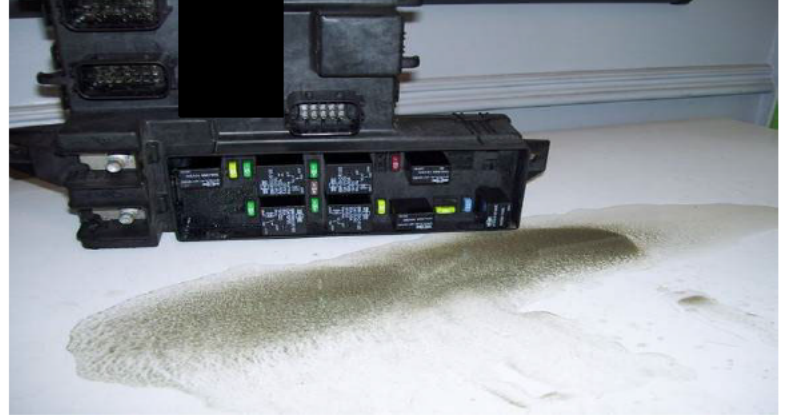
Water inside module

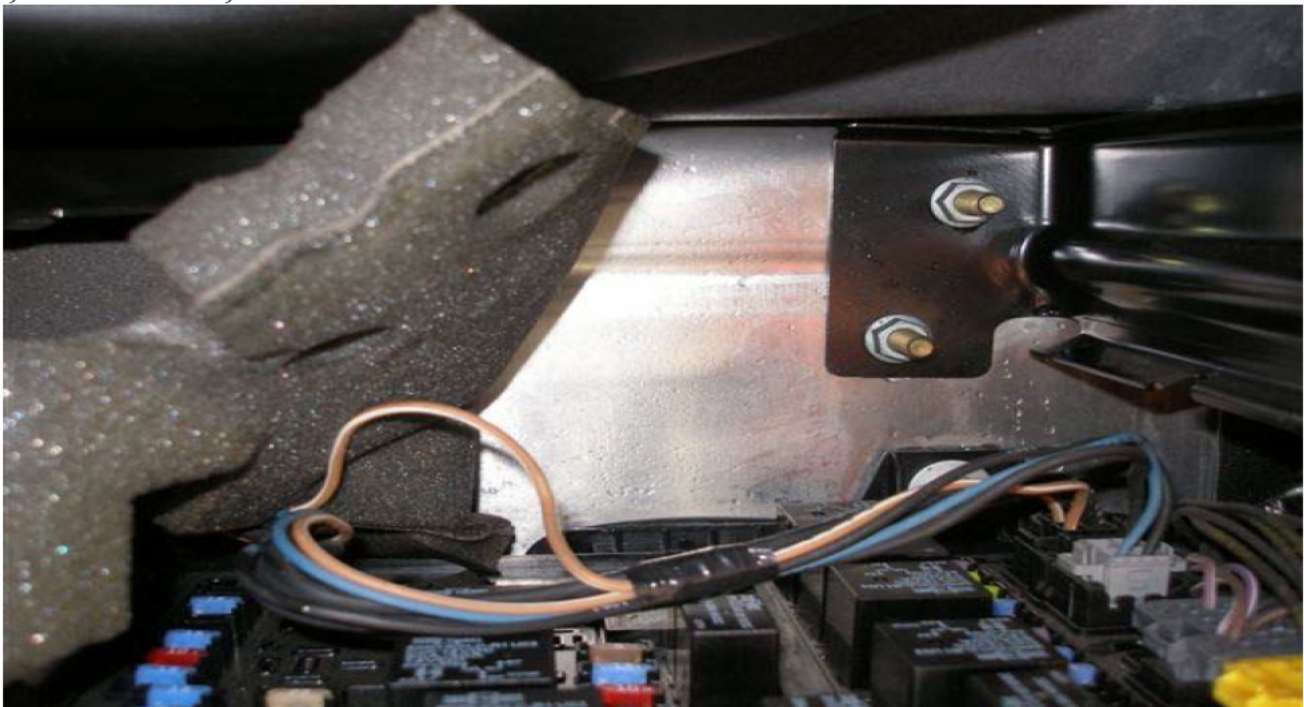
Damp insulation above the SAM Chassis or SAM Cab modules may indicate a roof-cap, windshield, and/or frontwall leak.

Wet frontwall and soaked insulation, above SAM Cab

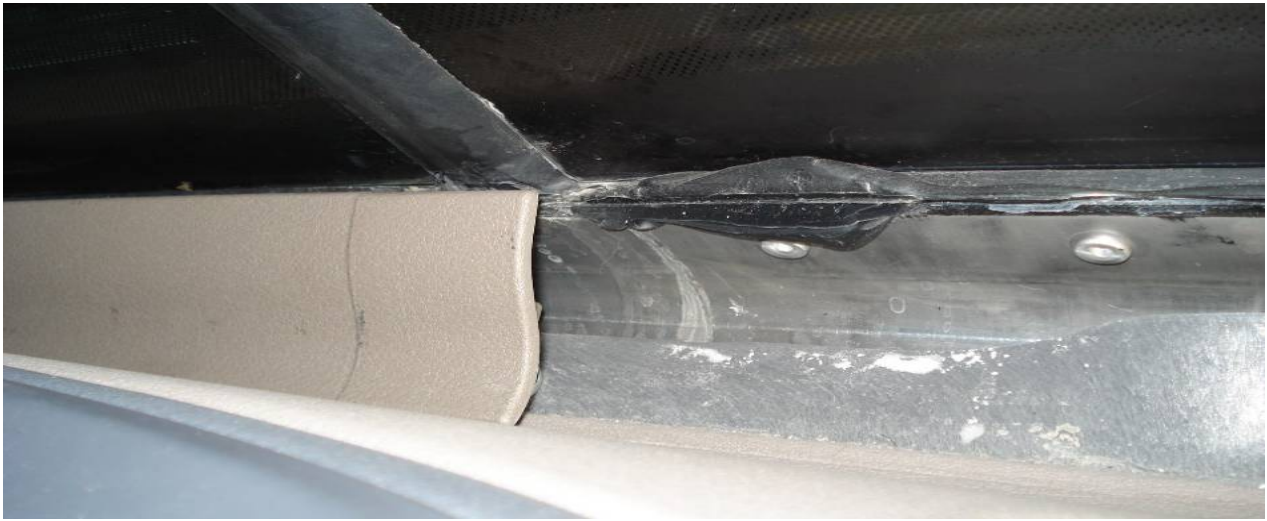
Residue trail indicating leak between windshield seal and glass and/or leak in windshield seal adhesive.

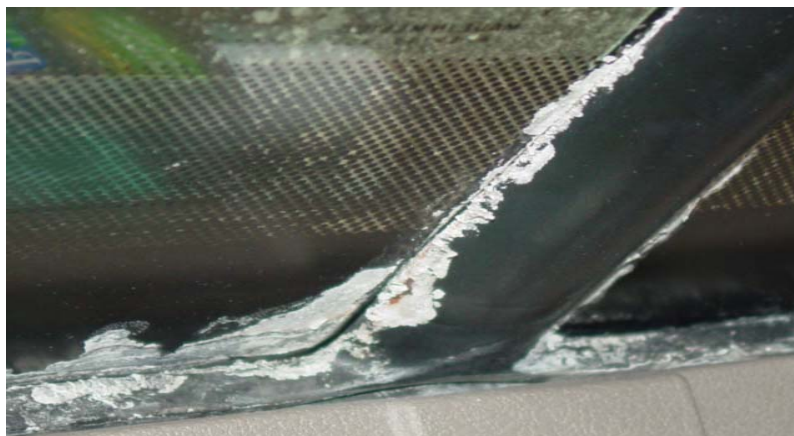
White residue (road salts) indicating leak between windshield seal and glass.

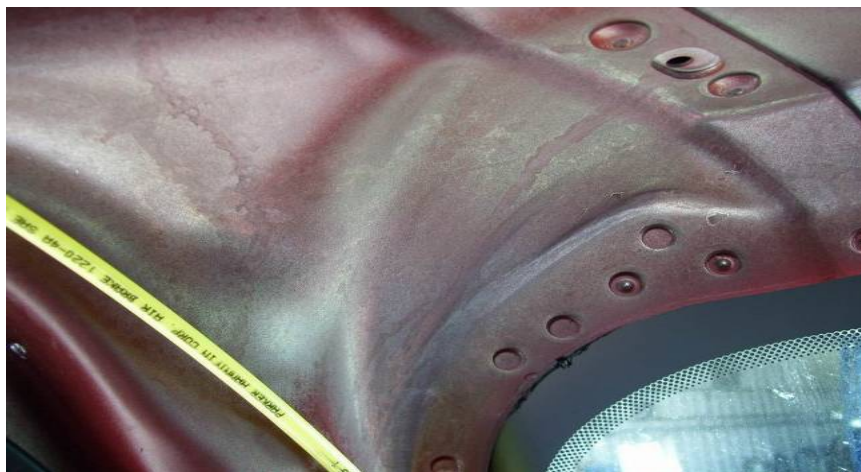
Signs of water coming in through leak in roof-cap joint and dripping down A-pillar.

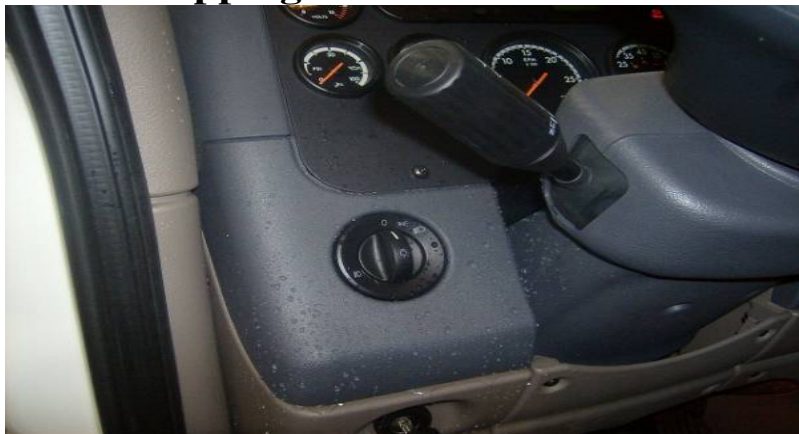
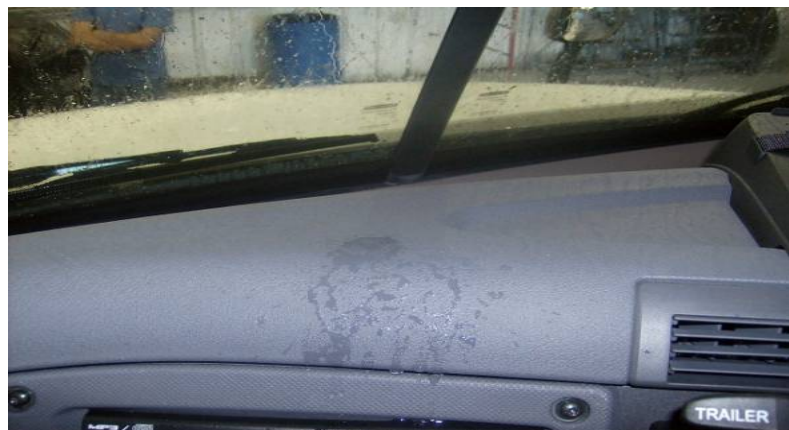
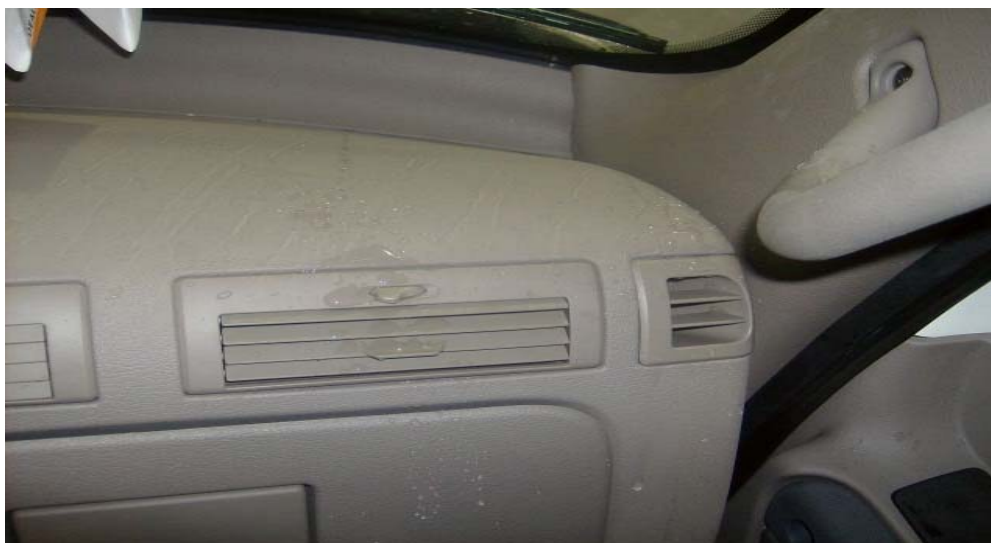
Water dripping onto dash indicates either a leak along the top of the windshield OR a leak at the roof-cap joint.

If any of these symptoms are present, proceed to the Service Solution 3495 attachment labeled “LOCATING LEAKS IN FRONT OF CAB” for more information on checking for potential water intrusion at the following locations:

1. Windshield leak? Refer to Service Solution #3497.
2. Roof leak? Refer to Service Solution #3498.
3. Frontwall leak? Refer to Service Solution #3499.
