## WINDSHIELD LEAKS

### ROPED-IN BONDED WINDSHIELDS

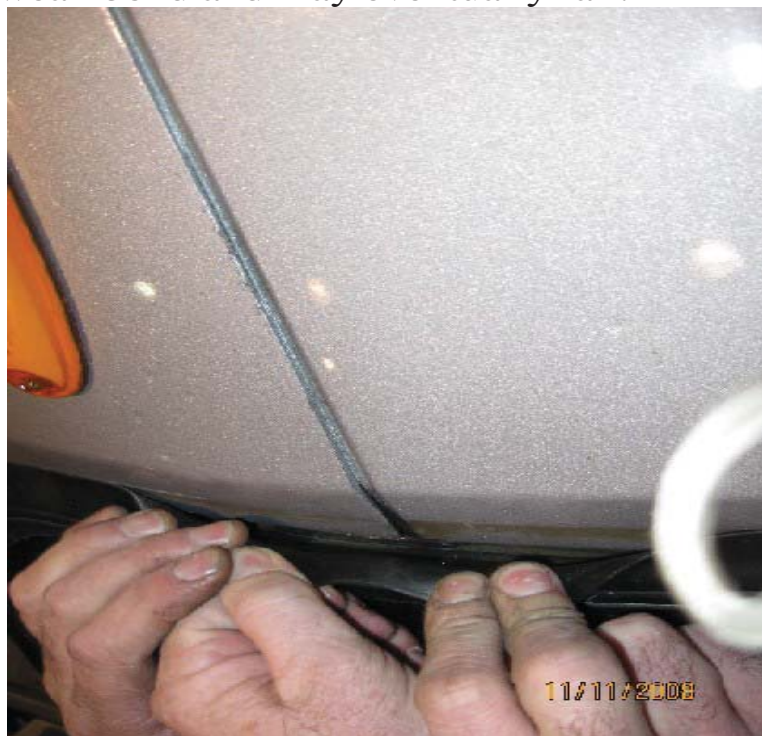
A leak between the windshield seal and the cab is either due to a void in the adhesive, or is an indication that the adhesive did not properly bond to the rubber seal. In the area of a suspected leak, remove the lockstrip and carefully lift the outside edge of the windshield seal to look for obvious voids in the adhesive. If the seal does not begin to separate from the adhesive with the light force required to look under the seal, the bond is adequate and a spot repair may be effective. Even if only a small leak is present, with evidence of an adhesive failure, a spot repair is not recommended due to the likelihood that other portions of the adhesive also have a weak bond and may eventually fail.

Remove the old seal and install a new seal per the instructions in the **Cascadia Workshop Manual, section 60.02**, with the following exceptions:

1. If the old seal is to be removed and discarded, it is a good idea to cut the old seal off the glass, to avoid any chance of cracking the glass during removal.
2. Prior to using the Aktivator product, as described in the Workshop Manual, apply Chemlok 7701 (supplied by LORD) to the bond surface of a new rubber seal. 7701 chemically etches the surface of the windshield seal and facilitates a stronger bond with the adhesive. After applying 7701 to the bond surface, allow at least 5 minutes of flash time before applying the Aktivator.
3. Omit the step of applying primer to the seal, and apply the adhesive directly to the Aktivator after allowing at least 10 minutes for the Aktivator to dry. Testing has shown that the Sika Primer-215 is not necessary when using Chemlok 7701. (Sika Primer-206 must still be used on any bare metal on the windshield opening.)

4. Rather than using Sikaflex 221 urethane, use SikaTack Ultrafast urethane. Ultrafast is a hot-applied single-part urethane that comes in a standard caulking tube and must be pre-heated to 170°-180°F before dispensing. Like Sikaflex 221, Ultrafast is a humidity-cure product. However, Ultrafast provides higher green strength and faster drive-away time, especially in colder, dryer environments.

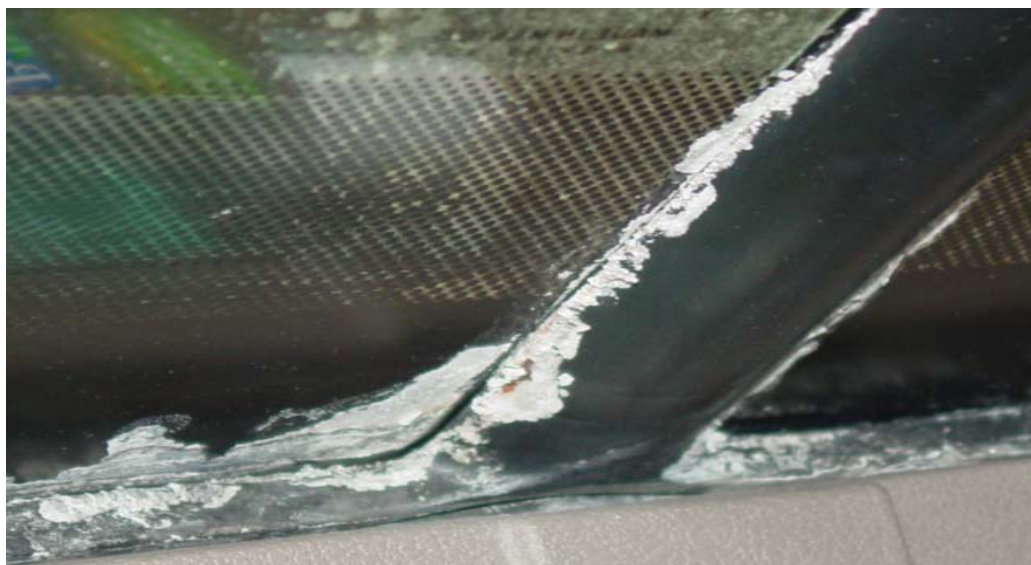
This type of leak should be easy to identify using the soapy water method, or simply by observing traces of white or brown residue in the area of the leak. This type of leak is most common at the center bar, and is usually found at the corners.

A wider, tighter-fitting lockstrip is available. Installing the wider lockstrip improves the seal between the rubber and the glass. The new lockstrip part numbers are 18-63362-000 (center) and 18-63362-001 (perimeter).
