### ROOF LEAKS

#### ROOF-CAP LEAK

### **FL545 RECALL CAMPAIGN**

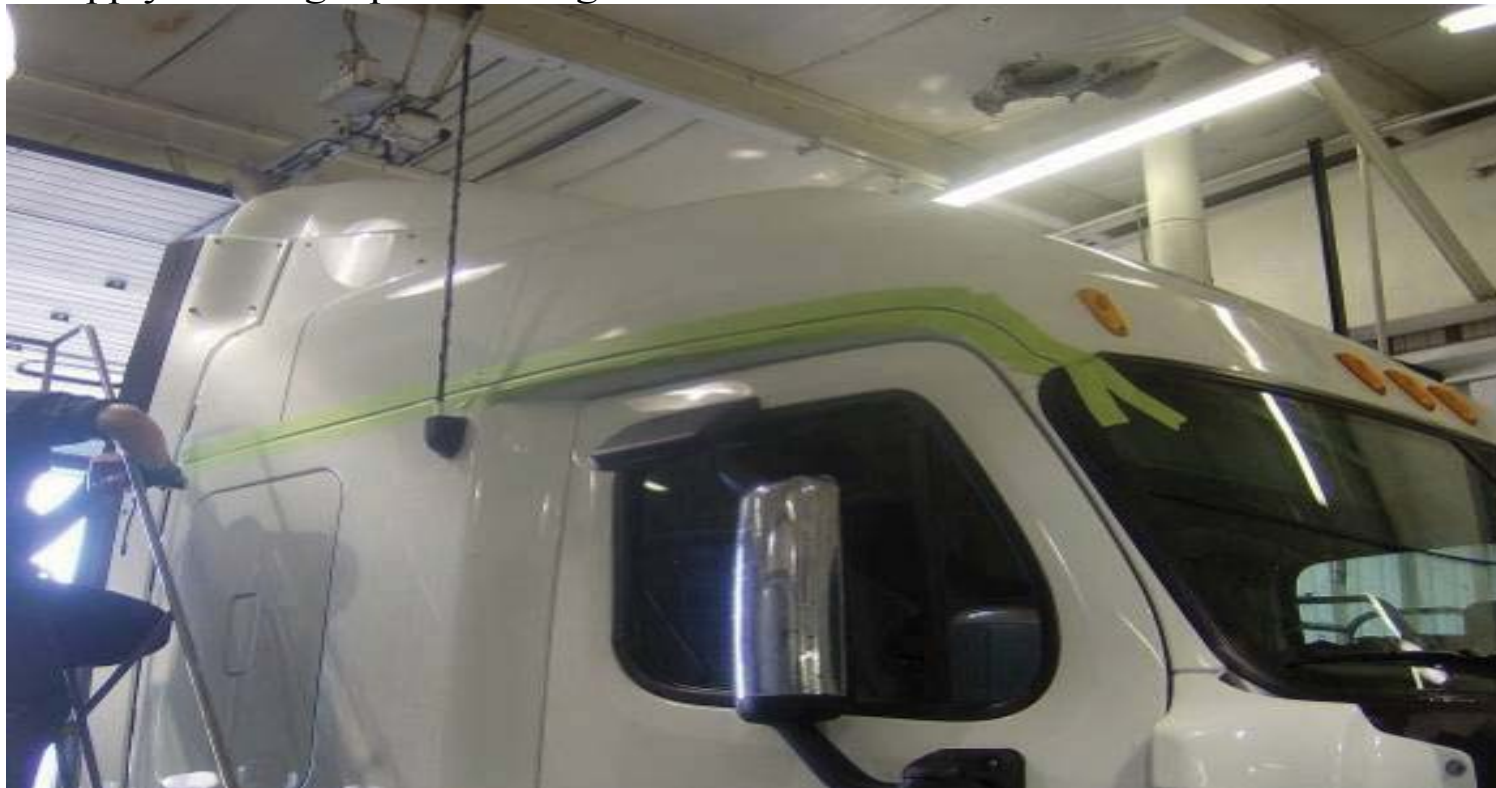
Roof-cap leaks are most commonly at the forward corners of the roof, above the A-pillars. The soapy water leak test may indicate a leak in this area. The garden hose leak test may also indicate a leak.

Water leaks in this area allow cavities between the roof-cap and cab, and inside the cab structure, to fill with water. As a result, 1 minute, or more, of holding a garden hose above the A-pillar may be required before water begins to drip onto the dash. If the cavities in the cab structure are filled with water, “sloshing” sounds may be heard from directly above the windshield while driving.

If the roof-cap seam leaks, apply a continuous bead of silicone or urethane sealant to the perimeter of the roof-cap to cab-wall seam.

1. Clean the seam area with air from a shop air hose and dry it with a clean shop rag.
2. Apply masking tape to the edges of the roof-to-cab seam.

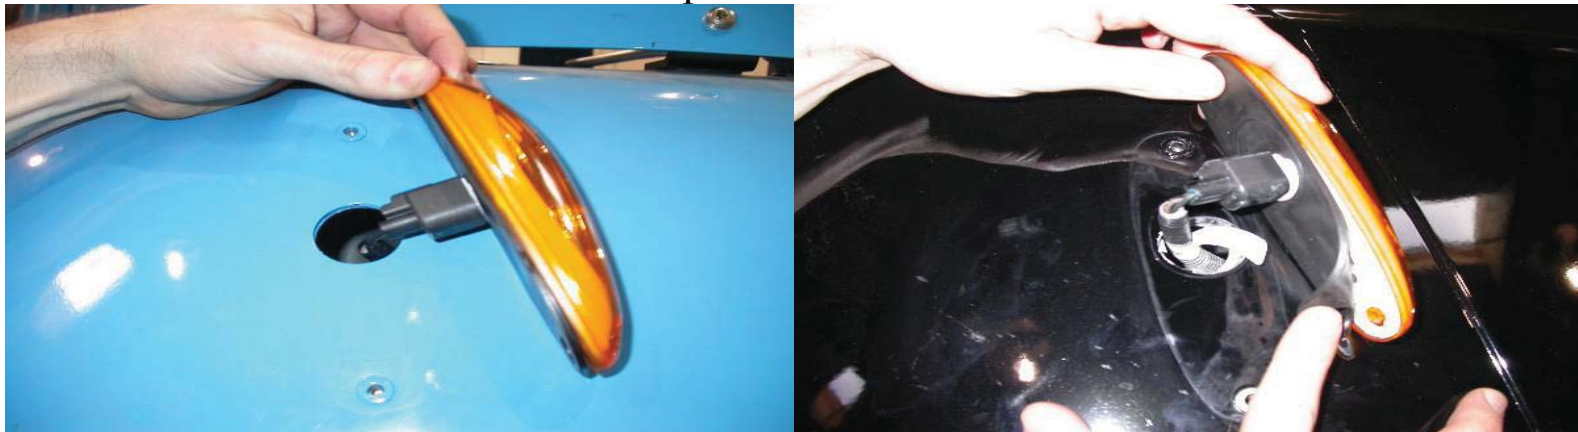
The threaded inserts in the cab have sealed ends and are a highly unlikely source of leakage. If a leak is found at a marker light, it is much more likely to be through the electrical connector hole in the roof-cap.

Remove any leaking marker lights from the cab and check to make sure the gasket is in good condition and correctly installed. Make sure the marker light fasteners are not under or over-tight.

The gasket is not sold separately. If a leak cannot be corrected by carefully re-installing a marker light, due to a damaged gasket, the entire light must be replaced.
