FRONTWALL LEAKS

LOWER A-PILLAR LEAK

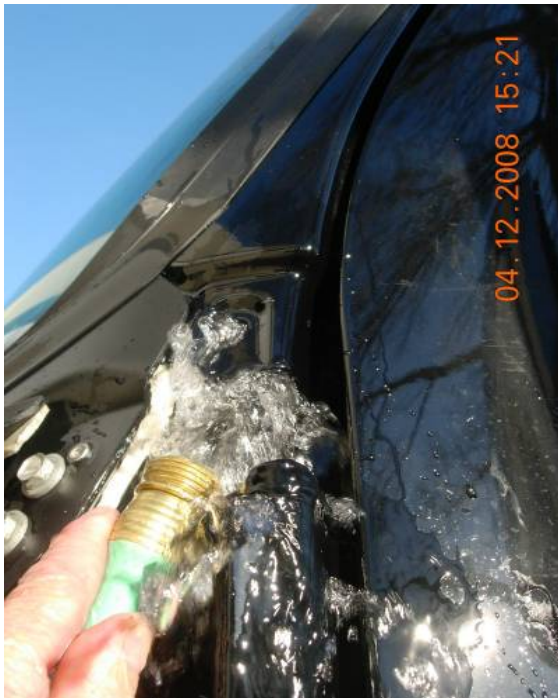
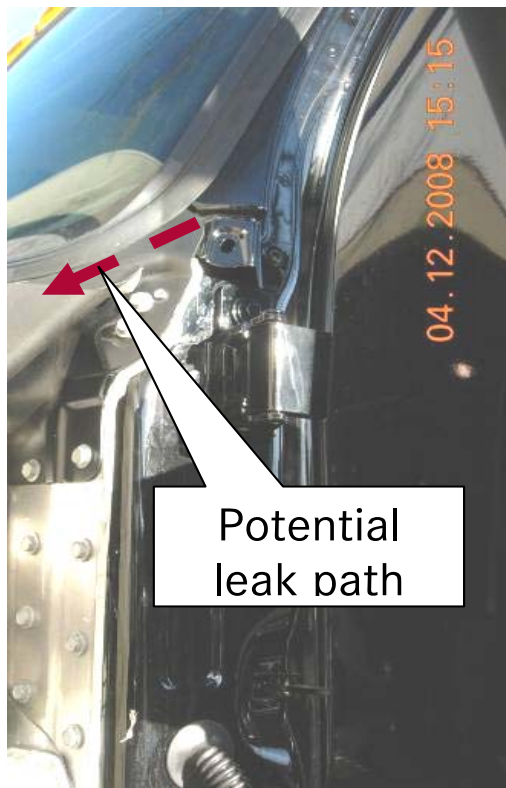
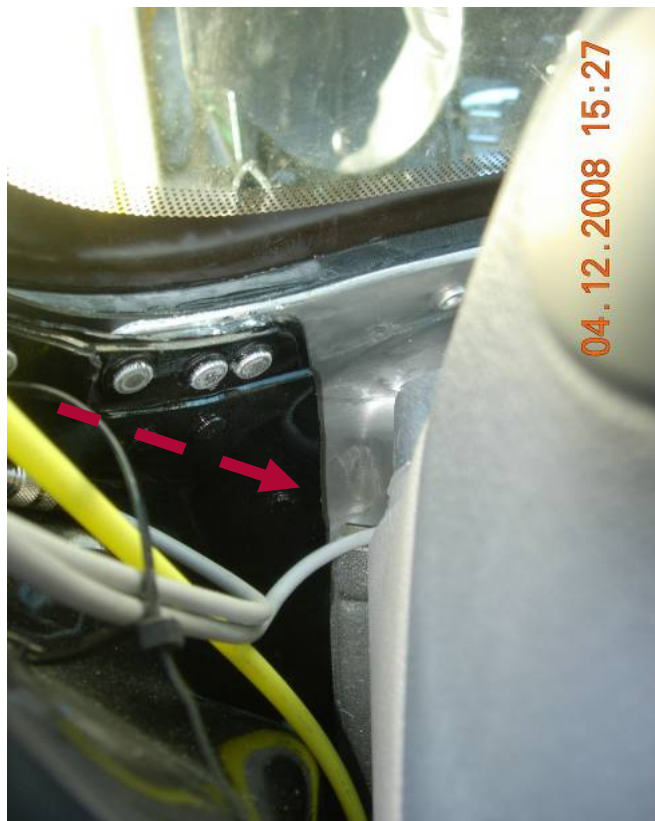
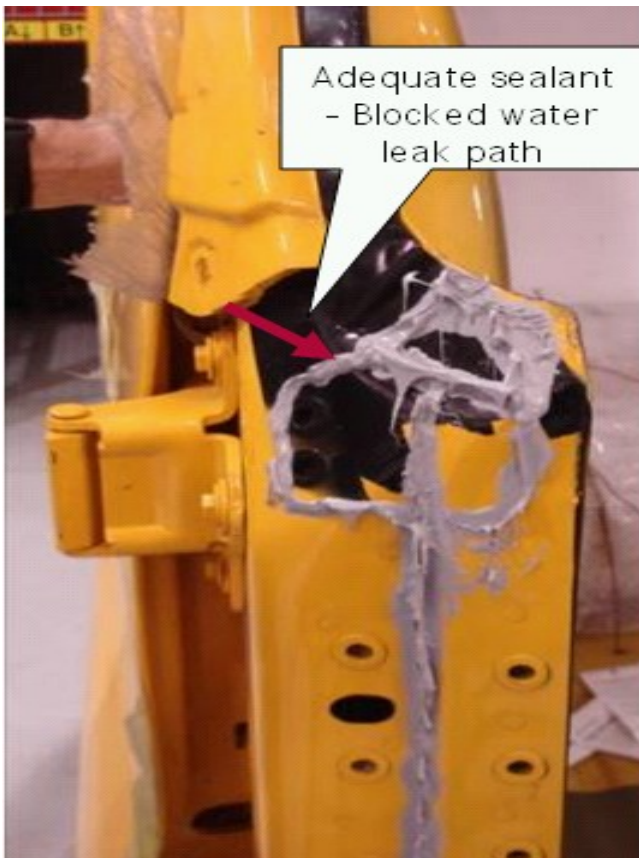
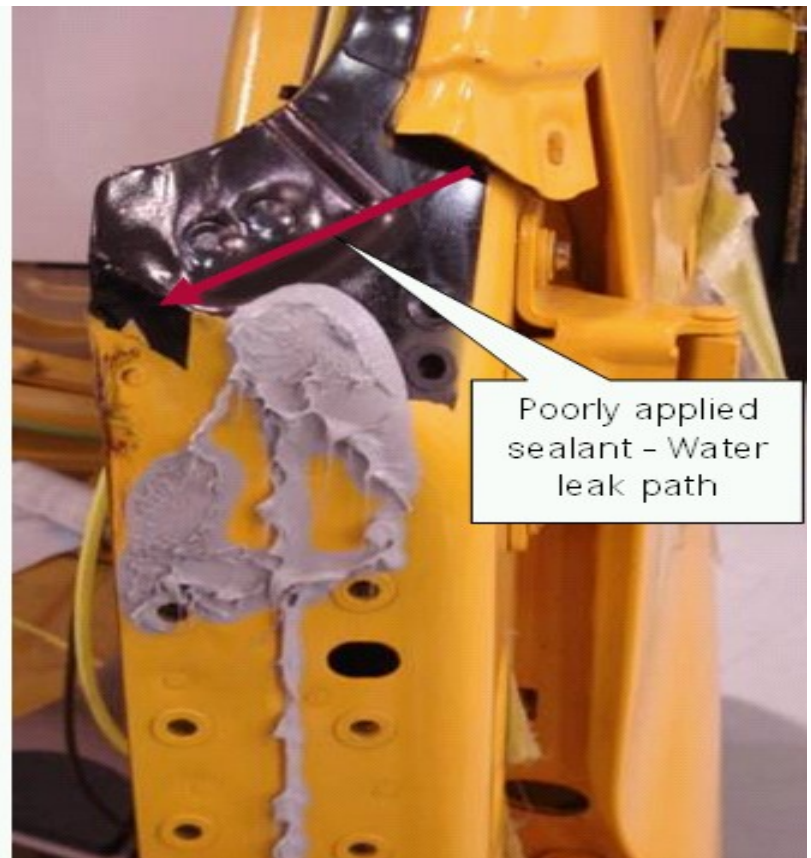
There is a chance that the frontwall was installed without adequate sealant at the upper corners. If this is the case, water can be seen running down the outboard edges of the inside of the frontwall when a garden hose is directed at this area of the cab. To observe this area of the frontwall, some interior panels will need to be removed.

With the side cowl removed, silicone or urethane sealant can be applied under the upper corner of the nosebeam and inside the A-pillar cover. Because there is no way to visually see if the void has been filled, recheck the area for leaks after the sealant has had some time to set-up. Apply additional sealant if required.
