Technical Service Note

SUBJECT: Cab Leaks and Water Intrusion into SAM Modules

PRODUCTS: Freightliner Cascadia

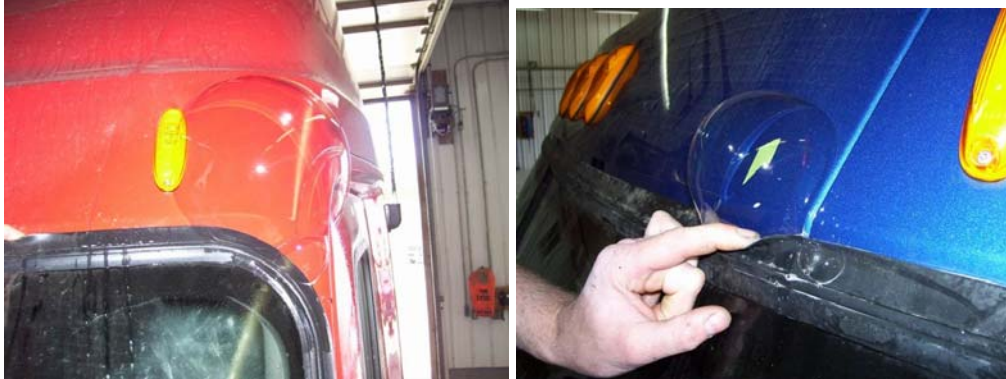
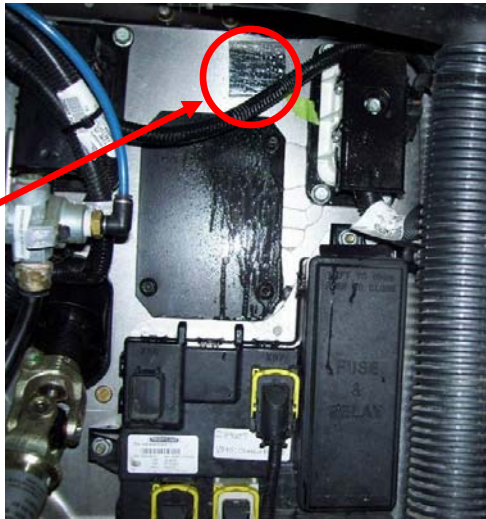
Make sure this auxiliary connector cover is in place and sealed.

- c. Ensure all doors are shut firmly.
- d. Use soapy water to check for air leaks at windshield seal, the roof-cap seam, and at the front-wall, directly above the SAM Chassis.

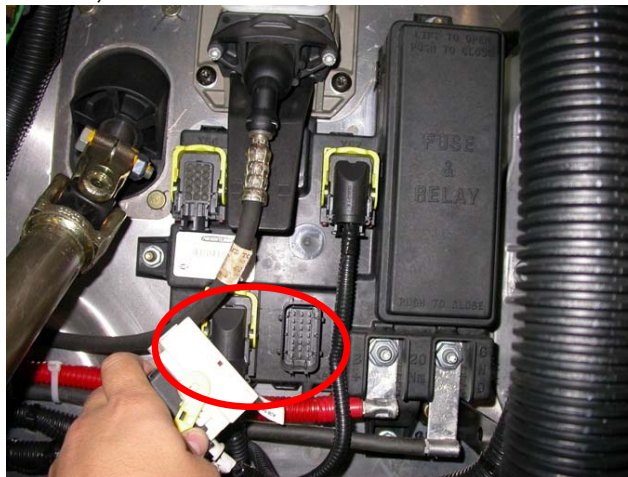
- b. If severe corrosion is evident on these pins, the SAM has been damaged by water. Replace the module.

- d. Smooth the silicone by running a wetted finger or a tongue-depressor over the bead.
5. Once tack-free, polyurethane sealant can be painted, if desired. Silicone cannot be painted.
6. Check SAM Chassis for water intrusion.
 - a. Remove both lower, outside connectors and check for corrosion on pins.

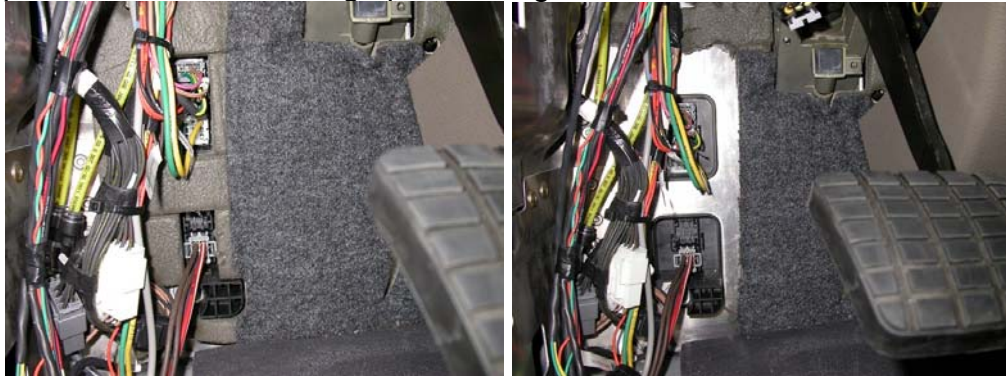
Before

After

- b. Using a utility knife or other suitable cutting tool, remove the insulation surrounding the inside SAM Chassis connectors. This reduces the potential of water wicking up the wiring harness from soaked insulation.

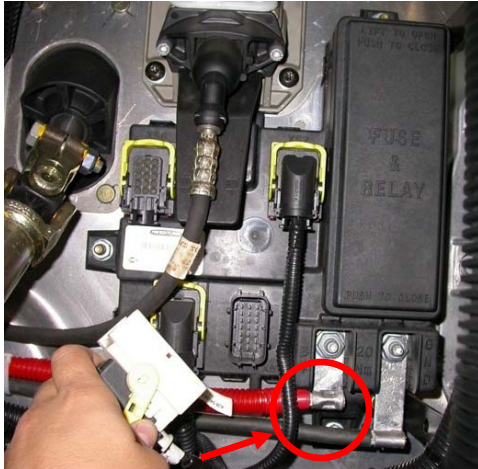
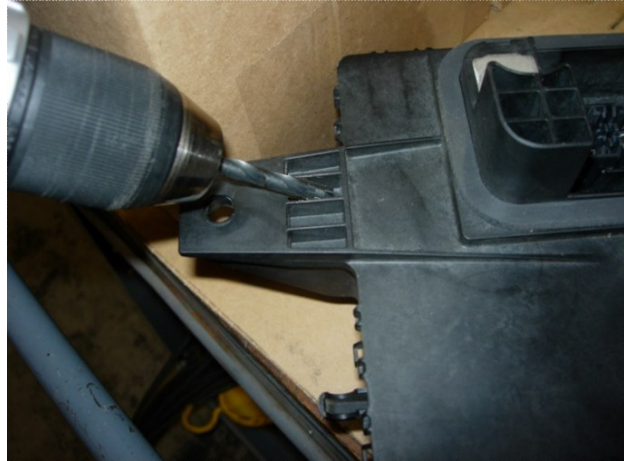
Drill from back-side of this mounting tab

- c. Unplug the inside connections to allow removal of the SAM Chassis.
 - d. Remove the SAM Chassis from the front wall of the vehicle. Using a 6mm drill bit, drill a small drain hole through the backside of the lower mounting tab at an upward angle so it allows water to exit the module. 1 to 1½ inches of drill penetration is required; be careful to avoid drilling out the front side of the module. Note: This area of the SAM contains no circuitry. This drain hole will prevent water from puddling inside the SAM and will reduce the chance of catastrophic damage to the circuitry.
