**Petition to the**  
**National Highway Traffic Safety Administration**

**Facts Necessitating Order of National Highway Traffic Safety Administration**

Petitioner is the owner of a 2013 Porsche 911 Carrera S Cabriolet with approximately 45,700 miles, which is equipped with a standard 7-speed manual transmission. This model year is part of the 991.1 variants of the Porsche 911, which began production in the middle of 2012 and continued through 2016. Petitioner's motor vehicle was manufactured in November of 2012 and first sold in 2013.

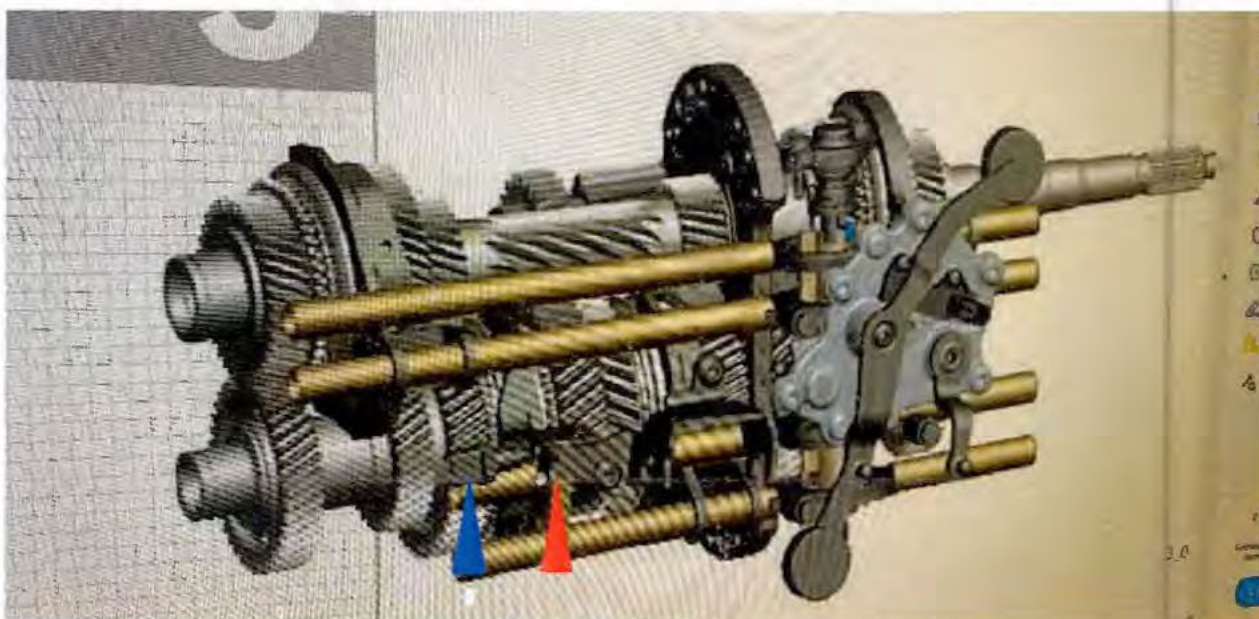
In order for the backup lamps to function properly in such vehicles equipped with the 7-speed manual transmission, an actuator must move inside of the manual transmission and make contact with a backup switch that is threaded into the transmission from the outside. The actuation occurs as the gearbox engages and disengages reverse gear.

The failure of this actuator – experienced by Petitioner – causes the actuator to completely detach inside of the transmission.

When the actuator detaches, the backup lamps cannot illuminate when the vehicle gearbox is shifted into reverse gear. Without backup lamps, a vehicle is not in compliance with Federal Motor Vehicle Safety Standards.

For illustration purposes, the following is a diagram believed by Petitioner to accurately represent the internal gearshift mechanism for the manual transmission present in the 2013 Porsche 911. The backup switch is identified with the blue cone and what is believed to be the actuator is identified with the red cone:

Additionally, Petitioner requests that NHTSA Order Porsche to remedy the defect by repairing the defective actuator inside of the transmission with safe equipment, or by replacing the transmission with a new transmission containing safe equipment.
