Field Product Quality Report

Distributor	KUS	Report #	[REDACTED]
Region	CE12	Report Create	08/11/2019
Dealer*	[OH072] BEAVERCREEK MOTORS, INC.	Dealer City, State	BEAVERCREEK, OH
Name	Hanagan, Jack - FTS	Attached	
Model Number	J4232	Model	Telluride 2020 - 2thx MY
VIN*	5XYP64H0GLC [REDACTED]	Production Date	04/14/2019
Engine No	G6DNKS874130	Delivery Date	04/26/2019
Trans No	LB8UCA994293	FTS Visit Date	08/01/2019
Trans Type	Auto	RO Open Date	07/10/2019
Mileage In	2554	Mileage Out	2554
Part No	99211 S9100	Part Desc	UNIT ASSY-FR VIEW CA
Other Part #1	-	Other Part #2	-
Condition/Nature	DA - Operation > Warning light on > Lamp on	Cause	ZZ3 - Part function/operation
Subject*	[REDACTED]

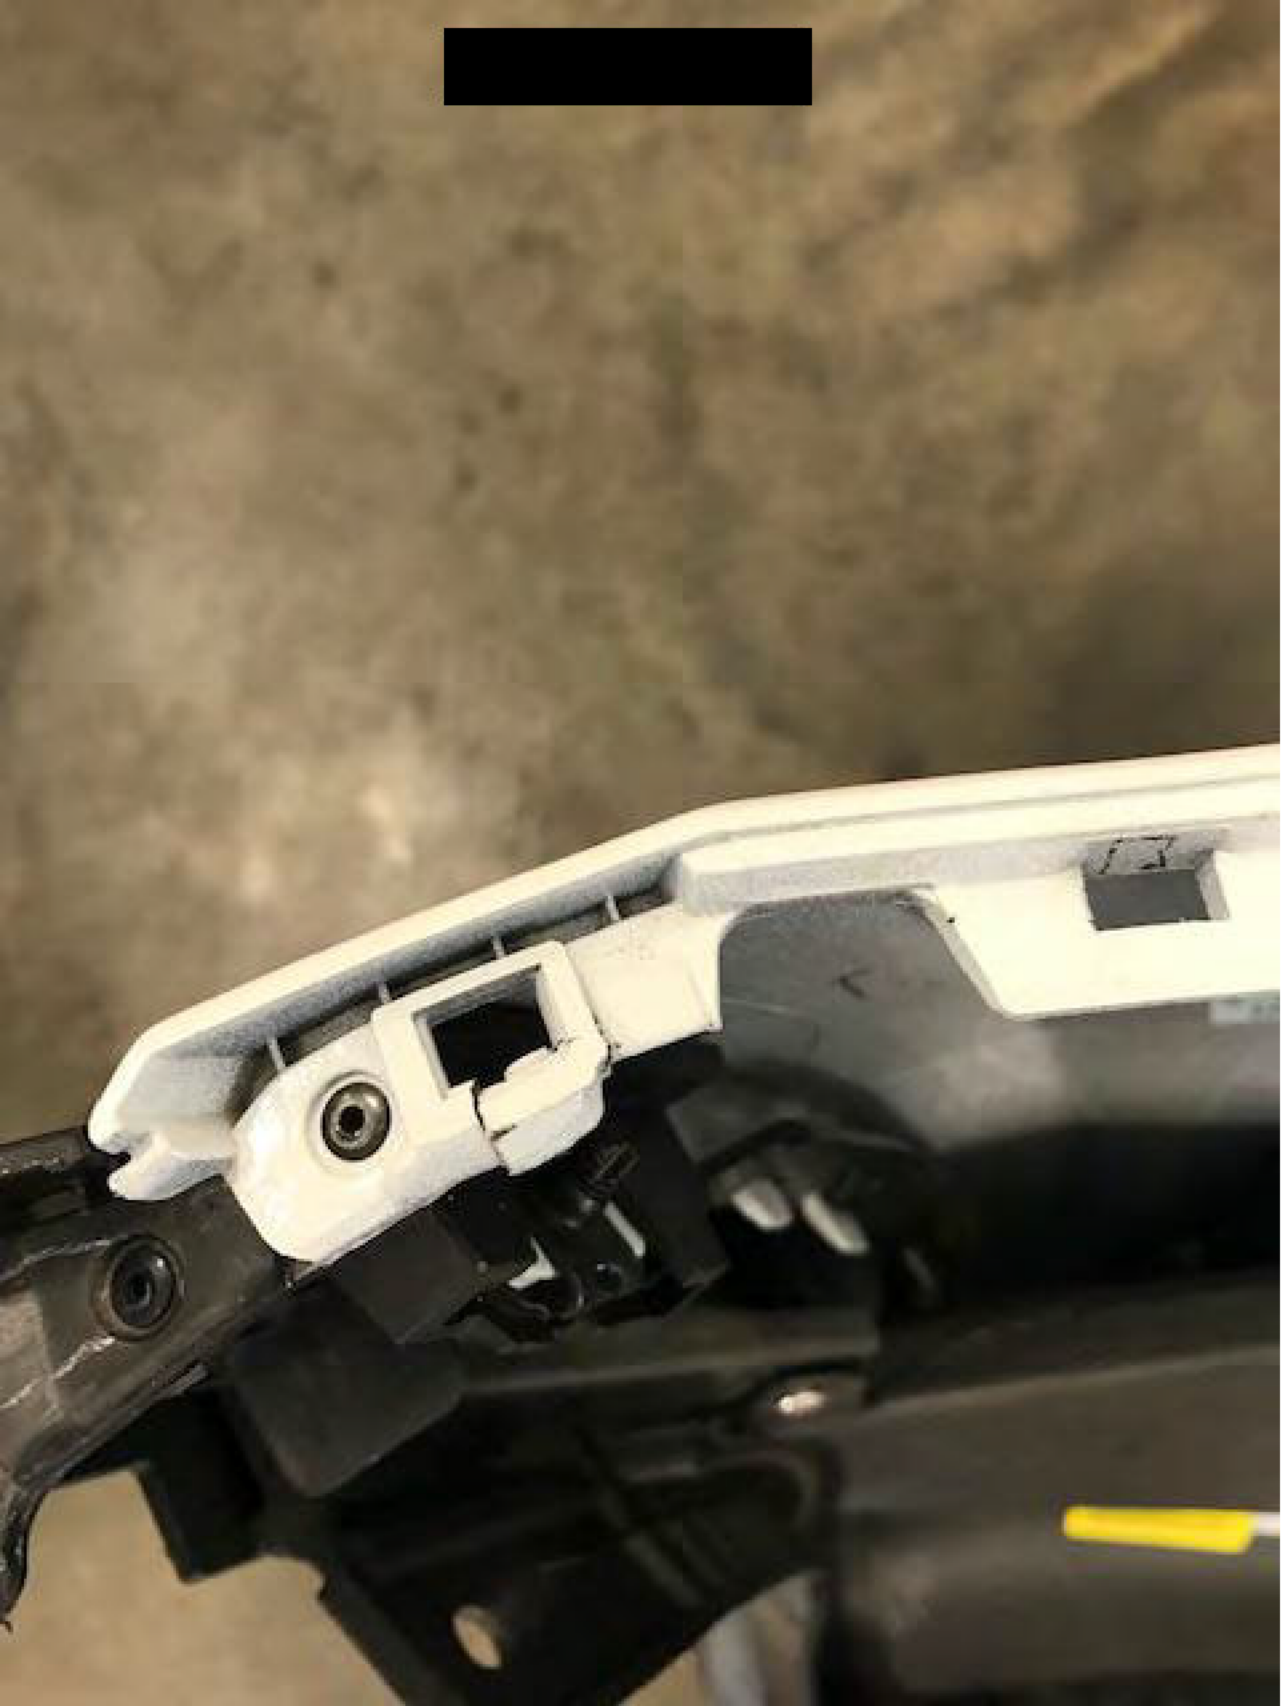
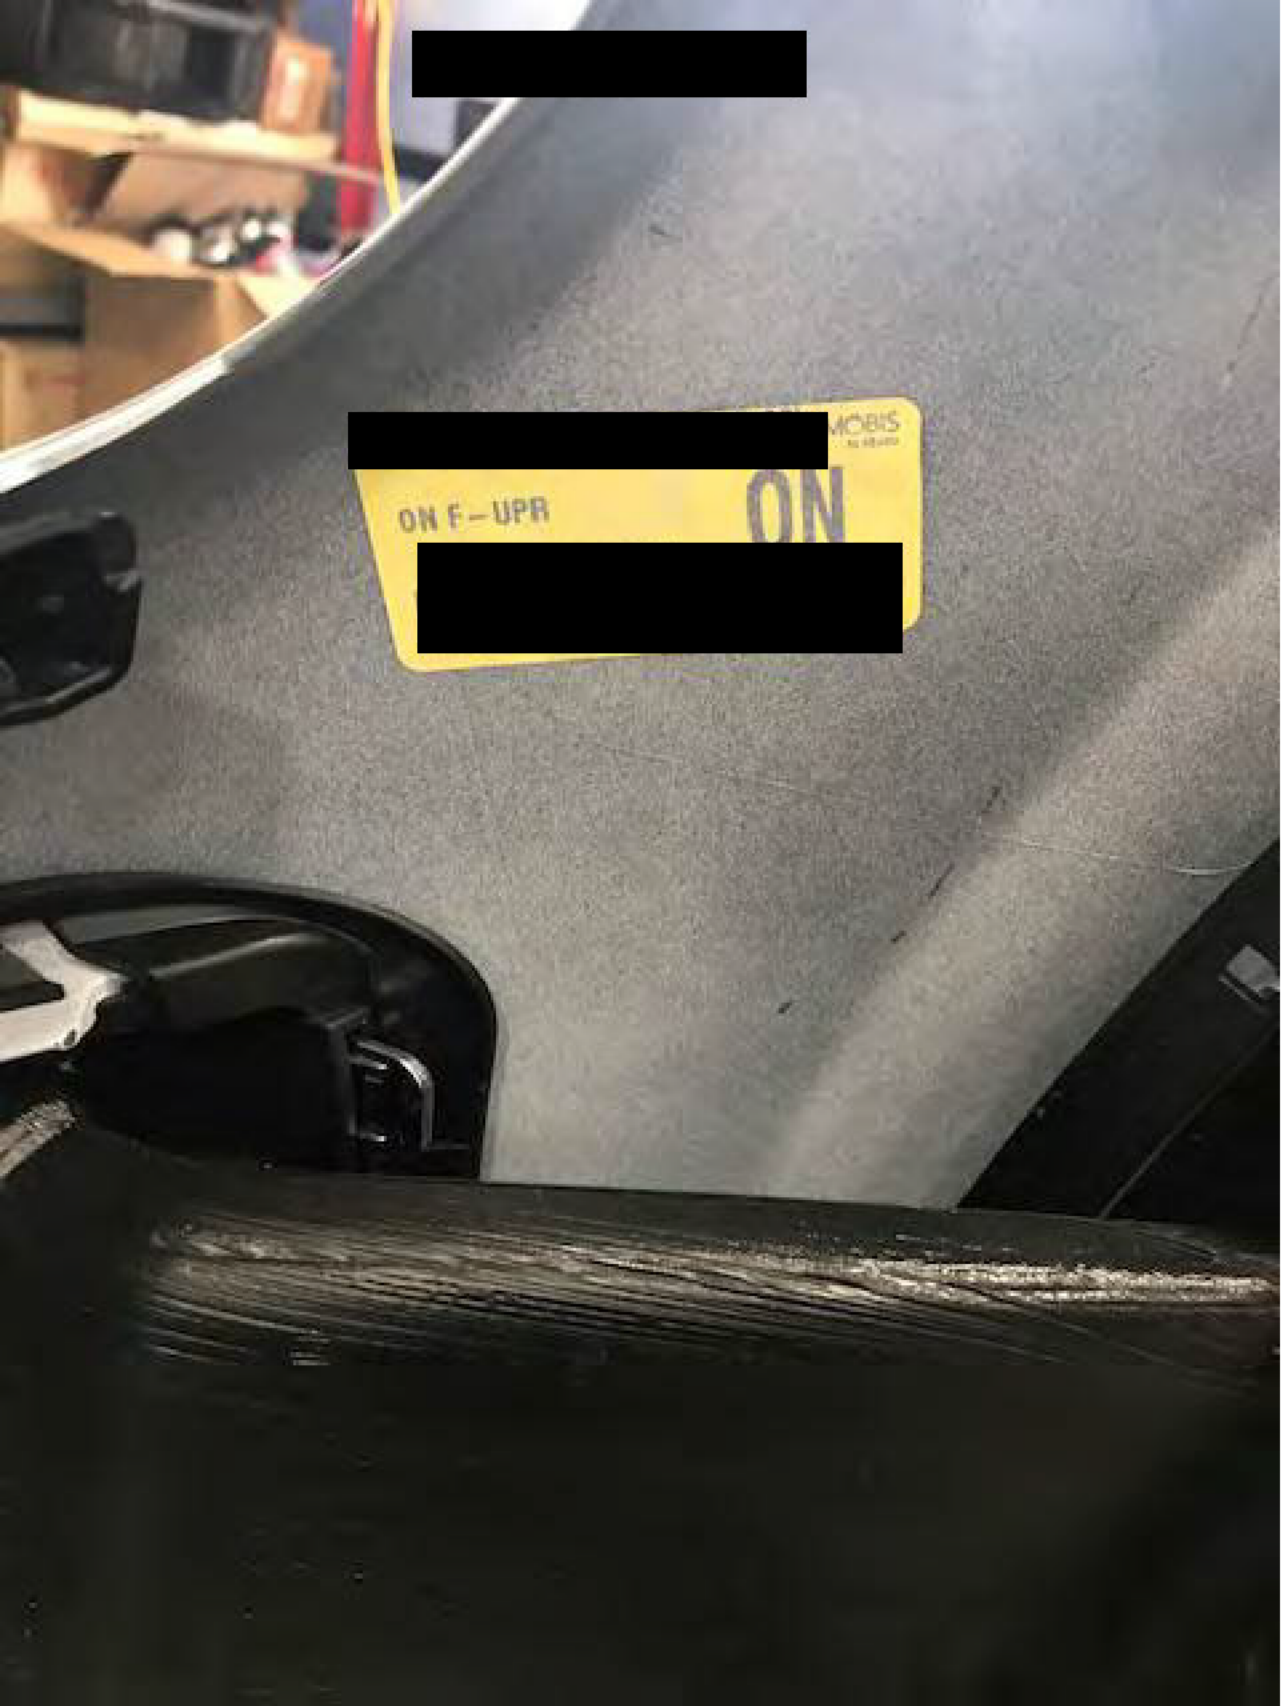
Condition	
Customer Complaint	Customer states that warning lights on dash came on when it was raining hard. Was intermittent and now is constant regardless of weather.
Actual Condition	Warning light on cluster comes on after driving short distance. C160049 ECU Software Error and C180581 LKAS CAN Signal Error.
Analysis	
Investigation Results	Dealer had previously replaced the LKAS camera assembly but were unable to communicate with system. Installed original camera and had communication. Checked related wiring to camera and radar unit (front bumper) with no issues noted. Noted vehicle had signs of minor repairs (over spray) to bumper cover.
Possible Cause	Undetermined at this time.
Corrective Action	Dealer was originally advised to replace the front radar unit and short wiring harness to unit. Per update from tech repair did not resolve concern. Advised dealer to order and install UNIT ASSY-FR VIEW CA due to sales manager denying request to test with stock unit. *** 08/13/2019 06:47:30 *** Web - Note created on 08/13/2019 06:47:30 and created by Jason Rudin We were directed by FTS to order another camera for vehicle since the first replacement camera was a faulty camera. Camera is in route to U.S. ETA is Sept 4th Note: Per update from tech on 8/15 the part is now scheduled to arrive on 8/17. The tech will keep me updated on progress after replacement.

System	DTC	Description	State
SCC	C180581	LKAS CAN Signal Error	Active
MFC	C160649	ECU Software Error	Active

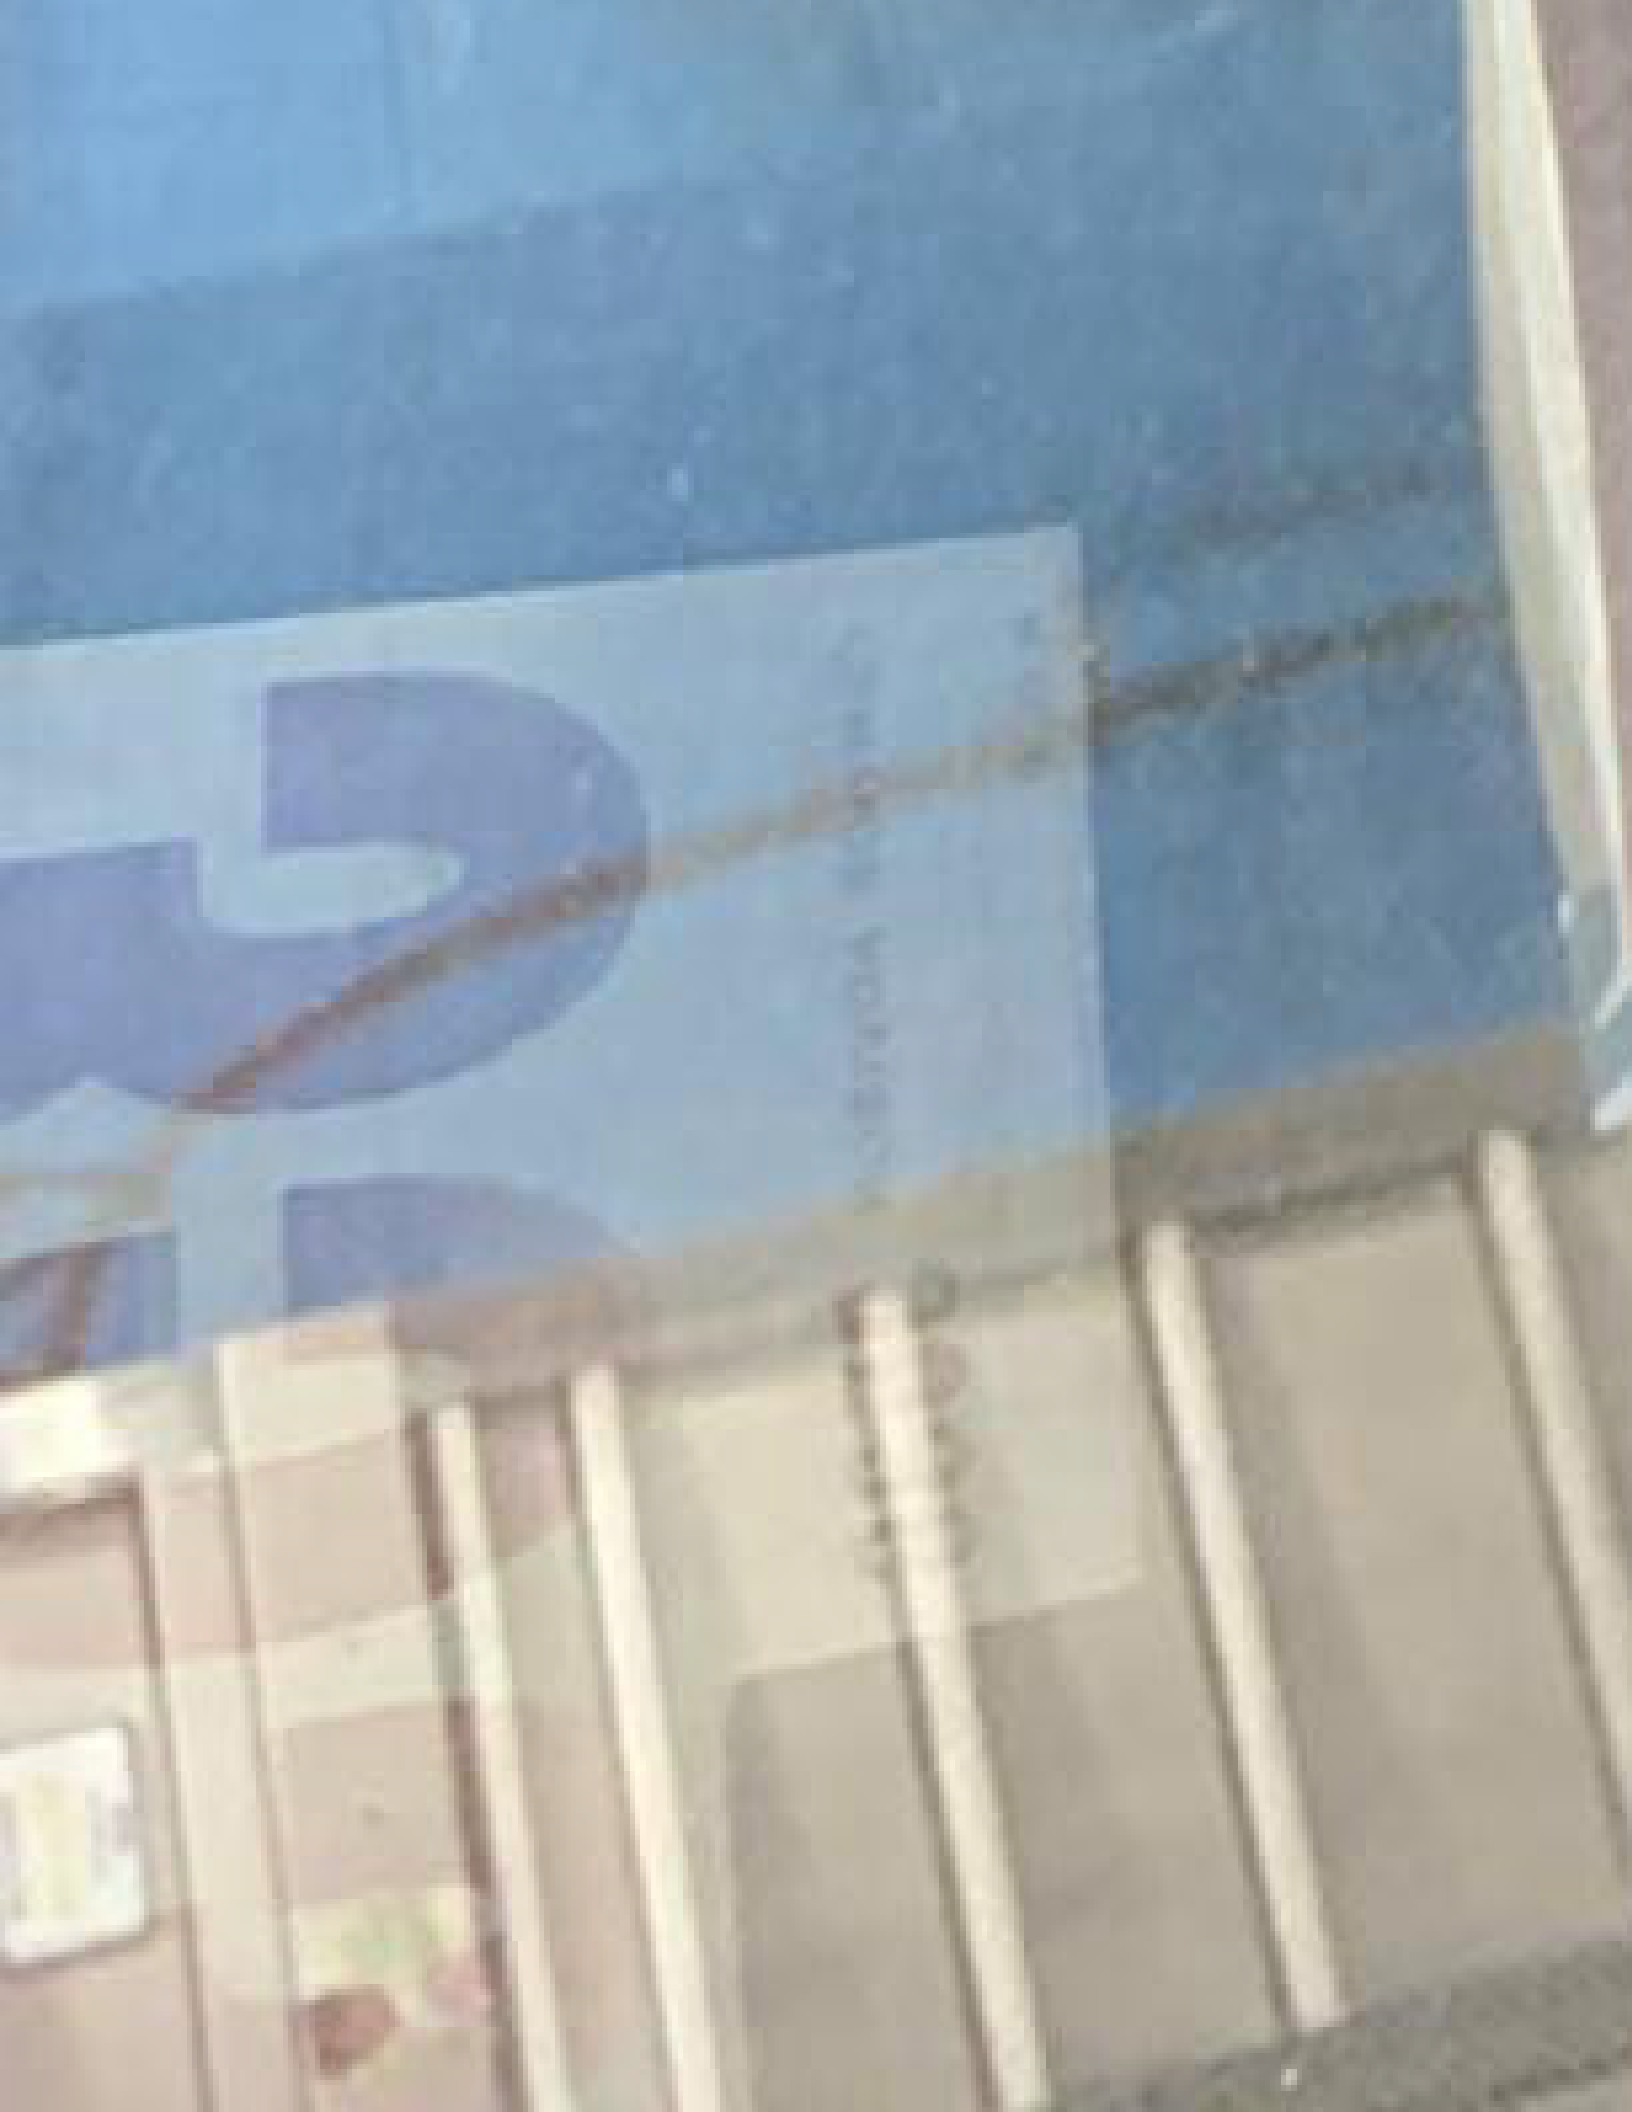
Condition	
Customer Complaint	Customer receives a check HAD (Highway driving assist) message in dash.
Actual Condition	The vehicle was started, and no MIL or warning messages were seen.
Analysis	
Investigation Results	I drove the vehicle with the MOBIS FSE. He collected CAN logs and head unit logs during the road test. The road test included city driving with several turns 25-35 MPH. The system was checked with the KDS and the code was reset several times during the test drive.
Possible Cause	The root cause was not identified during the inspection.
Corrective Action	Information was passed on to NAGC. More data was requested. I had them order a Head unit but hold off on the replacement.
