# Customer Satisfaction Program

## N202310850 Airbag Indicator Light Intermittent

**Release Date:** December 2020

| <b>Condition</b> | In certain 2021 model year Cadillac Escalade, Escalade ESV, Chevrolet Suburban, Tahoe, GMC Yukon and Yukon XL vehicles, driver movement can disrupt the electrical connection to the seat-mounted inboard airbag system. This airbag system is supplemental and not required equipment under applicable Federal Motor Vehicle Safety Standards. If this occurs, the vehicle's driver information center will display a “Service Restraints System” message to the driver before resistance at the connection will prevent the deployment of the airbag. |

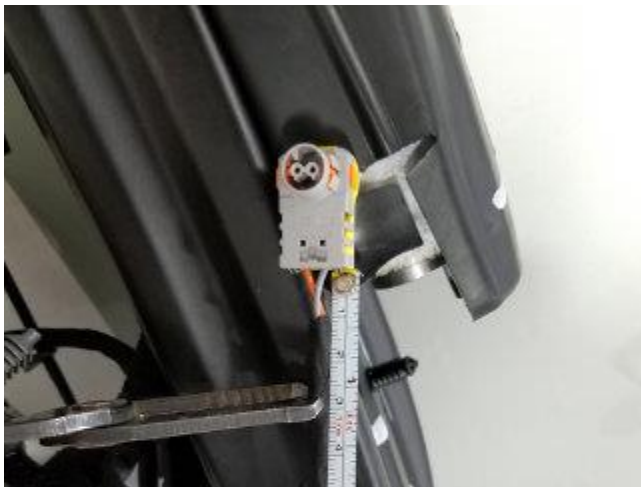
5672141

**Note:** There may be butyl tape over the harness and connector from a previous repair. Remove the butyl tape as necessary. Tape residue can be left on the repair area, it does not need to be completely removed.
