**Subject:** RE: T1XX DAB Status and Next steps

We are focused on identifying the feature(s) that are different on the airbag to connector interface for Stage 1 (WOW) and Stage 2(BOB) in order to find cause.

Senior Mgr. – Global Red X

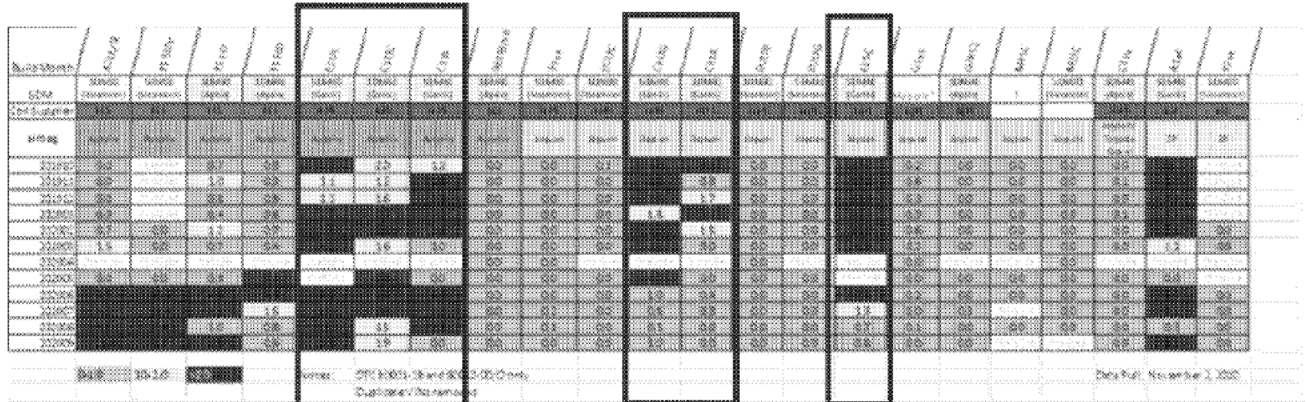
With the findings yesterday that the Conti SDM40 is combining open circuit and high resistance symptom bytes which would increase the DTCs and include any vehicles that deployed the bag (as an open), the only reds on the bingo chart are T1XX and A2. (see bingo chart below)
