## WMA5 - Updating Software for Various Control Units (Workshop Campaign)

Revision: This bulletin replaces bulletin Group 9 15/21 WMA5, dated April 15, 2021.

Model Line: **Taycan (Y1A)**

Concerns: **Software update (software version VR12.1.1)**

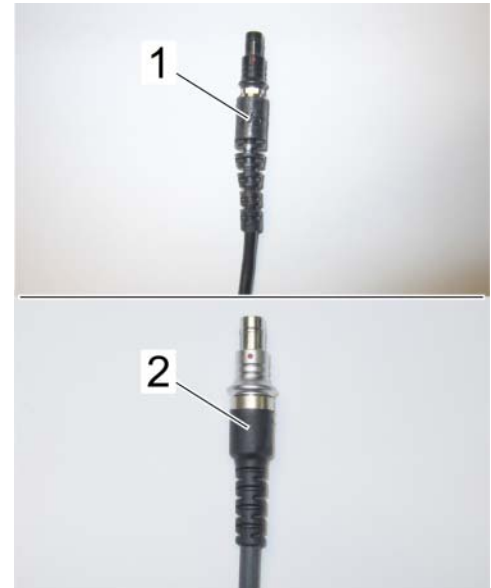
*PIWIS Tester data cable*

Use the **new** PIWIS Tester data cable to carry out the campaign. The difference between the old  $\Rightarrow$  *PIWIS Tester data cable -1-* and new  $\Rightarrow$  *PIWIS Tester data cable -2-* data cable is shown in the illustration.

If the connection between the vehicle and PIWIS Tester is interrupted, check the data cable for the PIWIS Tester for signs of damage. If the data cable is damaged, it **must** be **replaced**. To do this, follow the instructions in the PPN for "Returning faulty USB cable caps" (PPN portal > Dr Ing. h.c. Porsche AG > Aftersales > Workshop > PIWIS > Documents).

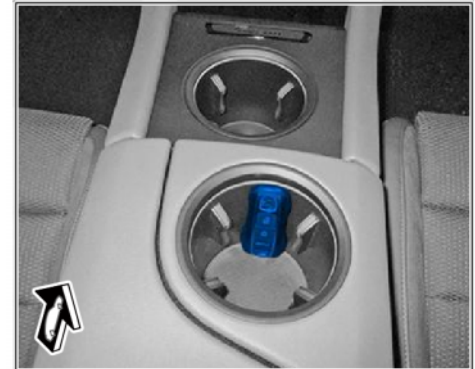
*Emergency start tray*

- 2 Position the **driver's key** with the back facing forward upright between the holding struts in the rear cupholder (**emergency start tray**) to guarantee a permanent radio link between the vehicle and remote control ⇒ *Emergency start tray*.

⇒ Position the driver's key with the back facing forward upright between the holding struts in the rear cupholder (emergency start tray) to ensure a permanent radio link between the vehicle and remote control.

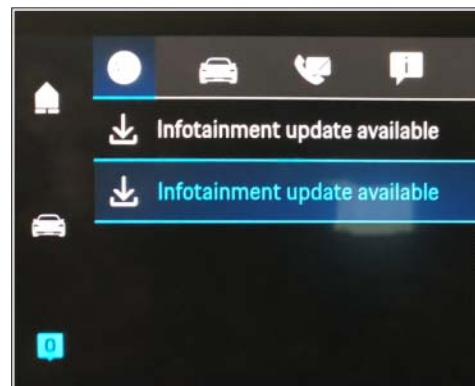
*Infotainment update in central display*

After carrying out the campaign, please inform customers that Infotainment updates are available via the central computer (PCM) and provide them with any help and support they need during installation ⇒ *Infotainment update in central display*.

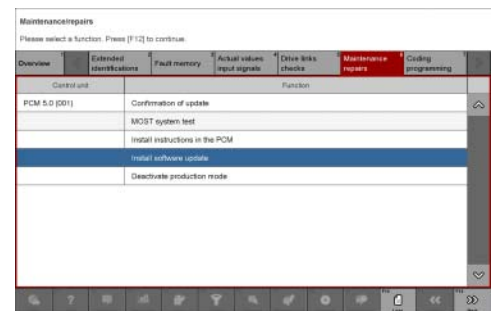
*Installing PCM 6.0 software update*

- 5.6 Once the PCM central computer control unit has been found and is displayed in the 'Overview', select the '**Maintenance / repairs**' menu.
- 5.7 Select the '**Install software update**' function and press •F12 “ ('Next') to perform the software update ⇒ *Installing PCM 6.0 software update*.

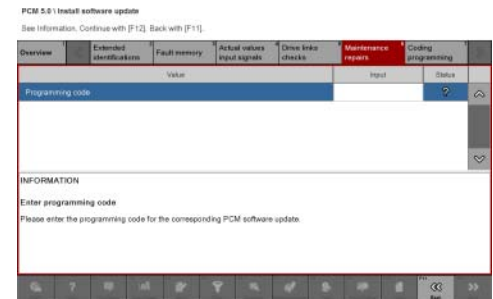
- 5.10 Enter the programming code **K4M4S** in the relevant column ⇒ *Entering PCM 6.0 programming code* and press •F12 “ ('Next') to confirm ⇒ *Entering PCM 6.0 programming code*.

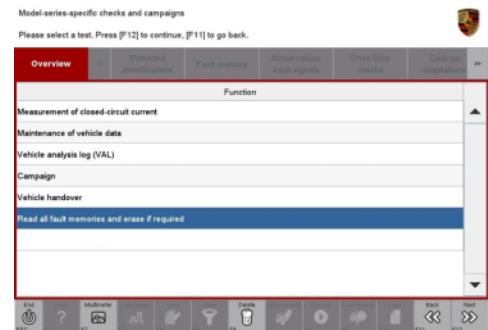
*Erasing fault memories*

- 9.4 Press •F8 “ ” to delete fault memory entries.
- 9.5 Press •F12 “ (‘Yes’) in response to the question as to whether you really want to delete all fault memory entries.
