## WMA6 - Updating Software for Various Control Units ((Workshop Campaign)

**Model Year:** **2021**

**Model Line:** **Taycan(Y1A)**

**Concerns:** **Software update (software version VR12.1.1)**

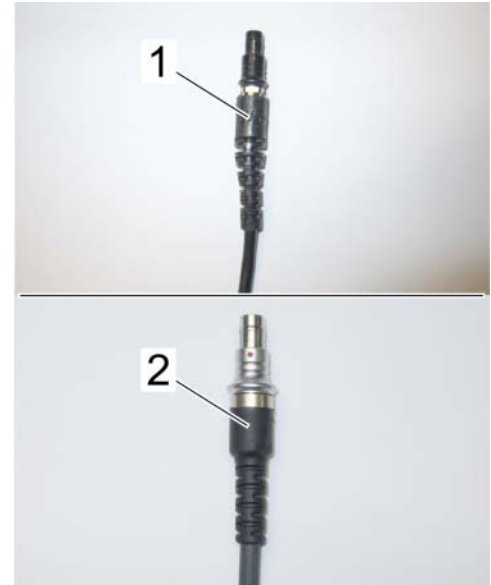
*PIWIS Tester data cable*

Use the **new** PIWIS Tester data cable to carry out the campaign. The difference between the old  $\Rightarrow$  *PIWIS Tester data cable -1-* and new  $\Rightarrow$  *PIWIS Tester data cable -2-* data cable is shown in the illustration.

If the connection between the vehicle and PIWIS Tester is interrupted, check the data cable for the PIWIS Tester for signs of damage. If the data cable is damaged, it **must be replaced**. To do this, follow the instructions in the PPN for "Returning faulty USB cable caps" (PPN portal > Dr Ing. h.c. Porsche AG > Aftersales > Workshop > PIWIS > Documents).
