DISTRONIC PLUS occasionally reacts too sensitively

Topic number	LI30.30-P-056782
Version	1
Function group	30.30 - Cruise control (CC), DISTRONIC (DTR)
Date	8/21/13
Validity	Model 166, 172, 204.9, 216, 218, 231 with production date 01.04.2013 to 30.06.2013 with code (233) DISTRONIC PLUS
Reason for change

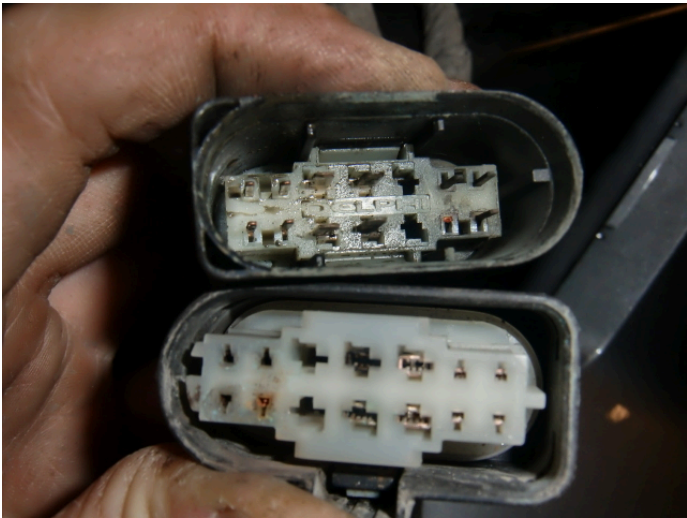
Corrosion may have occurred at the connecting point X174/1 from the front bumper to the interior wiring harness.

Attachments	
File	Description
CIMG3906.JPG	Corrosion at connecting point X174/1

1. Replace connecting point X174/1.
2. Reinstall all contacts and replace connector housing on interior wiring harness.

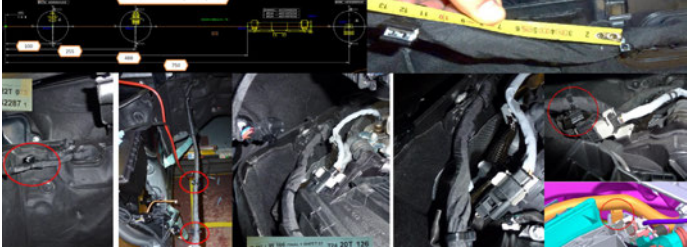
Wiring harness may have chafe mark in area of metal bracket for oxygen sensor upstream of catalytic converter or differential pressure sensor B28/8 retaining clamp, possibly caused by faulty mounting / routing of wiring harness.

- Picture shows "good" example of clip direction.

Repair wiring harness and position clips / cable straps correctly.

- Change to cable strap from A 000 995 82 90 to A 005 997 62 90 and shifted from 90 mm to 100 mm, also rotate clip from 3-o'clock position to a 6-o'clock position.
- Change to cable strap from A 000 995 82 90 to A 000 995 12 90 and shift to new dimension of 255 mm, also rotate clip from a 3-o'clock position to a 6-o'clock position.
- Move cable duct line guide A 222 546 62 80 (not replacement part) from 468 mm to 488 +/-5 mm.
- Move cable strap A 000 995 65 90 from 740 mm to 750 mm, also rotate clip from 9-o'clock position to 6-o'clock position.

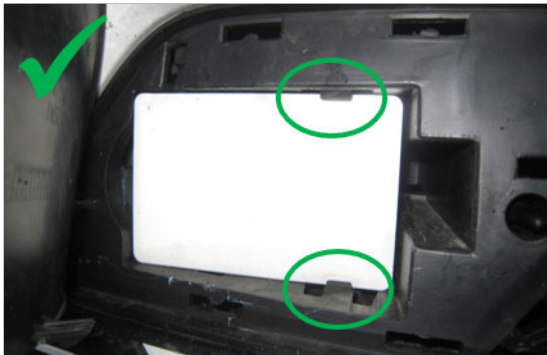
Attachments	
File	Description
i.O. Verrastung Sensor.jpg

- 2.1 Check part number of short range radar sensors --> If current part number of inserted sensor is NOT A000 905 99 06, then please replace sensor to part number A000 905 99 06.
- 2.2 Create a PTSS case and request a new grid (cover/plastic trim in front of the radar sensors) via PTSS.

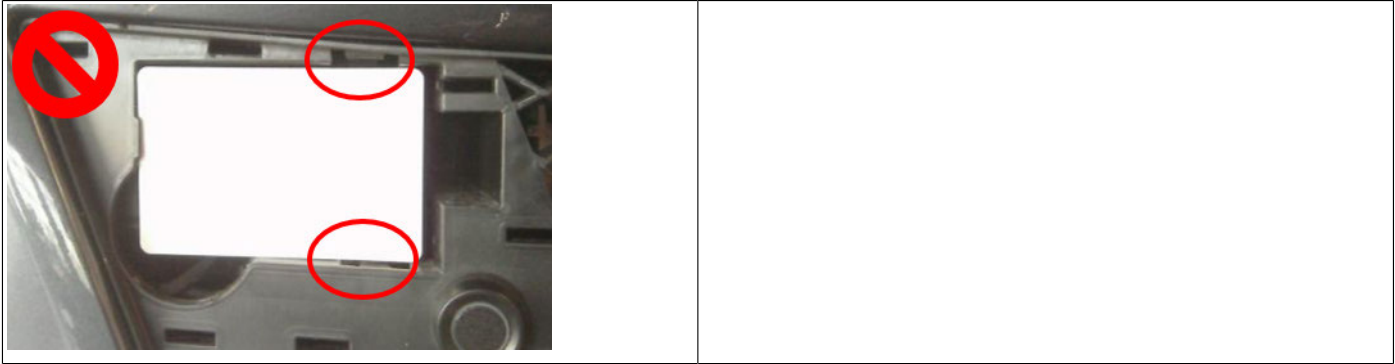
Sensor adjustment OK
n.i.O. Verrastung Sensor.jpg	Sensor adjustment not OK
