**NUMBER:** 18-054-21 REV. A

**SUBJECT:**

Diesel Fuel Pump Failure and System Contamination

This bulletin involves inspecting for fuel pump failure and fuel system contamination. Also fuel system cleaning and fuel system kit replacement.

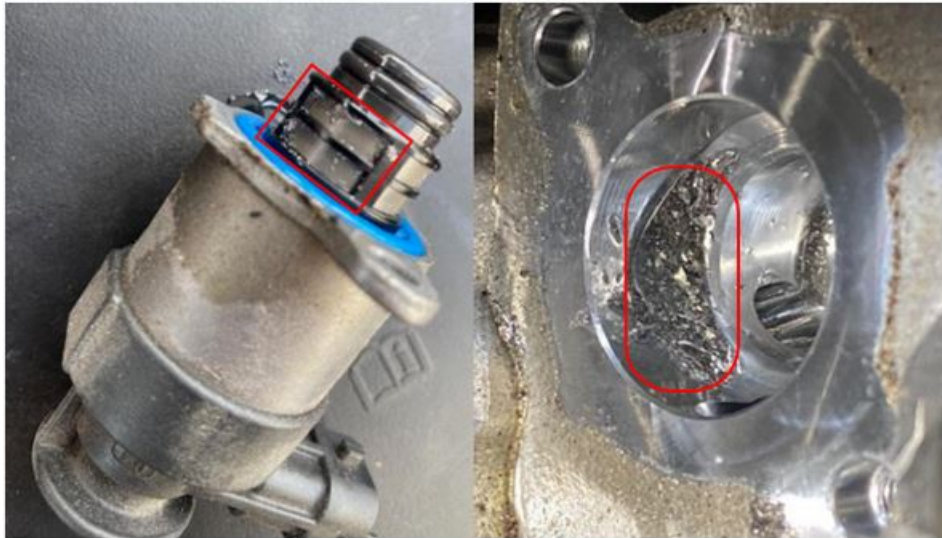
Fig. 1

**Metal Contamination On The FQS And In The FQS Bore**

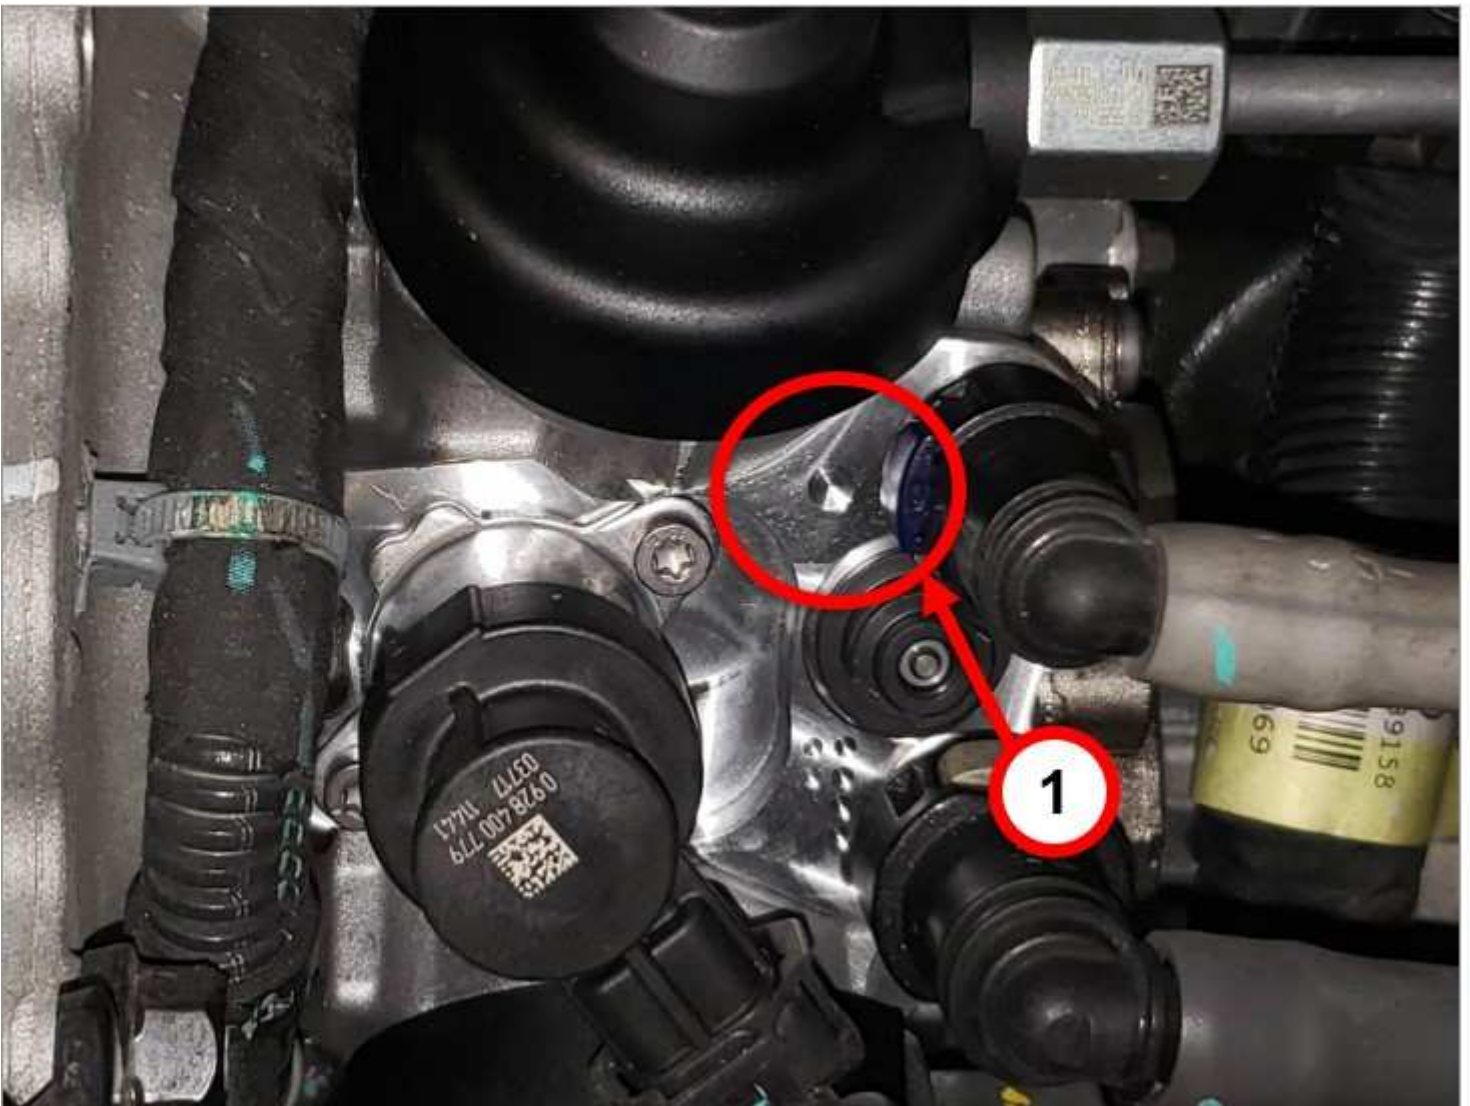
**Fig. 1**  
**New Style Symmetrical Cam Design Pump**

- Vehicles with the new style Symmetrical Cam design pump will have one large single dot embossed in the pump housing (Fig. 1) .
- Vehicles equipped with a Symmetrical Cam pump, choose the calibration labeled Symetric Cam, or Sym Cam.

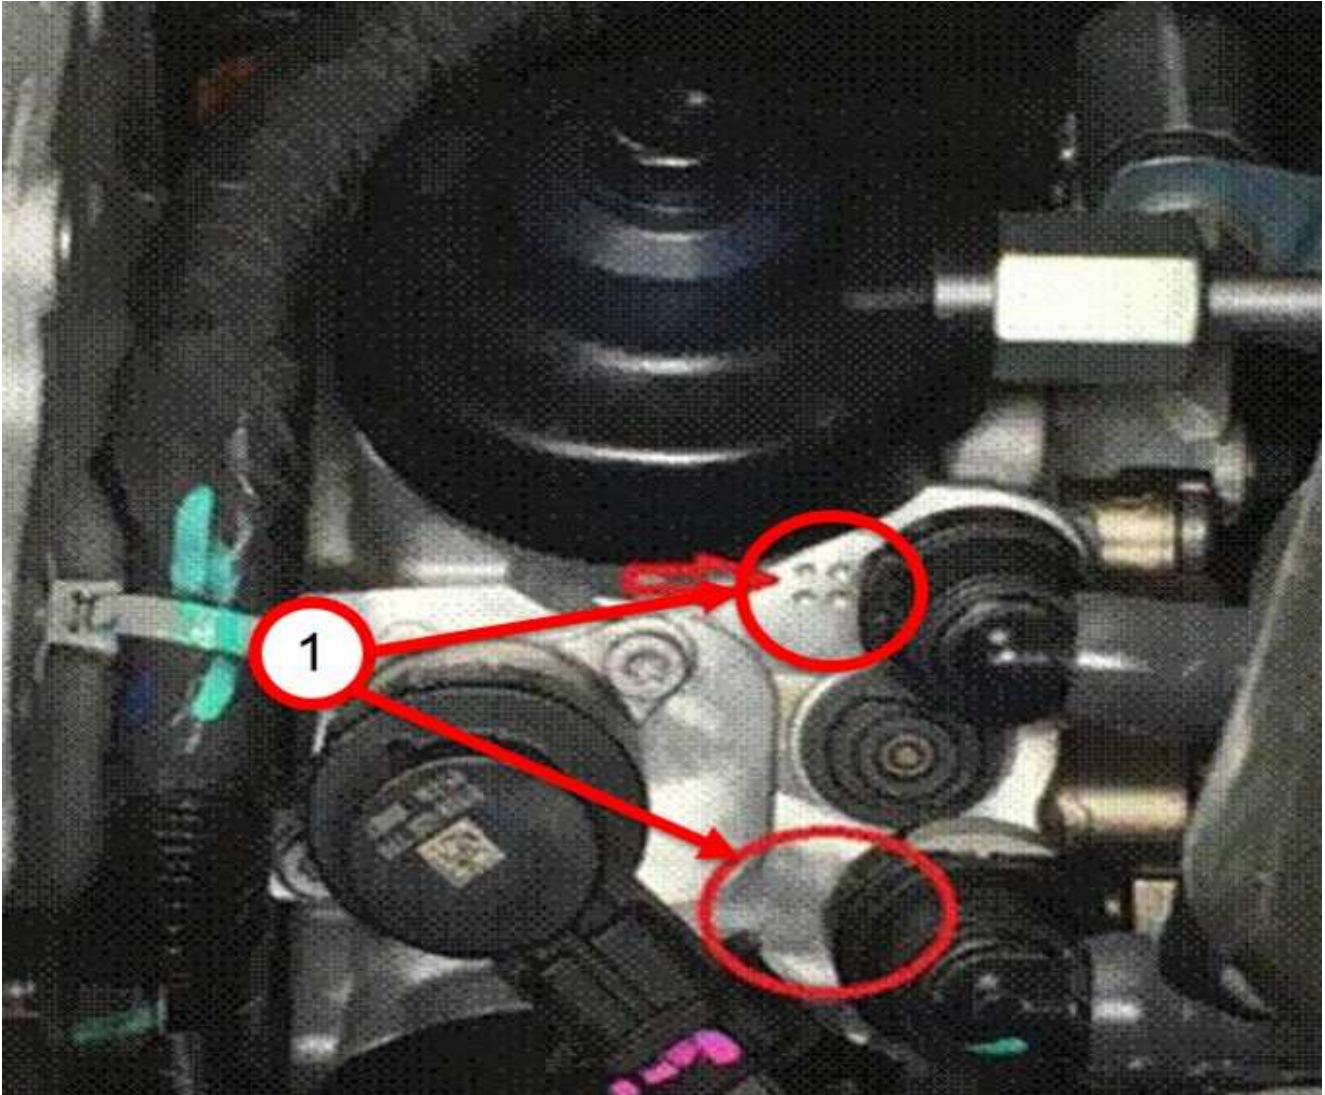
Fig. 2

- Vehicles with the old syle Asymmetrical Cam design will have either multiple dots or no dots embossed in the pump housing (Fig. 2) .
- Vehicles with an Asymmetrical Cam pump, choose the calibration labeled Asymetric Cam or Asym Cam.

Old Style Asymmetrical Cam Design Pump

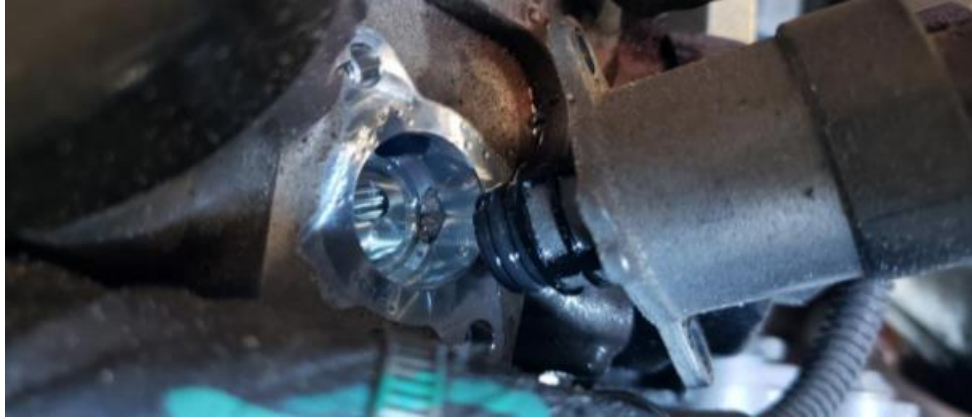
1. **Vehicle Scan Report**
2. **wiTECH Duty Cycle Report** (email to FCA\_DC@cummins.com)
  - 1.) Connect to the truck using WiTech 2.0 MicroPod  
**NOTE:** If there is a flash available for the PCM, do not flash the PCM as you will lose the duty cycle information.
  - 2.) From the topology screen, select the PCM module
  - 3.) Select the Misc. Functions tab
  - 4.) Select Cummins 6.7L Duty Cycle Monitor
  - 5.) Run the routine, it takes about 10 seconds
  - 6.) You will then be prompted to input an email address. Input FCA\_DC@cummins.com as the email address and be sure to click "**Add**" after doing so otherwise the email will not be sent.  
- After selecting add click continue.
3. **Inspect the fuel system for external contamination and describe in STAR Case Narrative**
4. **Take a clear photo of the FQS and FQS Bore of the pump to confirm the failure (see example below)**
