Service Bulletin

Bulletin No.: 21-NA-048

Subject: Black Screen in Reverse with Red Triangle and Red Camera with A Circle and Slash Through It

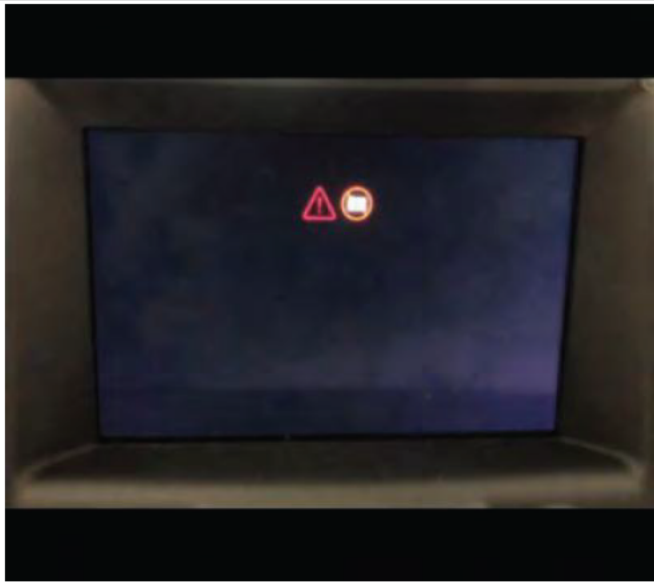
</div> <p style="text-align: right; font-size: small;">5758378</p> <p>Some customers may comment on seeing a black screen with red triangle and red camera with a circle and slash through it when vehicle is in Reverse. This condition may be intermittent.</p>
Cause	The cause of the condition may be that the crimping of the coaxial cable connectors to the cable is causing an excessive resistance that interrupts the video signal and causes the black screen.
Correction	Note: Verify the Condition, then depending on Model and Year, follow the appropriate repair in the list of Repair Procedures below.

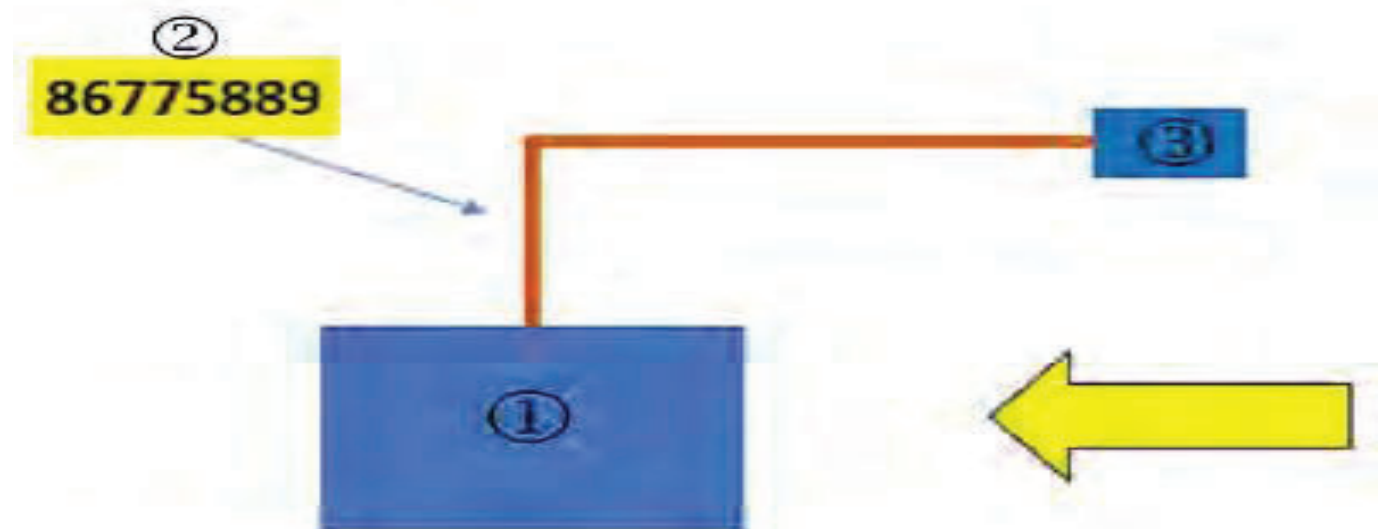
2020-2021 XT6 IP Coaxial Cable Routing (DRZ & UV2)

1. A11 Radio
2. IP Coax
3. IP to Body Coax In-line Connection

Replace the short (IP) coaxial cable from the in-line connection to the A11 Radio, located behind the right kick panel.

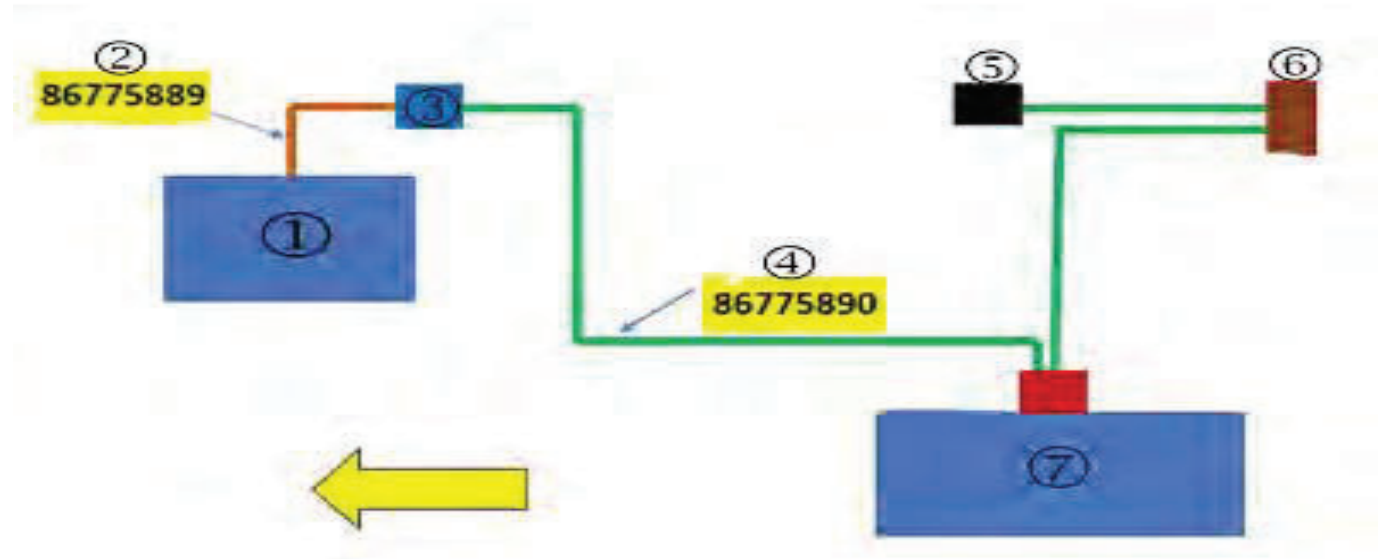
2020-2021 XT5 IP and Body Coaxial Cable Routing (DRZ & UV2)

1. A11 Radio
2. IP Coax
3. IP to Body Coax In-line Connection
4. Body Coax
5. To Headliner
6. To Liftgate Harness
7. VPM

Note: On XT5, the (Body) cable runs from the VPM to the In-line connection to the (IP) short cable behind the right kick panel. It also routes to the liftgate coaxial connector and to the coax at the top of the left "D" pillar headliner area for the rearview mirror.

Note: The long cable will be an overlay routed with, and affixed to, the body harness. The original body coax will just need the ends off and can be abandoned in the main body wiring harness.

1. Replace the long Coaxial cable (Body) from the VPM in the left rear of the vehicle, to the In-line connection to the (IP) short cable behind the right kick panel and to the liftgate connector and connect to the cable to the rearview mirror in the top left "D" pillar headliner area.
2. Replace the short (IP) coaxial cable from the in-line connection to the A11 Radio, located behind the right kick panel.

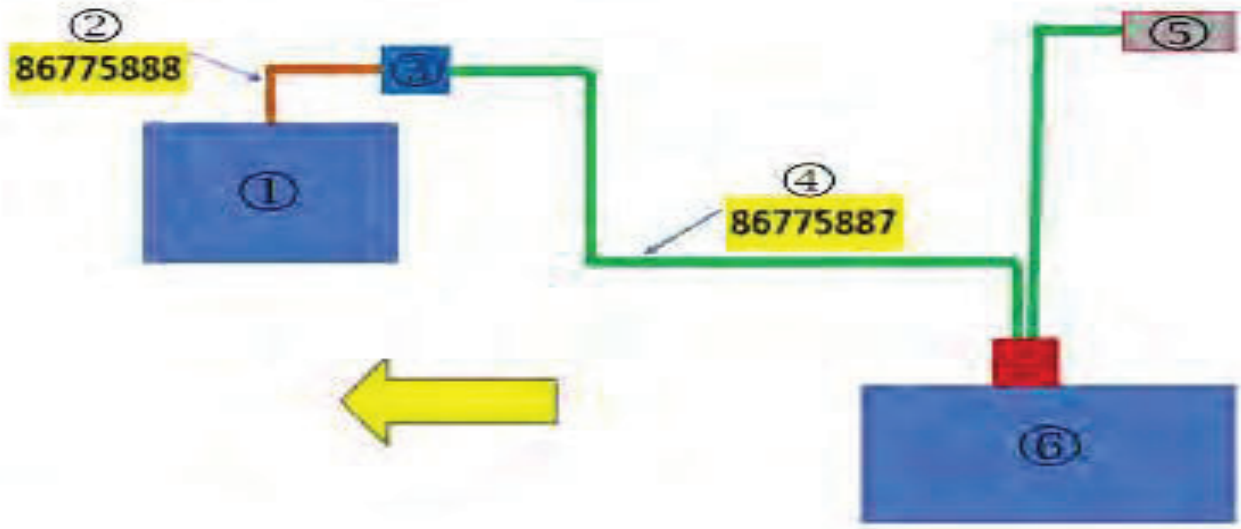
Acadia
 2020-2021 Acadia IP and Body Coaxial Cable
 Routing (UV2)

- 1. A11 Radio
- 2. IP Coax
- 3. IP to Body Coax In-line Connection
- 4. Body Coax
- 5. To Liftgate Harness
- 6. VPM

Note: On Acadia, the (Body) cable runs from the VPM to the In-line connection to the (IP) short cable behind the right kick panel and to the liftgate coaxial cable connector.

Note: The long cable will be an overlay routed with, and affixed to, the body harness. The original body coax will just need the ends off and can be abandoned in the main body wiring harness.

- 1. Replace the long Coaxial cable (Body) from the VPM in the left rear of the vehicle, to the In-line connection to the (IP) short cable behind the right kick panel and to the liftgate coaxial cable connector.
- 2. Replace the short (IP) coaxial cable from the in-line connection to the A11 Radio, located behind the right kick panel.

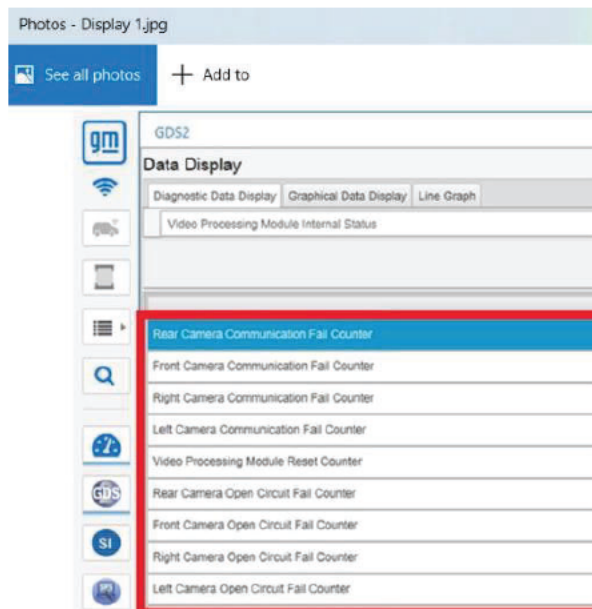
Module Diagnostics / K157 Video Processing Module / Video Processing Module Internal Status.

3. The three most critical parameters to look at are:
 - a. Camera Communication Fail Counter
 - b. Video Processing Module Reset Counter
 - c. Camera Open Circuit Counter
4. Write down the counters found in the VPM using the scan tool.
5. Cross-reference the DTC's and counters with the trouble shooting table below to determine most probable cause.

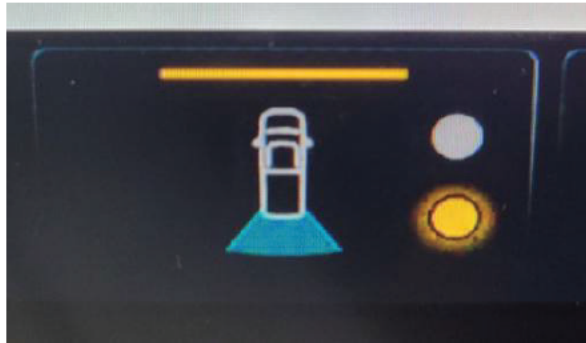
7. If it's difficult to determine the causal component, unplug all the cameras.
- Leave the rear camera input and video output at VPM.
 - Activate the Rearview Camera (RVC) using the "Cameras" touch button.

- If there is no image output, swap to the front, left, or right cameras into VPM rear camera input and repeat previous steps to check images again.
8. If concern(s) persist, refer to published diagnostics in SI.

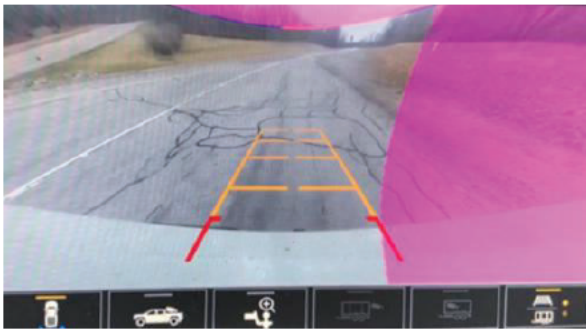
Pink on the screen will be most likely an intermittent Coax issues caused by damaged or frayed coax cables.

Some intermittent conditions can be caused by wire terminal fretting corrosion, which is a build-up of insulating, oxidized wear debris that can form when there is a small motion between electrical terminals.

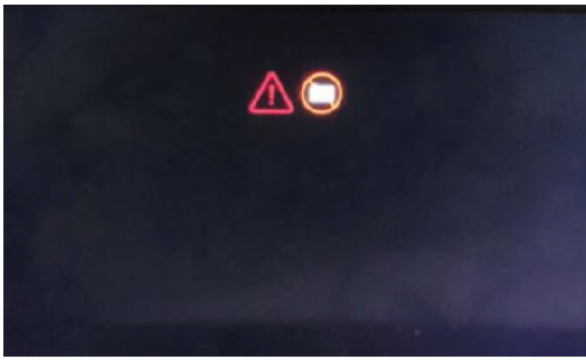
If the rear camera or the VPM do not provide the rolling counter, you will see the following black screen with an icon:

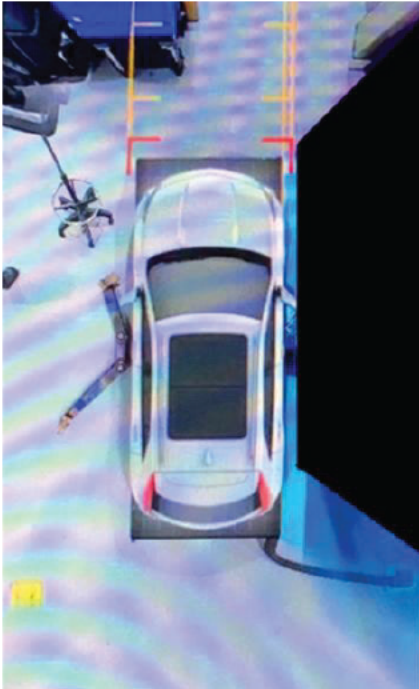
The VPM does not monitor the left, right or front cameras with a rolling counter. These camera's will display in black on their perspective side if there is an issue.

Figure below is of a right camera issue:
