# CONNECTION NEEDED ON NEW CABLE

X903 -- LEFT D-PILLAR  
NOT COMPATIBLE WITH  
UPDATED CABLE FROM  
WPC

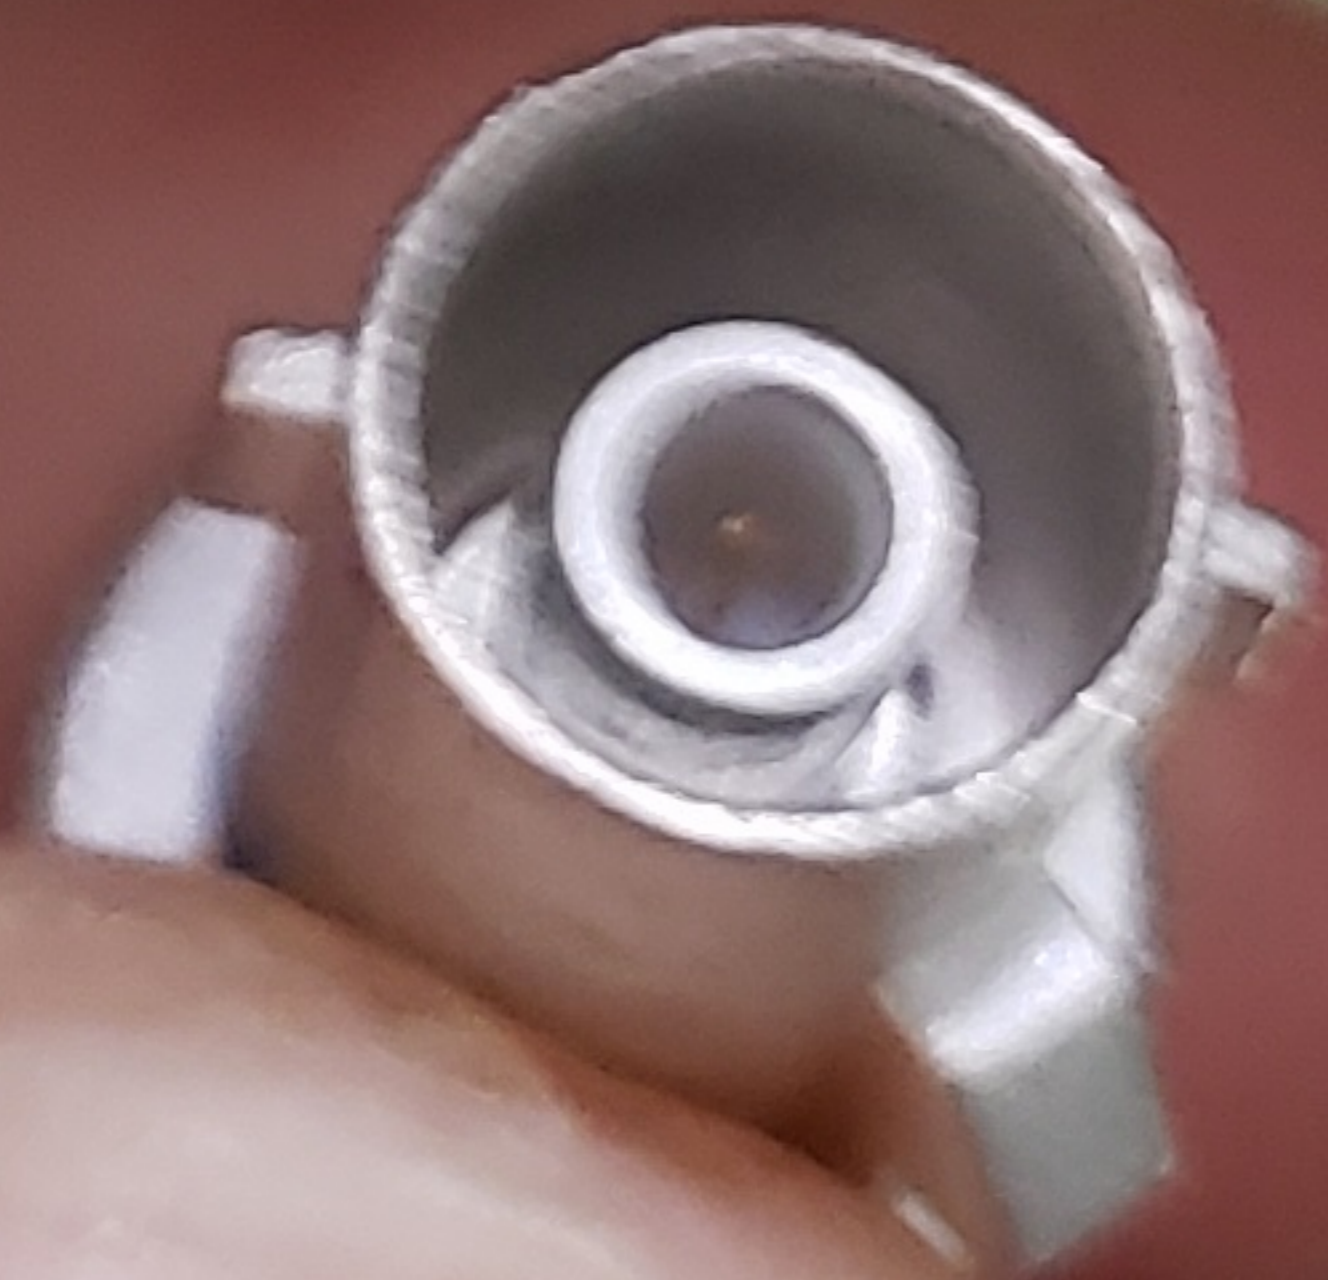
CONNECTION TO  
CAMERA

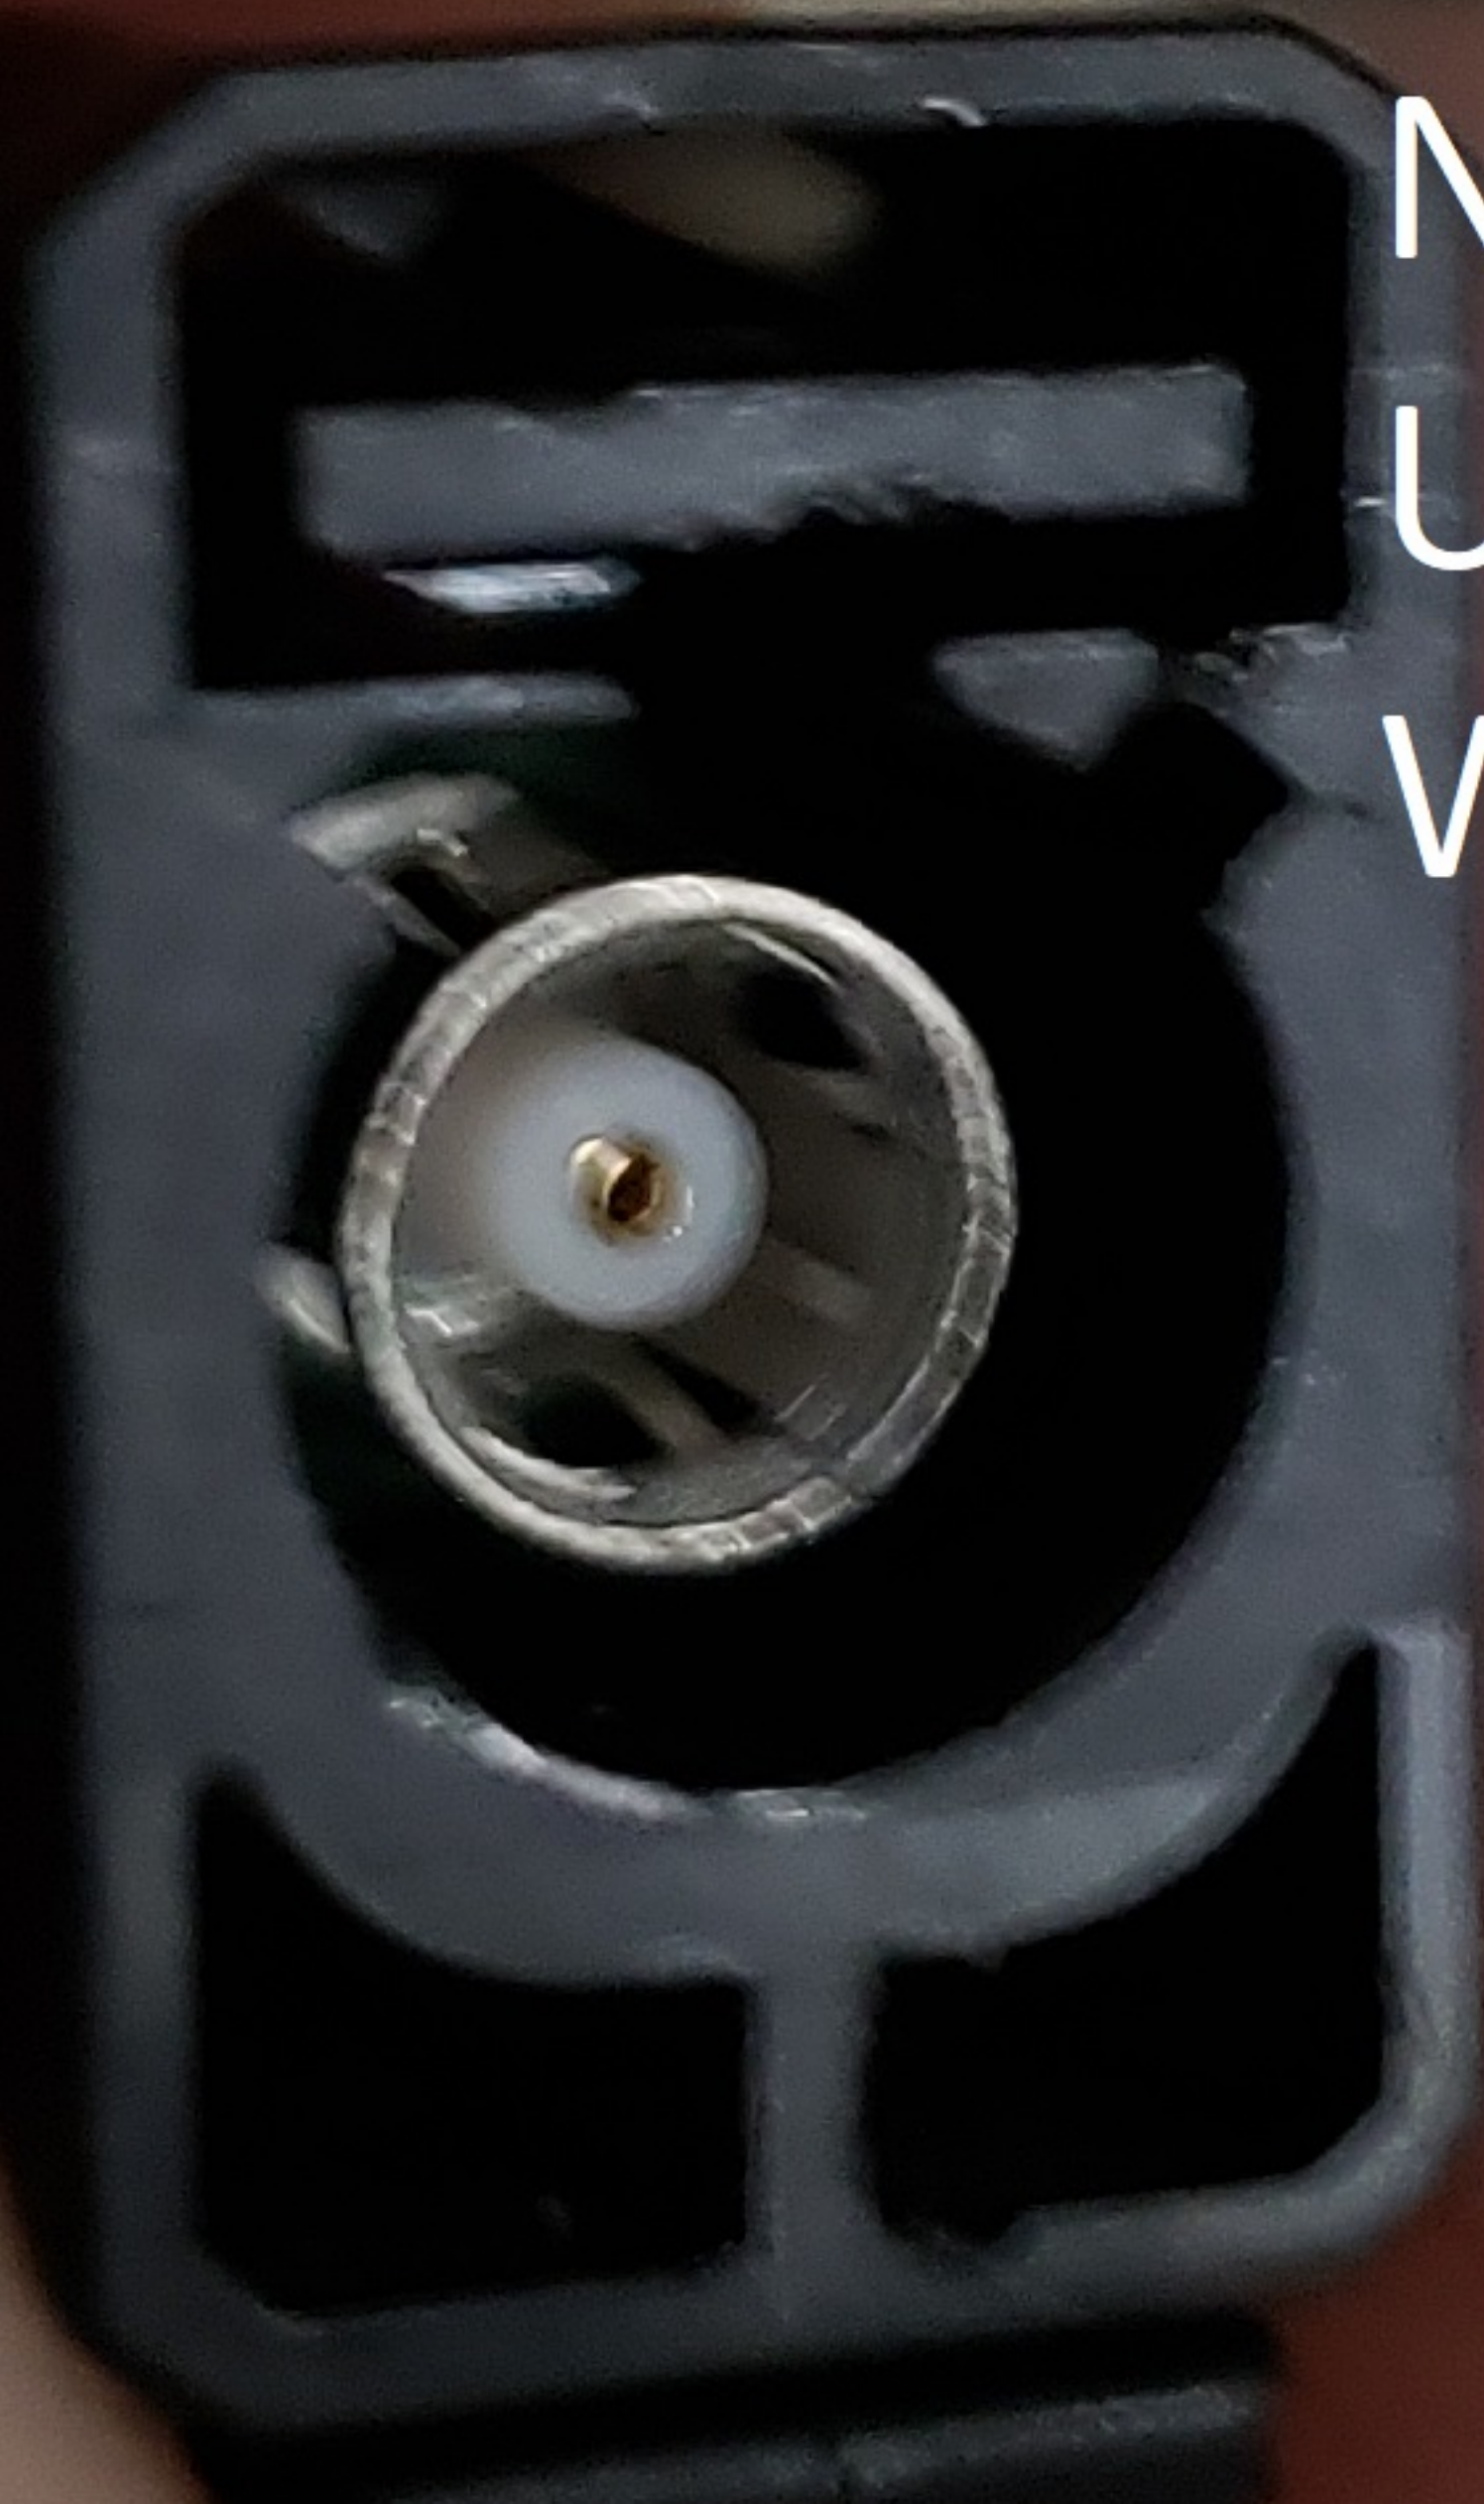
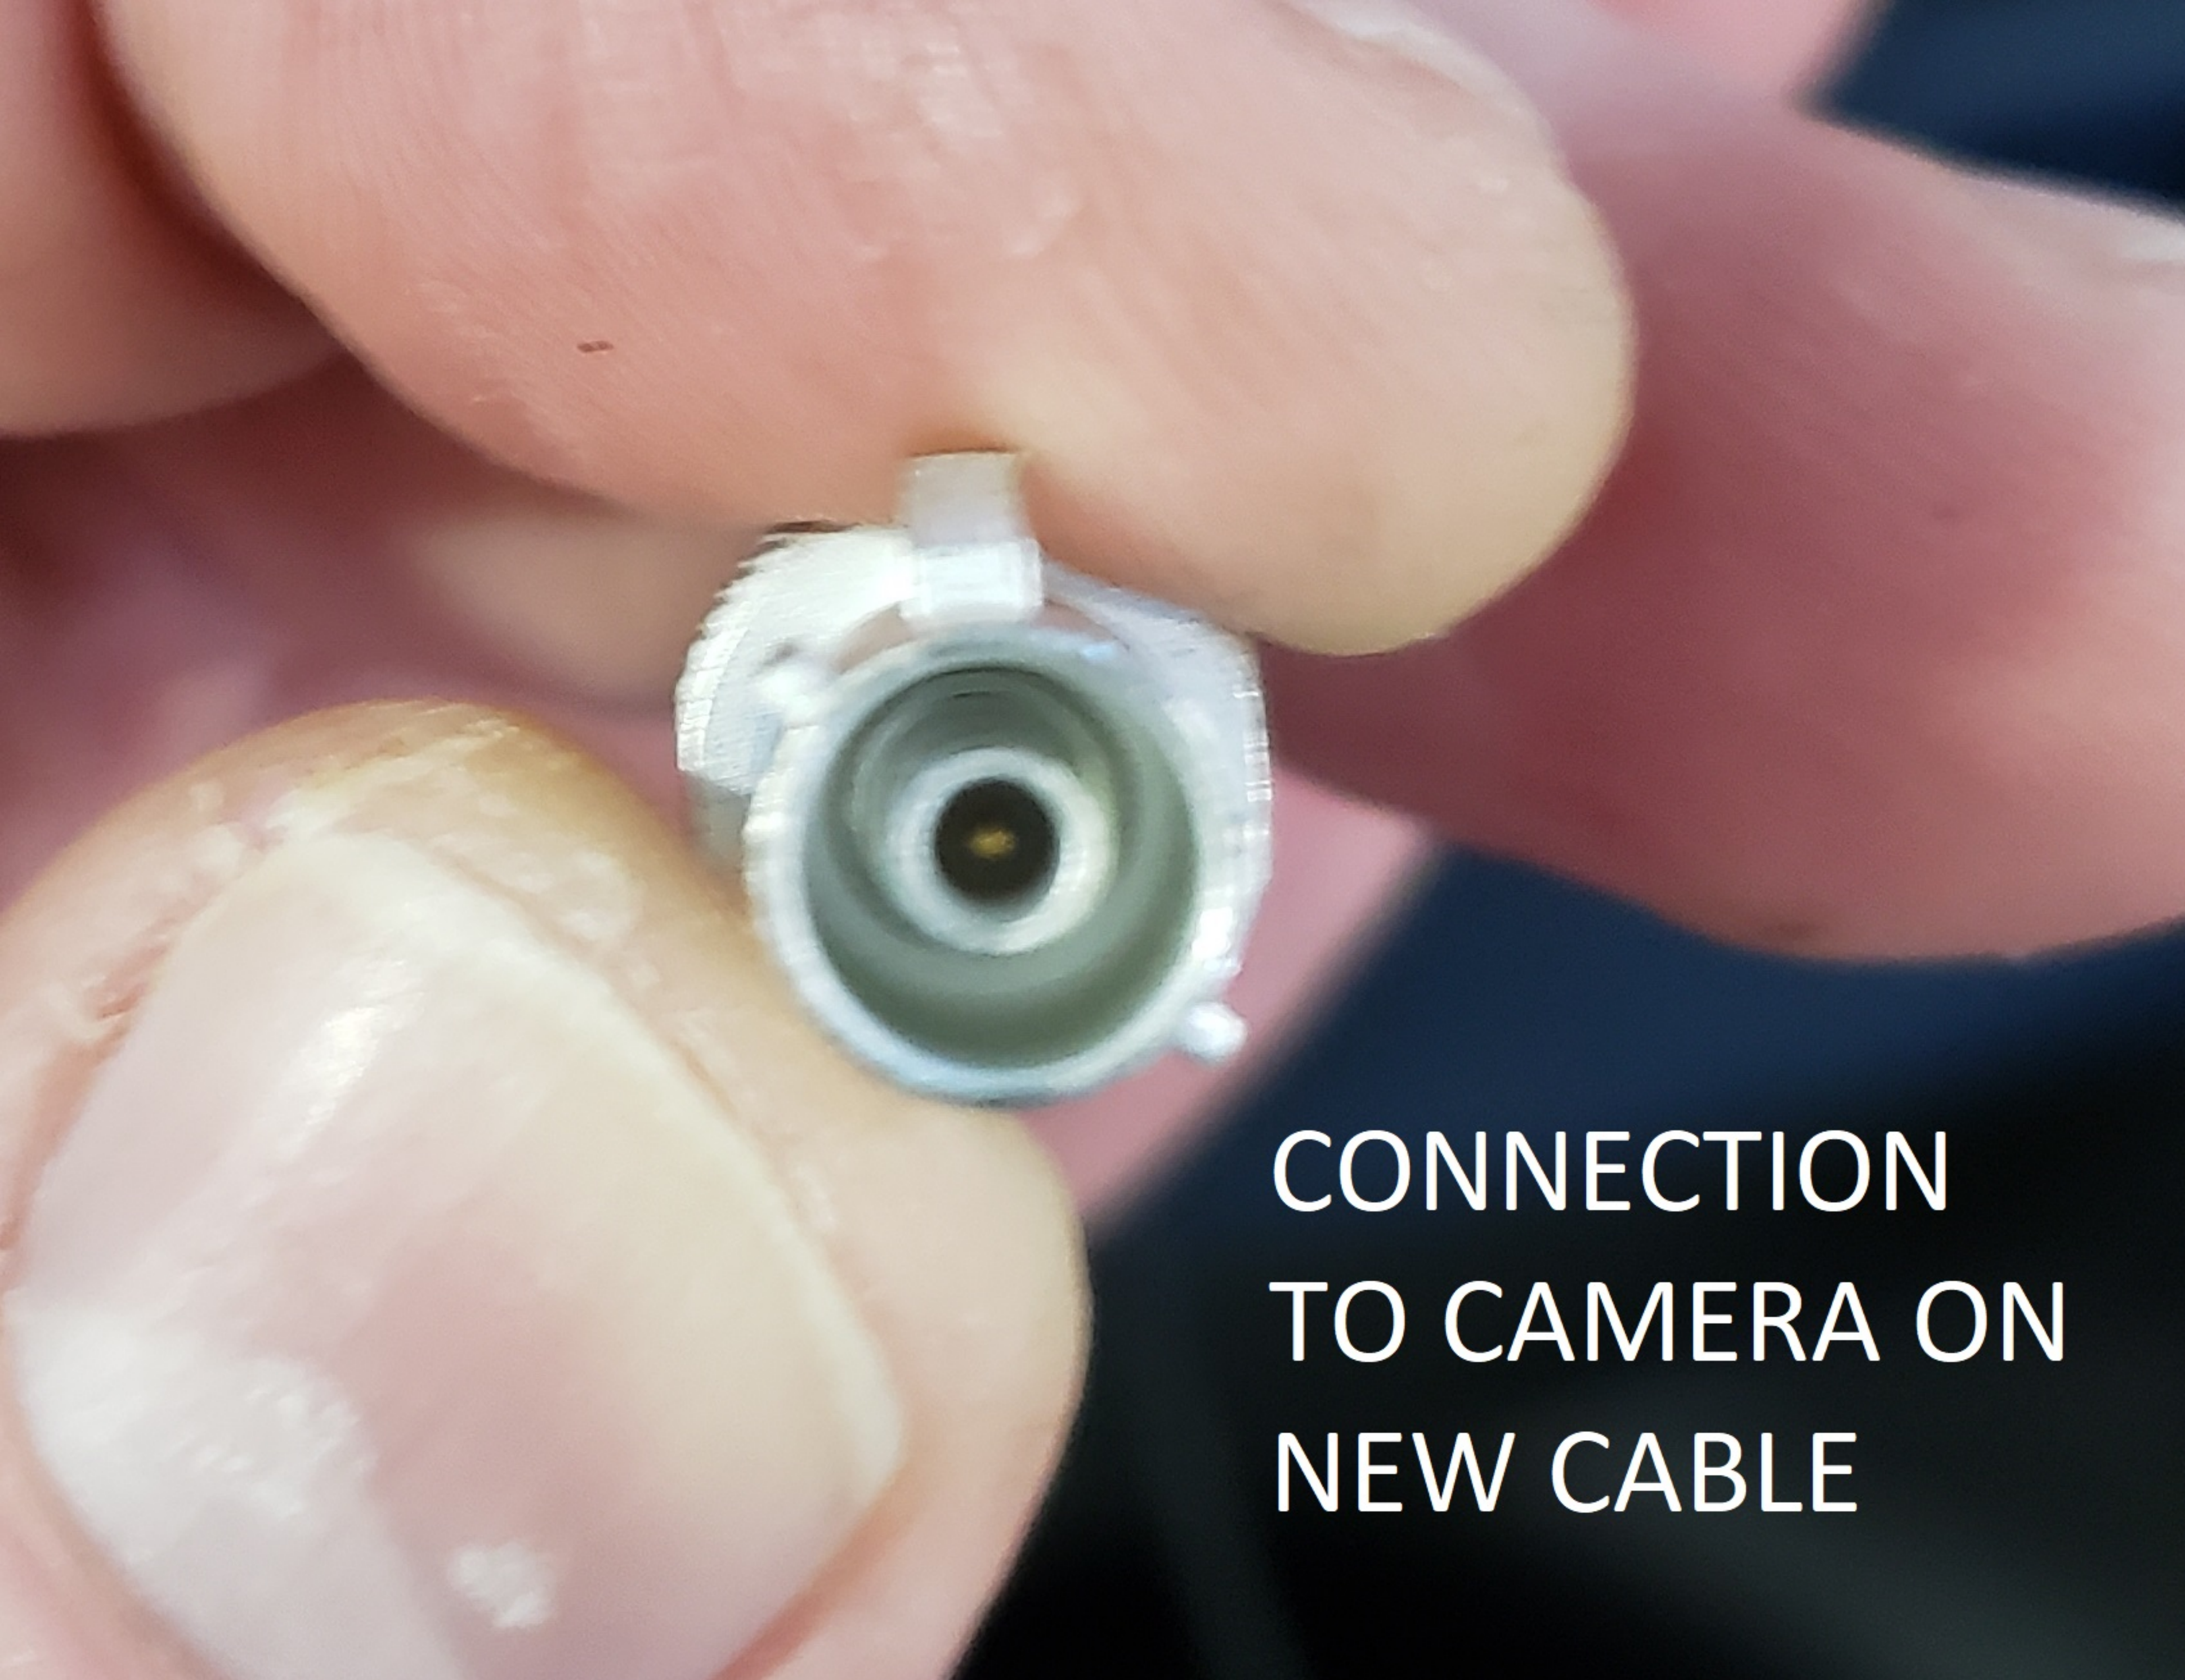
CONNECTION  
TO CAMERA ON  
NEW CABLE

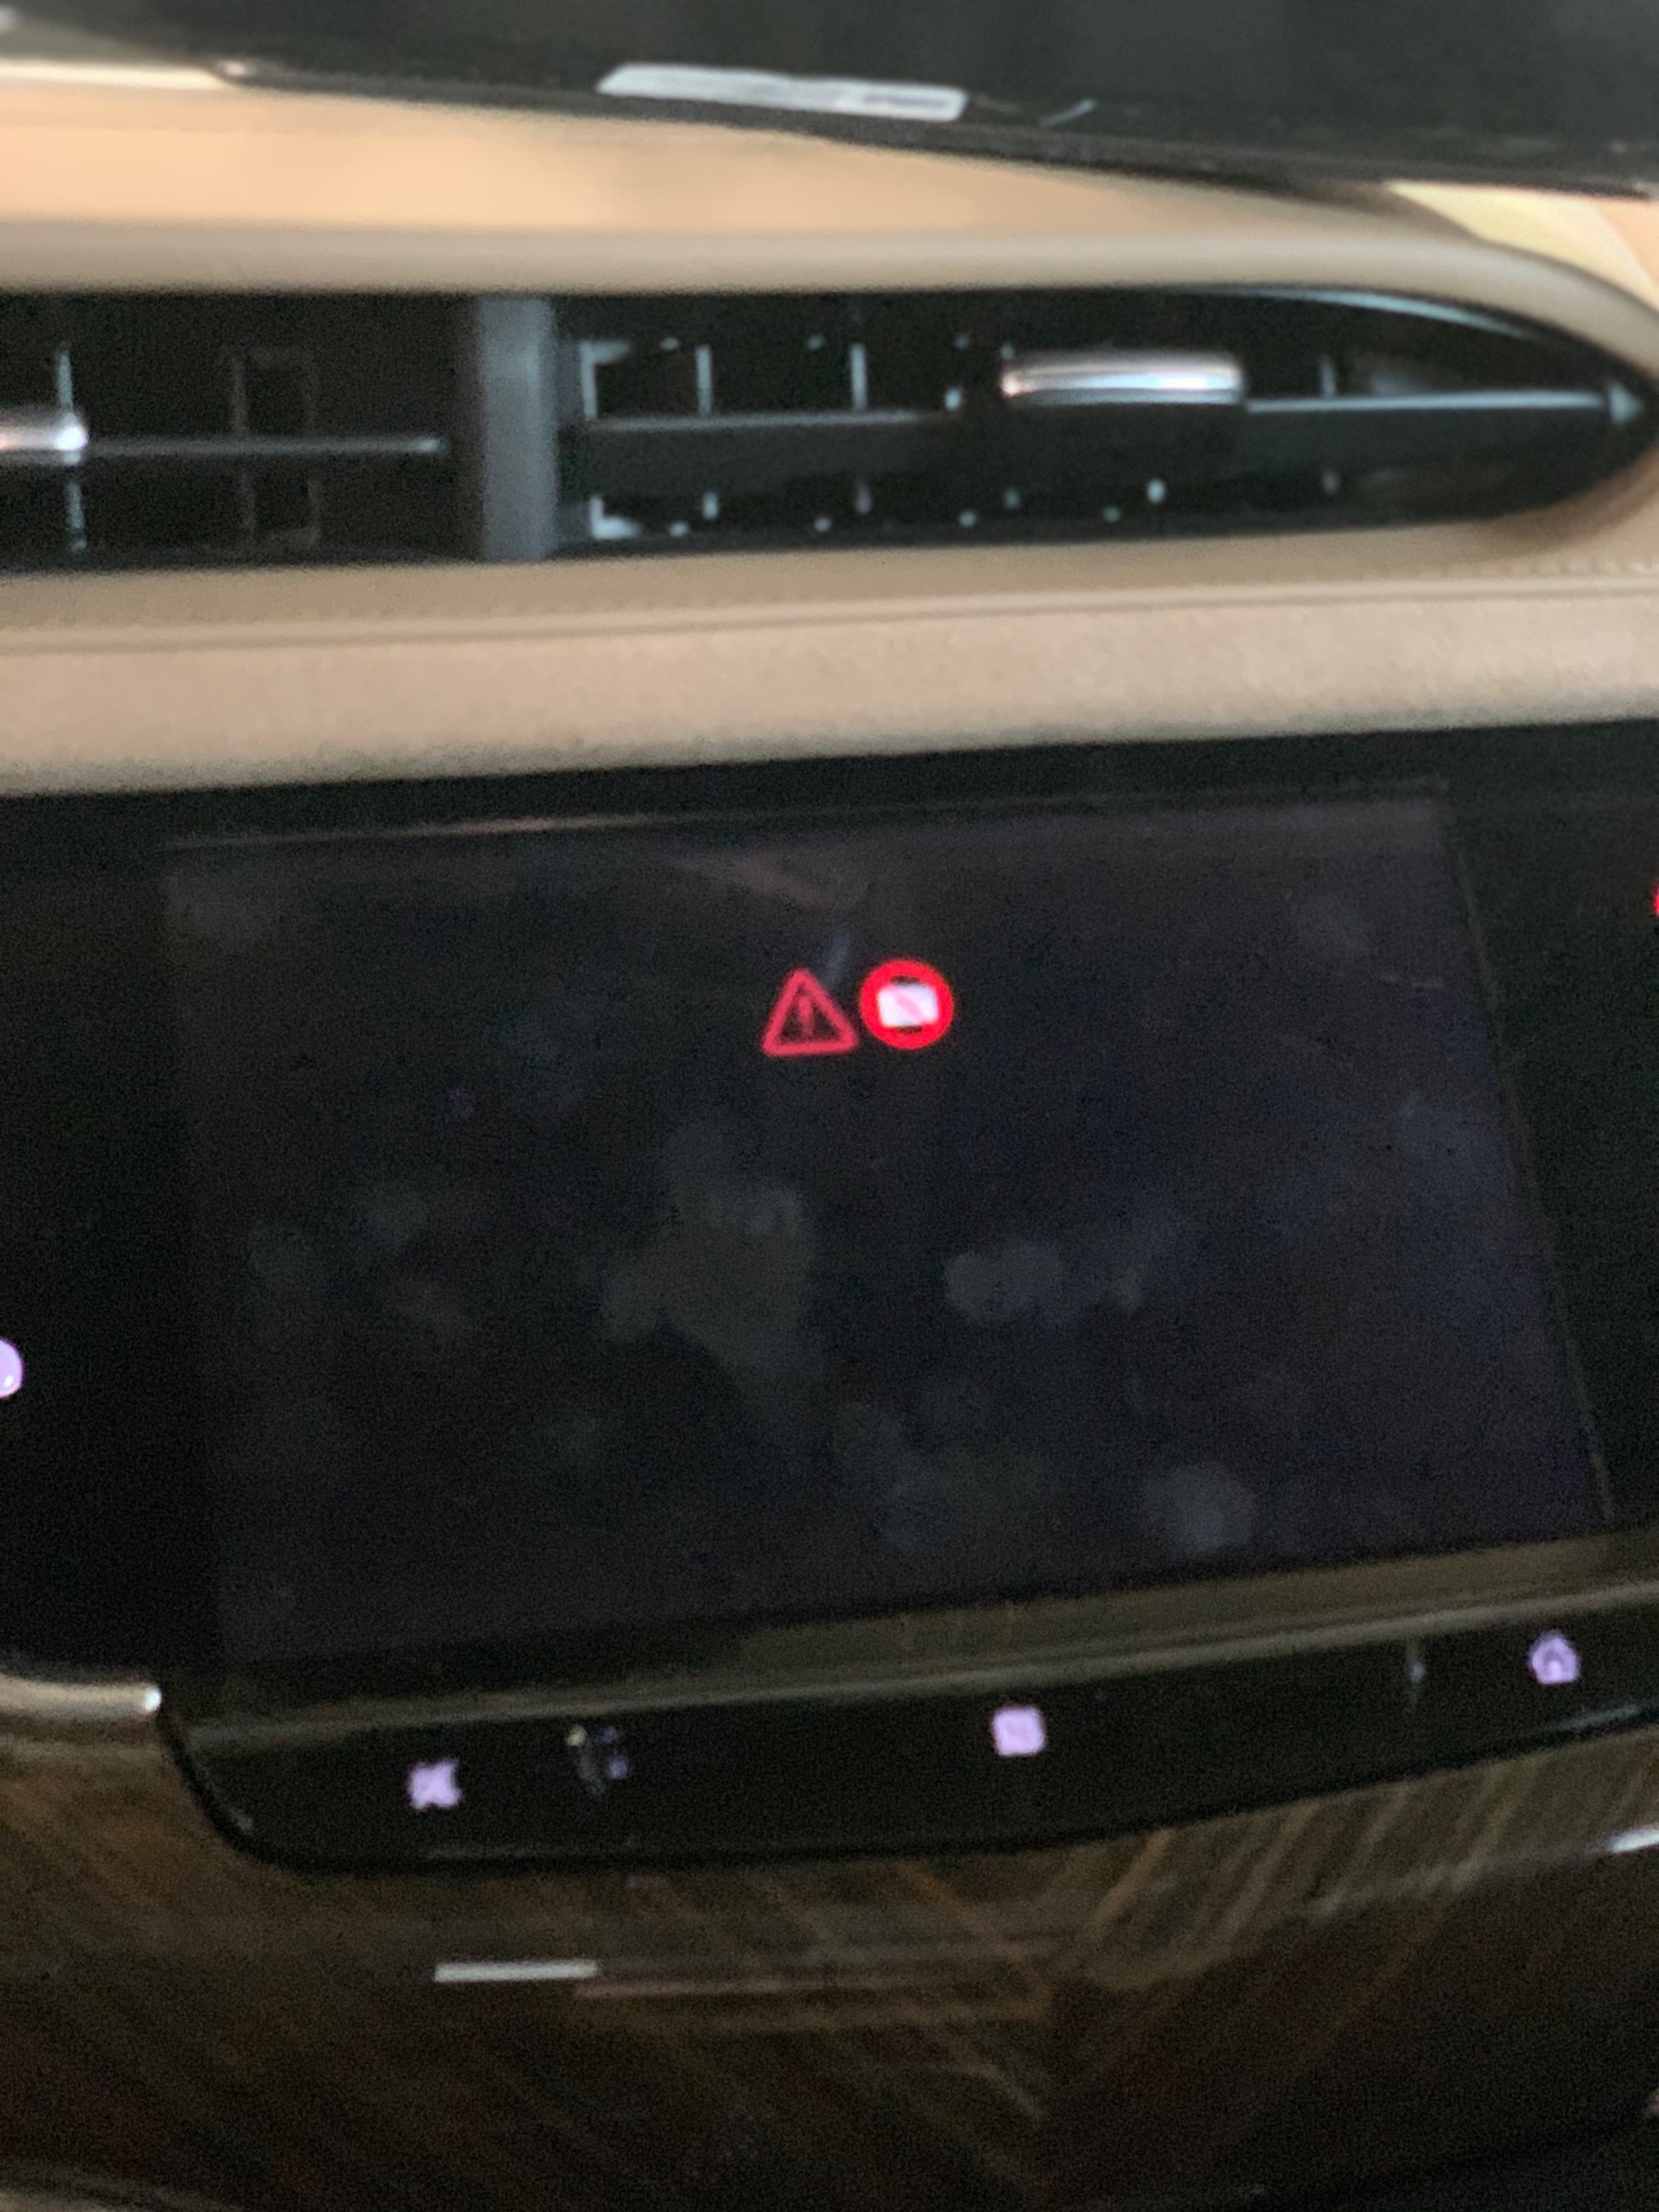
← This brown connector does not fit in this pass-thru.
