#21-NA-048: Black Screen in Reverse with Red Triangle and Red Camera with A Circle and Slash Through It - (May 19, 2021)

Subject: Black Screen in Reverse with Red Triangle and Red Camera with A Circle and Slash Through It

2020 Cadillac XT6 - [REDACTED]

2020 XT6 No 360 Camera Image When Put Into Reverse

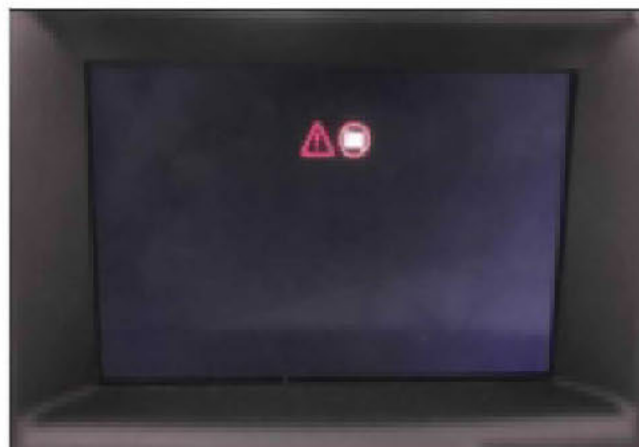
Some customers may comment on seeing a black screen with red triangle and red camera with a circle and slash through it when vehicle is in Reverse. This condition may be intermittent.

Cause	The cause of the condition may be that the crimping of the coaxial cable connectors to the cable is causing an excessive resistance that interrupts the video signal and causes the black screen.
Correction	Note: Verify the Condition, then depending on Model and Year, follow the appropriate repair in the list of Repair Procedures below.

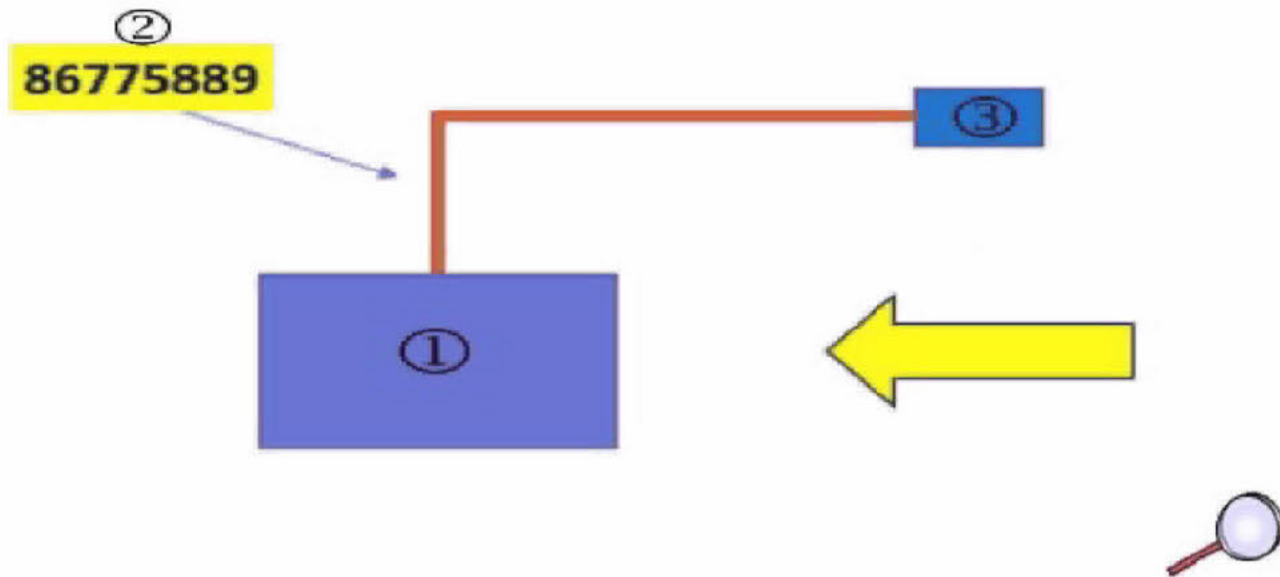
2020-2021 XT6 IP Coaxial Cable Routing (DRZ & UV2)

1. A11 Radio
2. IP Coax
3. IP to Body Coax In-line Connection

Replace the short (IP) coaxial cable from the in-line connection to the A11 Radio, located behind the right kick panel.

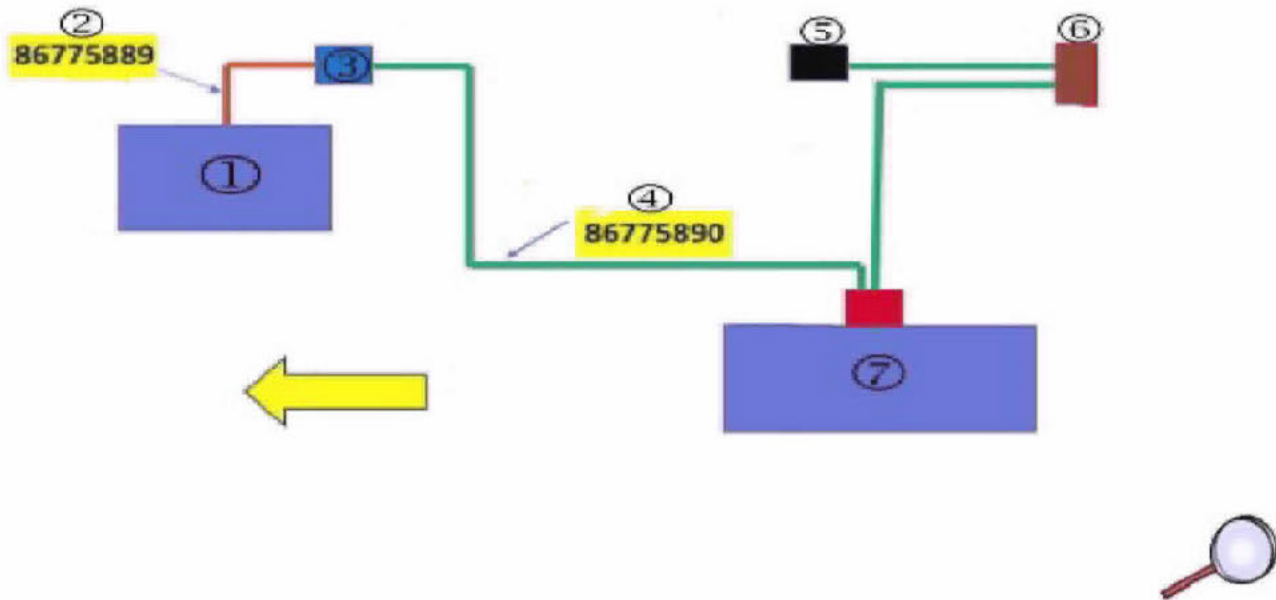
2020-2021 XT5 IP and Body Coaxial Cable Routing (DRZ & UV2)

1. A11 Radio
2. IP Coax
3. IP to Body Coax In-line Connection
4. Body Coax
5. To Headliner
6. To Liftgate Harness
7. VPM

Note: On XT5, the (Body) cable runs from the VPM to the In-line connection to the (IP) short cable behind the right kick panel. It also routes to the liftgate coaxial connector and to the coax at the top of the left "D" pillar headliner area for the rearview mirror.

1. Replace the long Coaxial cable (Body) from the VPM in the left rear of the vehicle, to the In-line connection to the (IP) short cable behind the right kick panel and to the liftgate connector and connect to the cable to the rearview mirror in the top left "D" pillar headliner area.
2. Replace the short (IP) coaxial cable from the in-line connection to the A11 Radio, located behind the right kick panel.

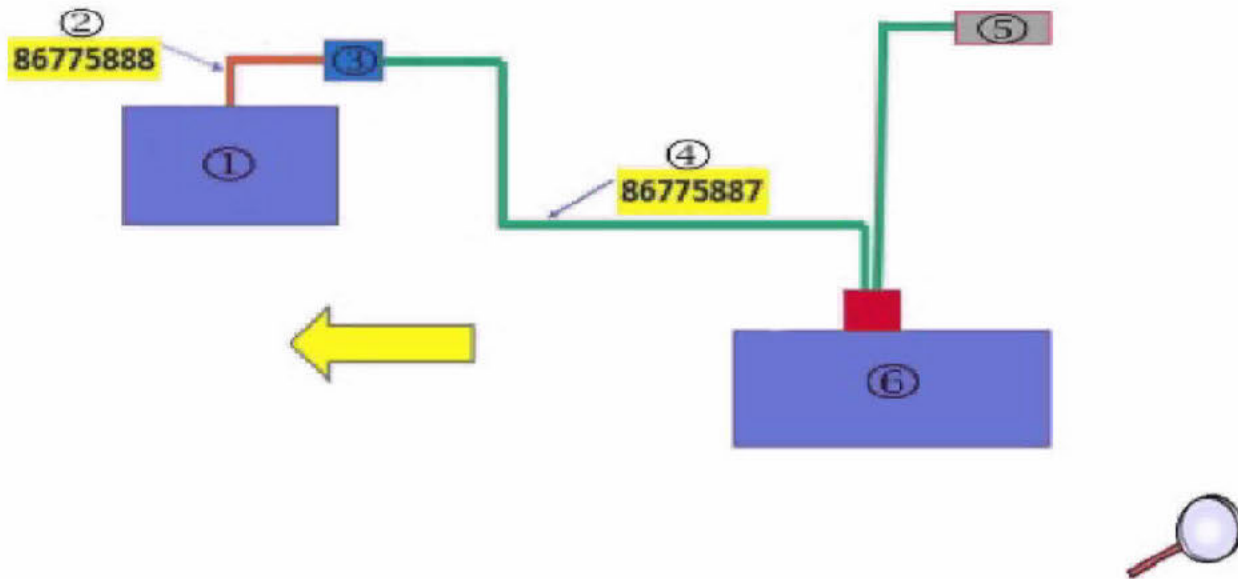
2020-2021 GMC Acadia IP and Body Coaxial Cable Routing (UV2)

1. A11 Radio
2. IP Coax
3. IP to Body Coax In-line Connection
4. Body Coax
5. To Liftgate Harness
6. VPM

Note: On GMC Acadia, the (Body) cable runs from the VPM to the In-line connection to the (IP) short cable behind the right kick panel and to the liftgate coaxial cable connector.

1. Replace the long Coaxial cable (Body) from the VPM in the left rear of the vehicle, to the In-line connection to the (IP) short cable behind the right kick panel and to the liftgate coaxial cable connector.
2. Replace the short (IP) coaxial cable from the in-line connection to the A11 Radio, located behind the right kick panel.

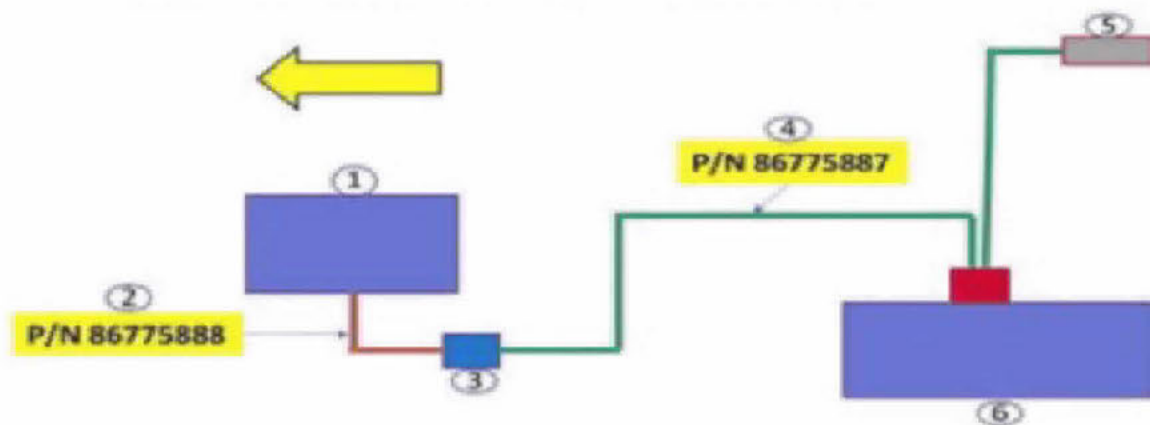
2020 Holden Acadia IP and Body Coaxial Cable Routing (UV2)

- 1. A11 Radio
- 2. IP Coax
- 3. IP to Body Coax In-line Connection
- 4. Body Coax
- 5. To Liftgate Harness
- 6. VPM

Note: On Holden Acadia, the (Body) cable runs from the VPM to the In-line connection to the (IP) short cable behind the left side of the IP near the glove box.

- 1. Replace the long Coaxial cable (Body) from the VPM in the left rear of the vehicle, to the In-line connection to the (IP) short cable behind the left IP near the glove box and to the liftgate coaxial cable connector.
- 2. Replace the short (IP) coaxial cable from the in-line connection to the A11 Radio, located behind the left IP near the glove box.

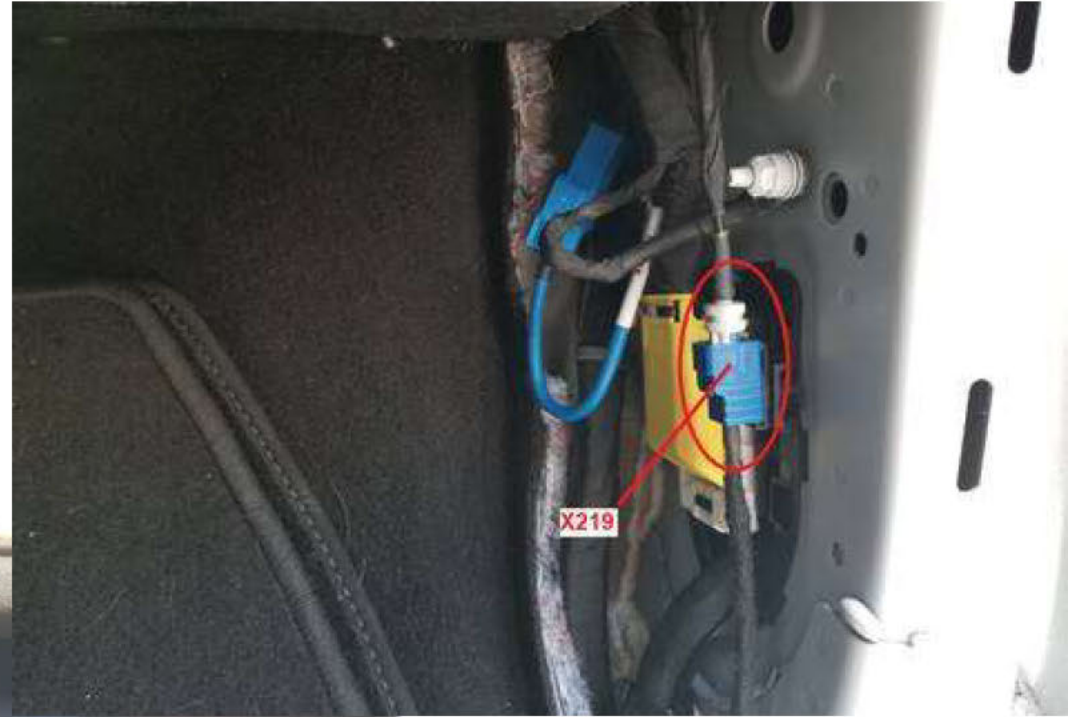
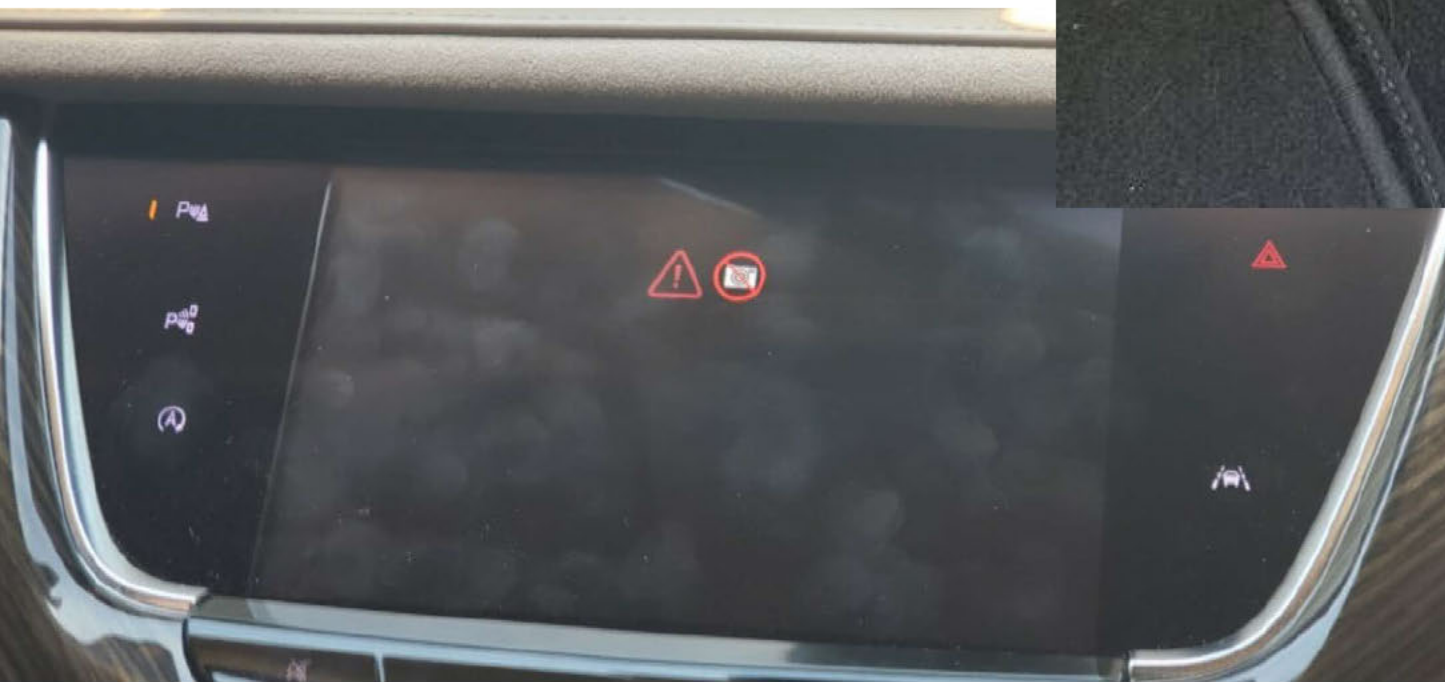
As soon as I touched X219, the concern occurred.

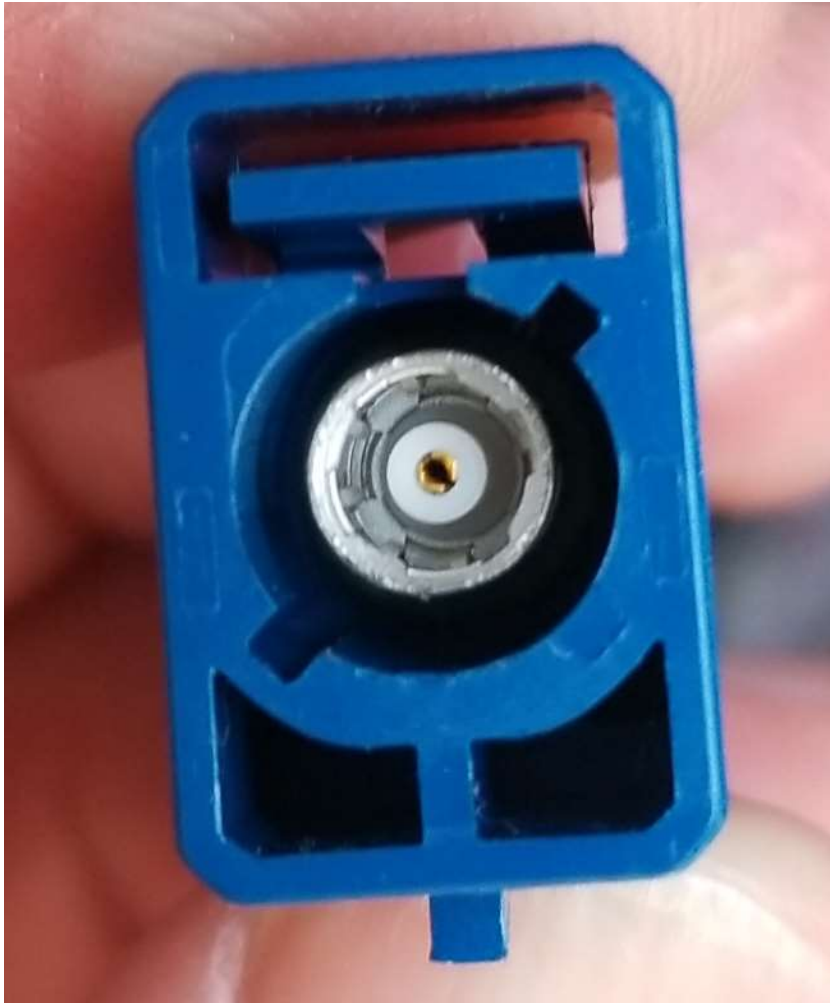
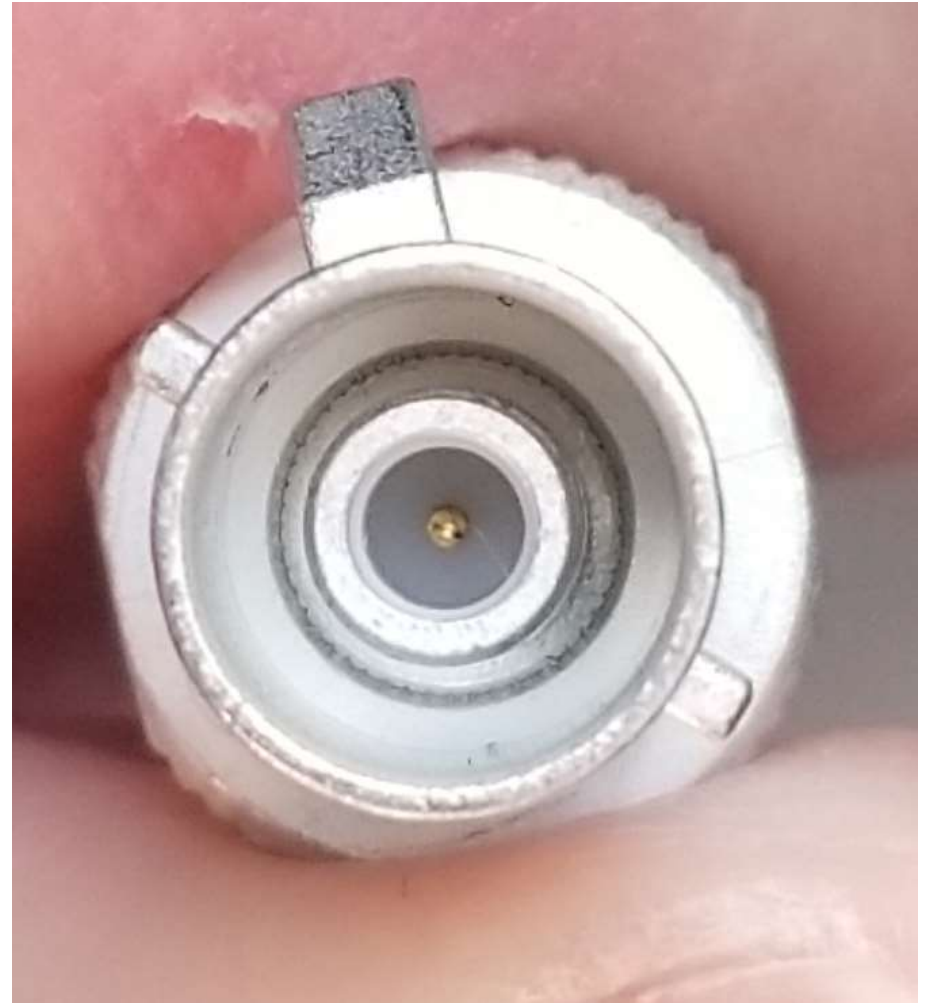
After manipulating X219 & separating the connector, I was unable to replicate concern again, found no obvious issues.

SME advised these coax cables are difficult to order and they had replaced harnesses on both sides of connector X219 on previous cases. (Not an ideal option).

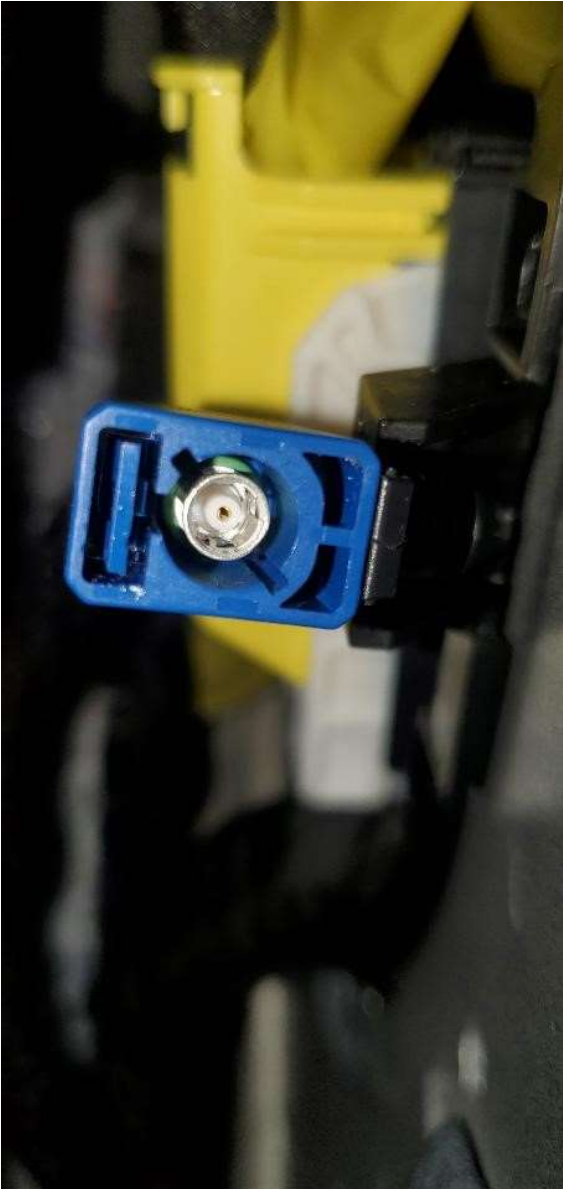
X219 located on right side kick panel below radio.

Cause: Key on engine off trying to remove X219 was able to duplicate concern. Found X219 female terminal spread.

Correction: Replace and overlay Coax cable from K157 VPCM to A11 Radio.

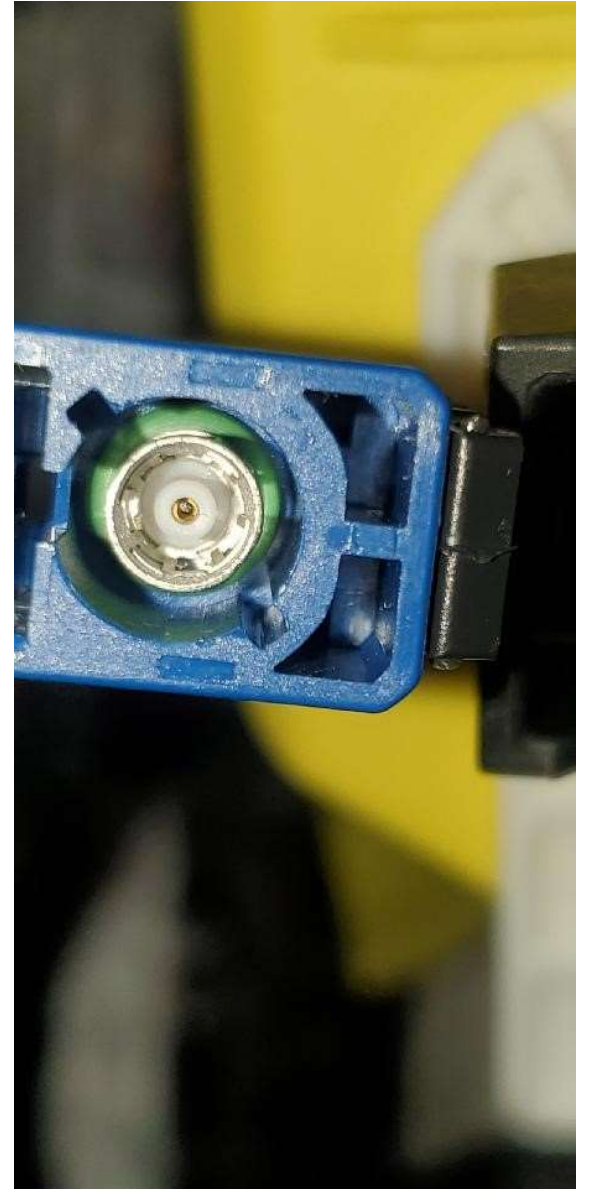
No codes stored in radio or VPCM when concern takes place. When performing initial inspection Foreman and I were able to duplicate concern with vehicle parked outside in the sun. Cabin temperature was very warm. Going over speed bumps did not effect concern. With vehicle parked inside shop where it was cool we were unable to duplicate the concern again until I tried to separate the X219 connector. When I tried to separate I was able to duplicate the blank screen concern twice. No dielectric grease was applied in the X219 connector. The Foreman was instructed to overlay the Coax cable between the VPCM and Radio. Note: When the K157 VPCM X3 connector is removed 2 codes will set reflecting the open circuit in the B87 Rearview Camera circuit. No codes will set pertaining to the open circuit between the VPCM and Radio. That would explain why no codes set pertaining to the customers concern.
