Document ID: 5757463

This bulletin replaces PIC6420D. Please discard PIC6420D.

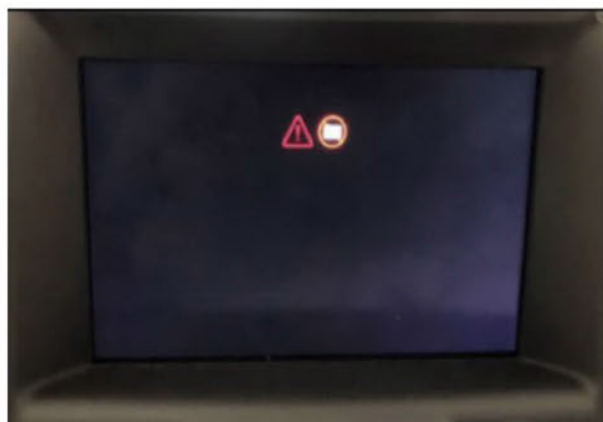
Some customers may comment on seeing a black screen with red triangle and red camera with a circle and slash through it when vehicle is in Reverse. This condition may be intermittent.

<p>Cause</p>	<p>The cause of the condition may be that the crimping of the coaxial cable connectors to the cable is causing an excessive resistance that interrupts the video signal and causes the black screen.</p>
<p>Correction</p>	<p>Note: Verify the Condition, then depending on Model and Year, follow the appropriate repair in the list of Repair Procedures below.</p>

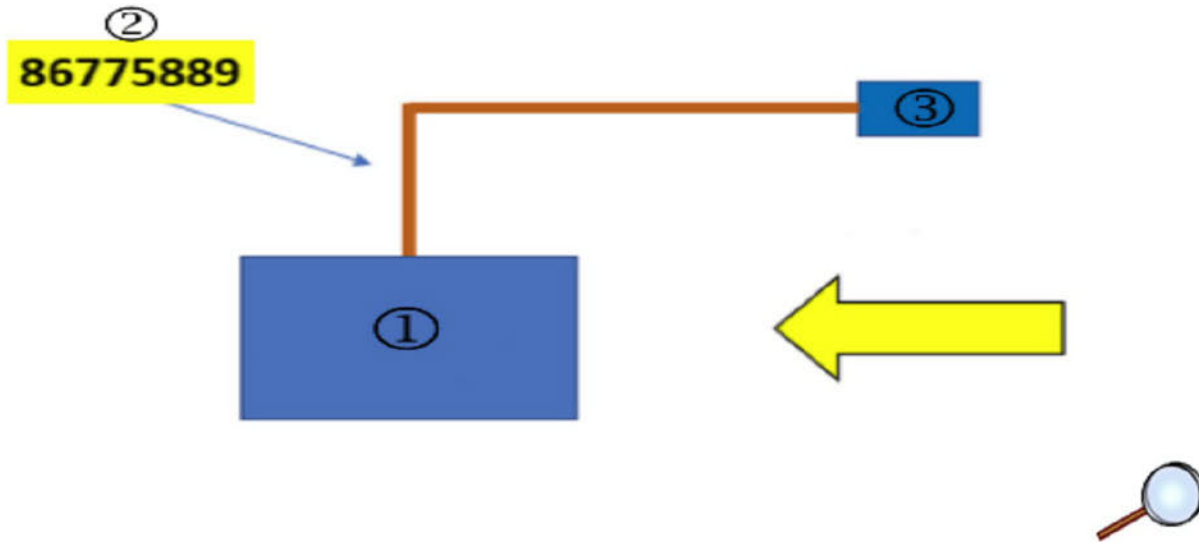
2020-2021 XT6 IP Coaxial Cable Routing (DRZ & UV2)

1. A11 Radio
2. IP Coax
3. IP to Body Coax In-line Connection

Replace the short (IP) coaxial cable from the in-line connection to the A11 Radio, located behind the right kick panel.

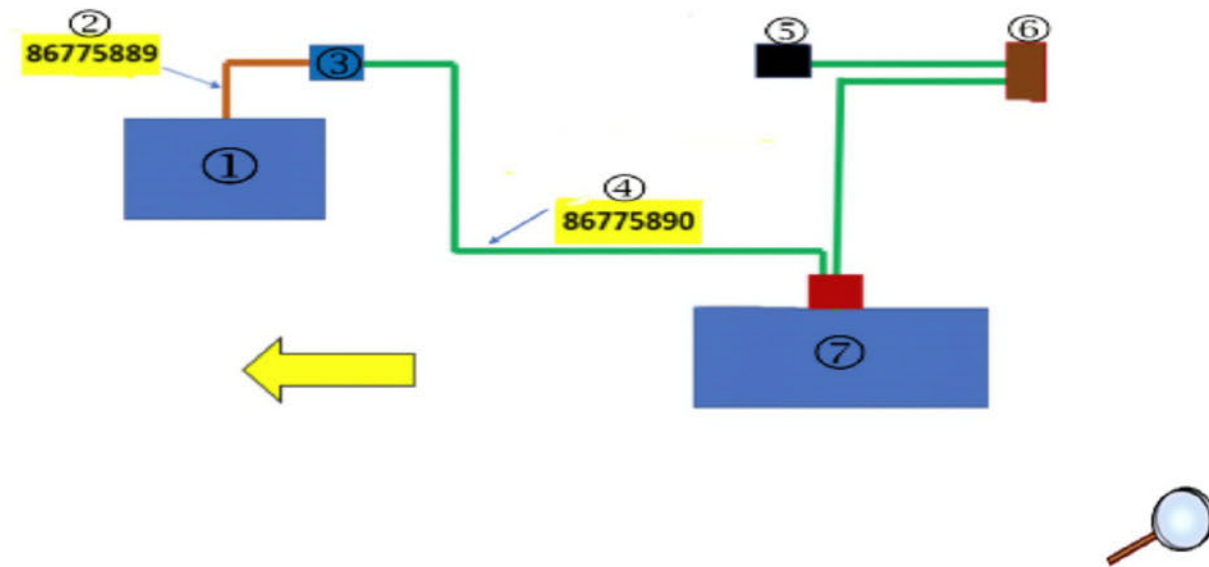
2020-2021 XT5 IP and Body Coaxial Cable Routing (DRZ & UV2)

1. A11 Radio
2. IP Coax
3. IP to Body Coax In-line Connection
4. Body Coax
5. To Headliner
6. To Liftgate Harness
7. VPM

Note: The long cable will be an overlay routed with, and affixed to, the body harness. The original body coax will just need the ends off and can be abandoned in the main body wiring harness.

1. Replace the long Coaxial cable (Body) from the VPM in the left rear of the vehicle, to the In-line connection to the (IP) short cable behind the right kick panel and to the liftgate connector and connect to the cable to the rearview mirror in the top left "D" pillar headliner area.
2. Replace the short (IP) coaxial cable from the in-line connection to the A11 Radio, located behind the right kick panel.

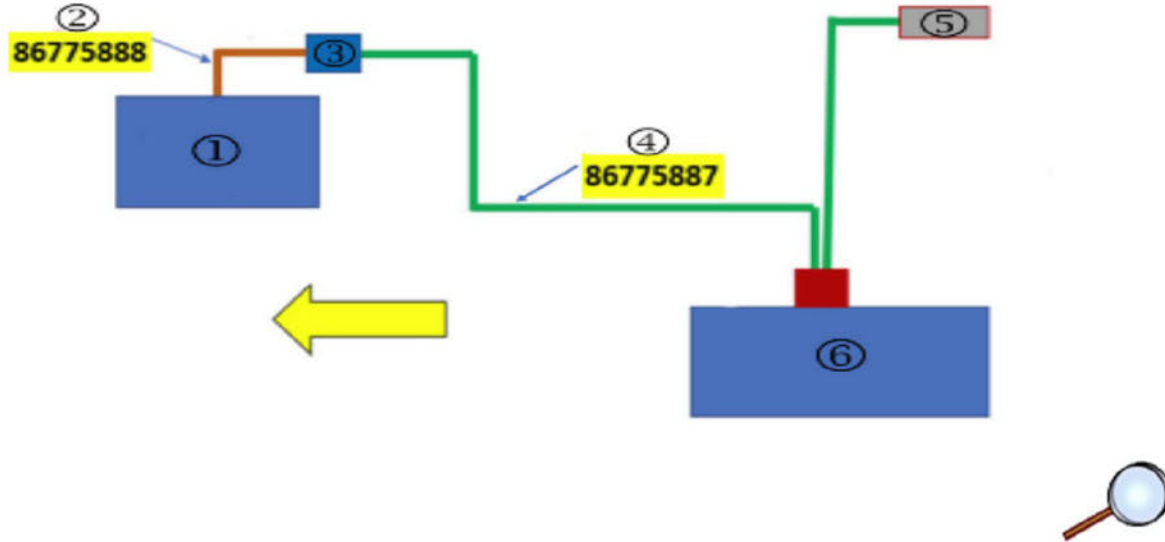
2020-2021 GMC Acadia IP and Body Coaxial Cable Routing (UV2)

1. A11 Radio
2. IP Coax
3. IP to Body Coax In-line Connection
4. Body Coax
5. To Liftgate Harness
6. VPM

Note: The long cable will be an overlay routed with, and affixed to, the body harness. The original body coax will just need the ends off and can be abandoned in the main body wiring harness.

1. Replace the long Coaxial cable (Body) from the VPM in the left rear of the vehicle, to the In-line connection to the (IP) short cable behind the right kick panel and to the liftgate coaxial cable connector.
2. Replace the short (IP) coaxial cable from the in-line connection to the A11 Radio, located behind the right kick panel.

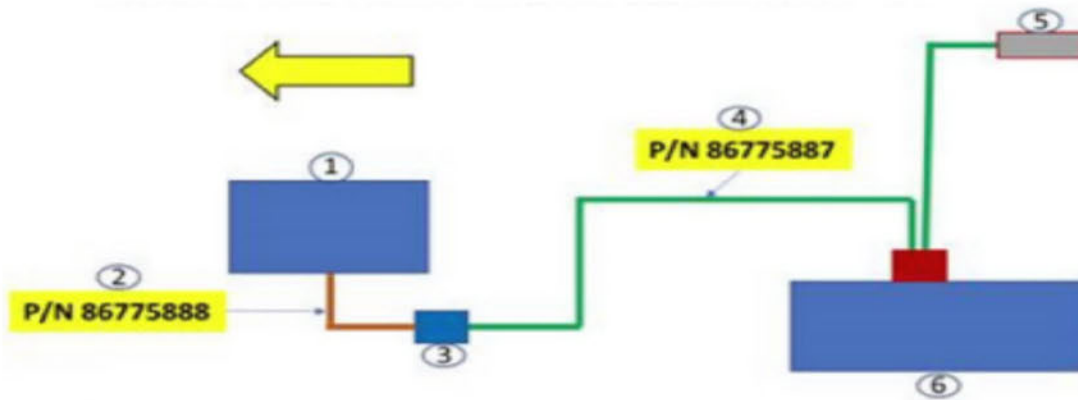
2020 Holden Acadia IP and Body Coaxial Cable Routing (UV2)

1. A11 Radio
2. IP Coax
3. IP to Body Coax In-line Connection
4. Body Coax
5. To Liftgate Harness
6. VPM

Note: The long cable will be an overlay routed with, and affixed to, the body harness. The original body coax will just need the ends off and can be abandoned in the main body wiring harness.

1. Replace the long Coaxial cable (Body) from the VPM in the left rear of the vehicle, to the In-line connection to the (IP) short cable behind the left IP near the glove box and to the liftgate coaxial cable connector.
2. Replace the short (IP) coaxial cable from the in-line connection to the A11 Radio, located behind the left IP near the glove box.

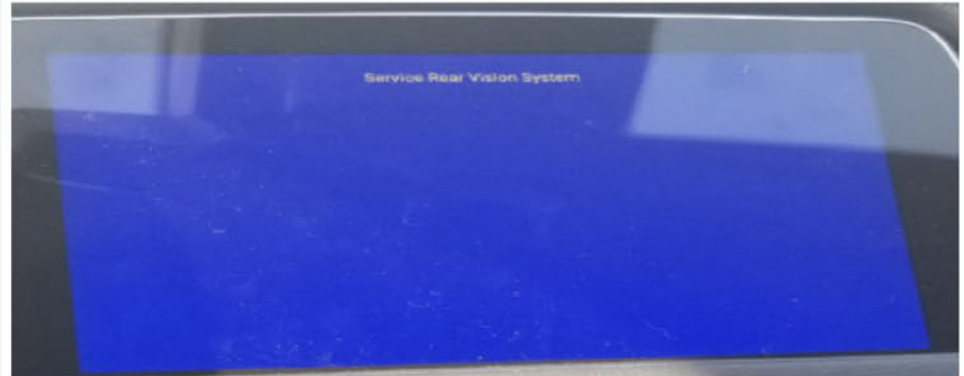
Blue Screen

The **blue** screen (with Service Rear Vision message), or **black** screen (with red triangle and no camera icon) condition can occur multiple times within the same power cycle and may return to normal functionality on the next power cycle. Or if this condition exists, it will occur every time the rear view is displayed to the customer within the same power cycle and may return to normal functionality on the next power cycle after the A11 radio enters and exits sleep cycle. A Diagnostic Trouble Code (DTC) B101D Symptom Byte 3C and/or 39 may be stored as a history DTC in the Video Processing Module (VPM) without any camera-related concern; If there are no DTCs setting in the VPM, and all DTCs are setting in the radio, refer to Service Bulletin # 21-NA-048.

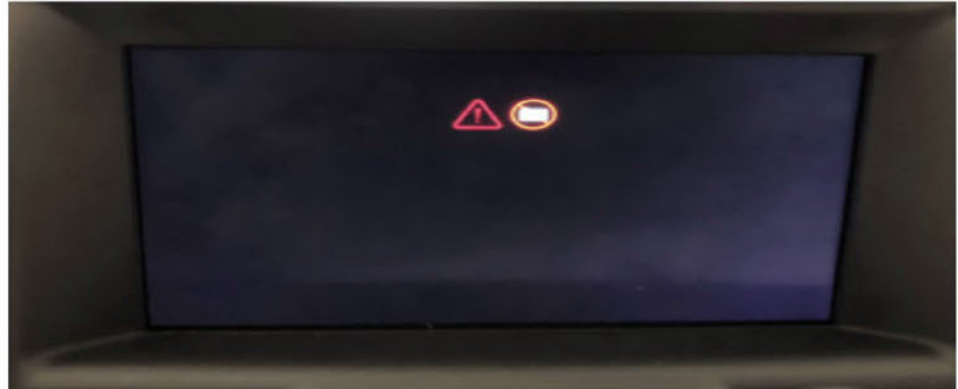
Black Screen

Some customers with select vehicles may notice that after having vehicle in idle for an extended period of time (length of time for black screen to occur depends on ambient temperature), a black screen with a red triangle and no camera icon will appear when the vehicle is put in Reverse and the camera icon will be crossed out on the radio center screen.

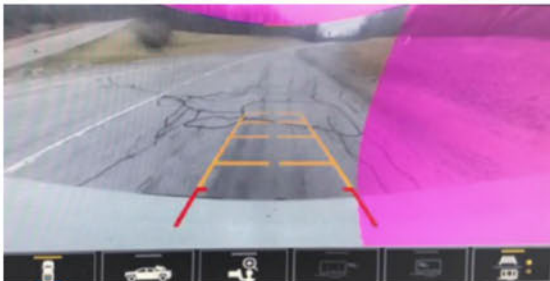
Flicker Issue

Pink on the screen will be most likely an intermittent Coax issues caused by damaged or frayed coax cables.

Some intermittent conditions can be caused by wire terminal fretting corrosion, which is a build-up of insulating, oxidized wear debris that can form when there is a small motion between electrical terminals.

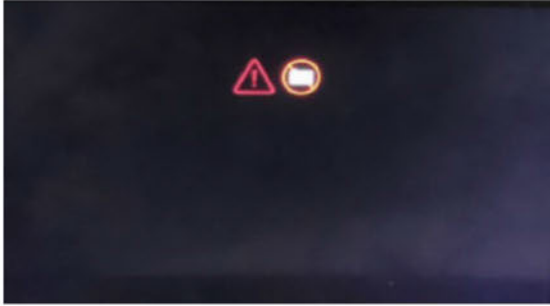
If the rear camera or the VPM do not provide the rolling counter, you will see the following black screen with an icon:

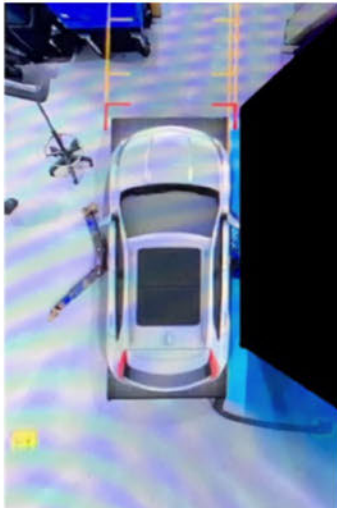
The VPM does not monitor the left, right or front cameras with a rolling counter. These camera's will display in black on their perspective side if there is an issue.

Figure below is of a right camera issue:
