Honda Motor Co. Light Vehicles	NHTSA Report for TREAD Act	NHTSA Reporting Period:
--	-----------------------------------	--------------------------------

Report ID : [REDACTED]	# of Attachments : 4	Zone / District : 03 / 03G
Report Method : V s t	Create Date : 06/20/2022 12:16:48	
Brief Description : Rear d fferent a eak

Make : Honda	Model Series : CR-V	Engine Number : L15BE6529417
NHTSA Model : CR-V	Model ID : RW2H9NKNW	Style :
Model Year : 2022	Mileage : 5750	Transmission : CVT
VIN : [REDACTED]	Unit Status : So d to Customer	Body : AWDTRG
	Date of Occurrence : 06/20/2022	Engine Type:

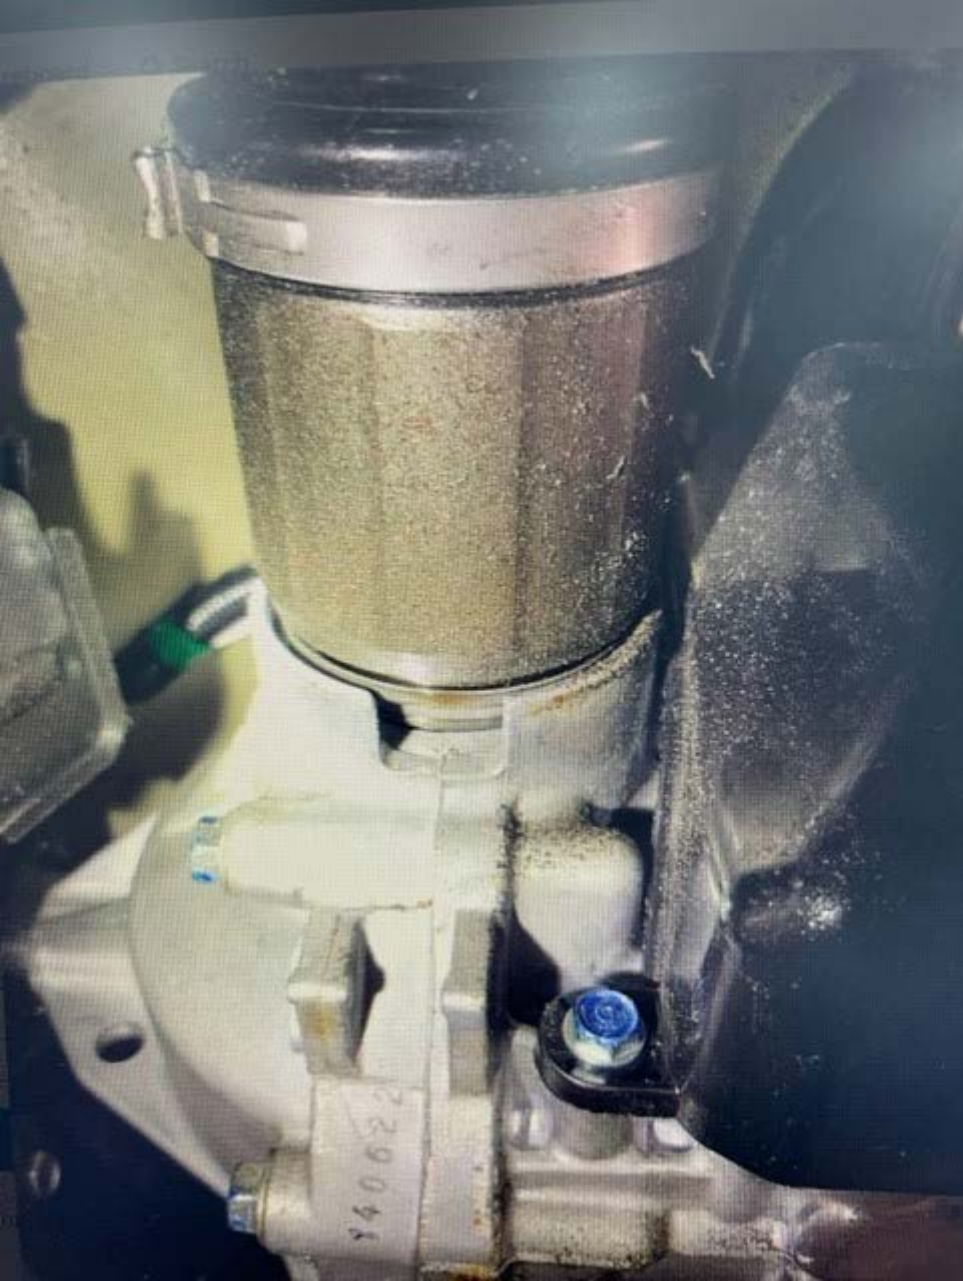
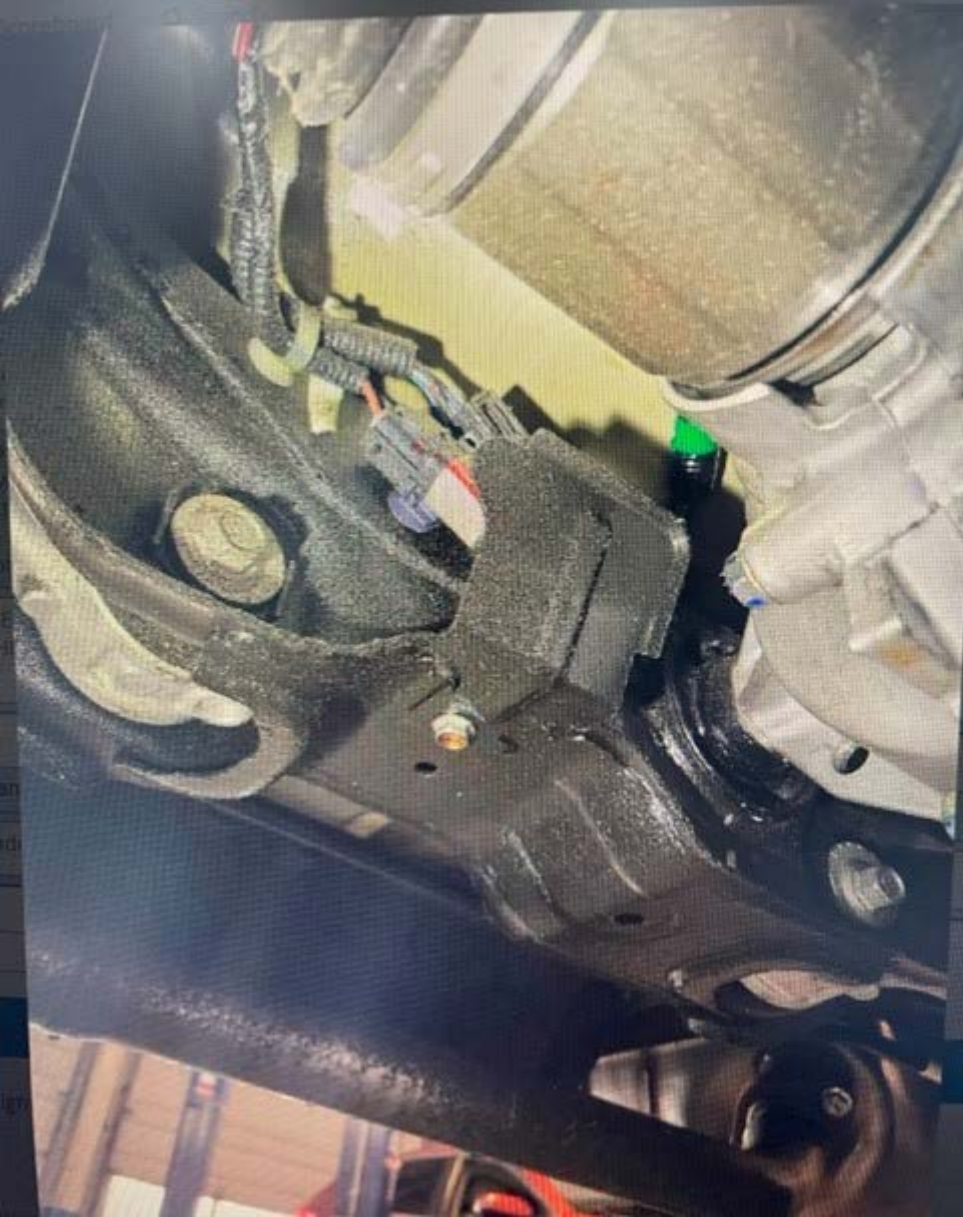
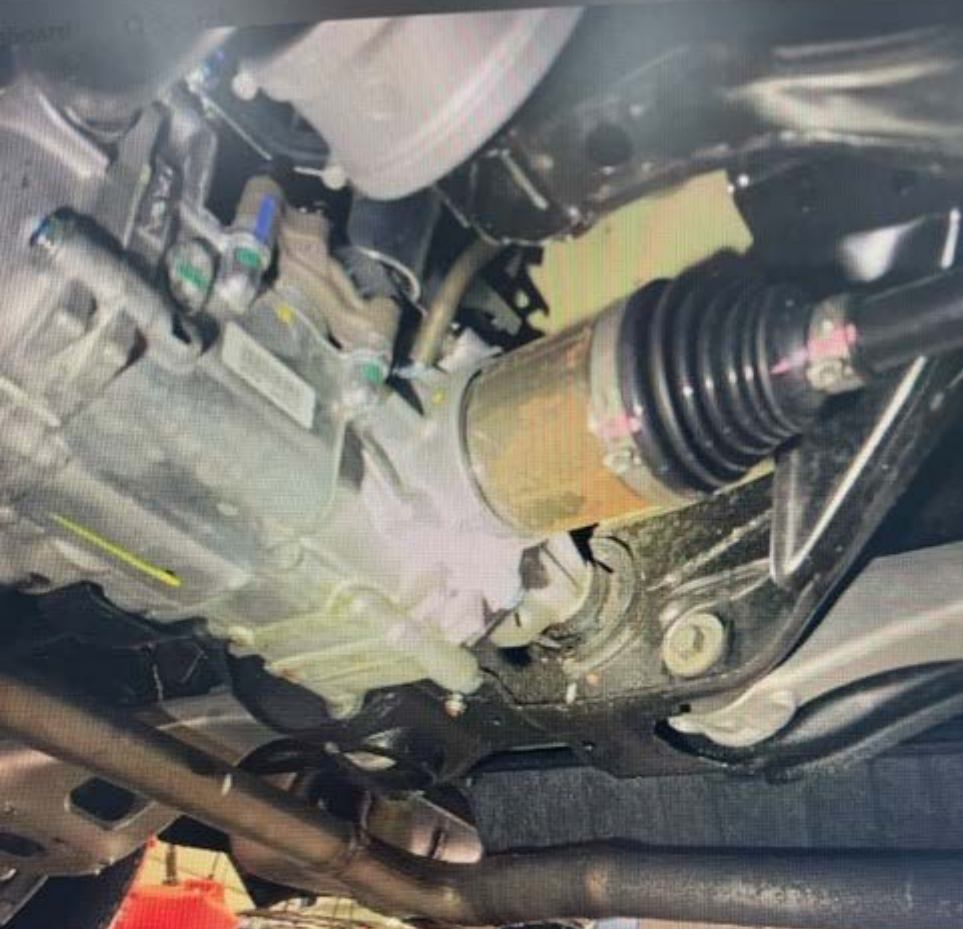
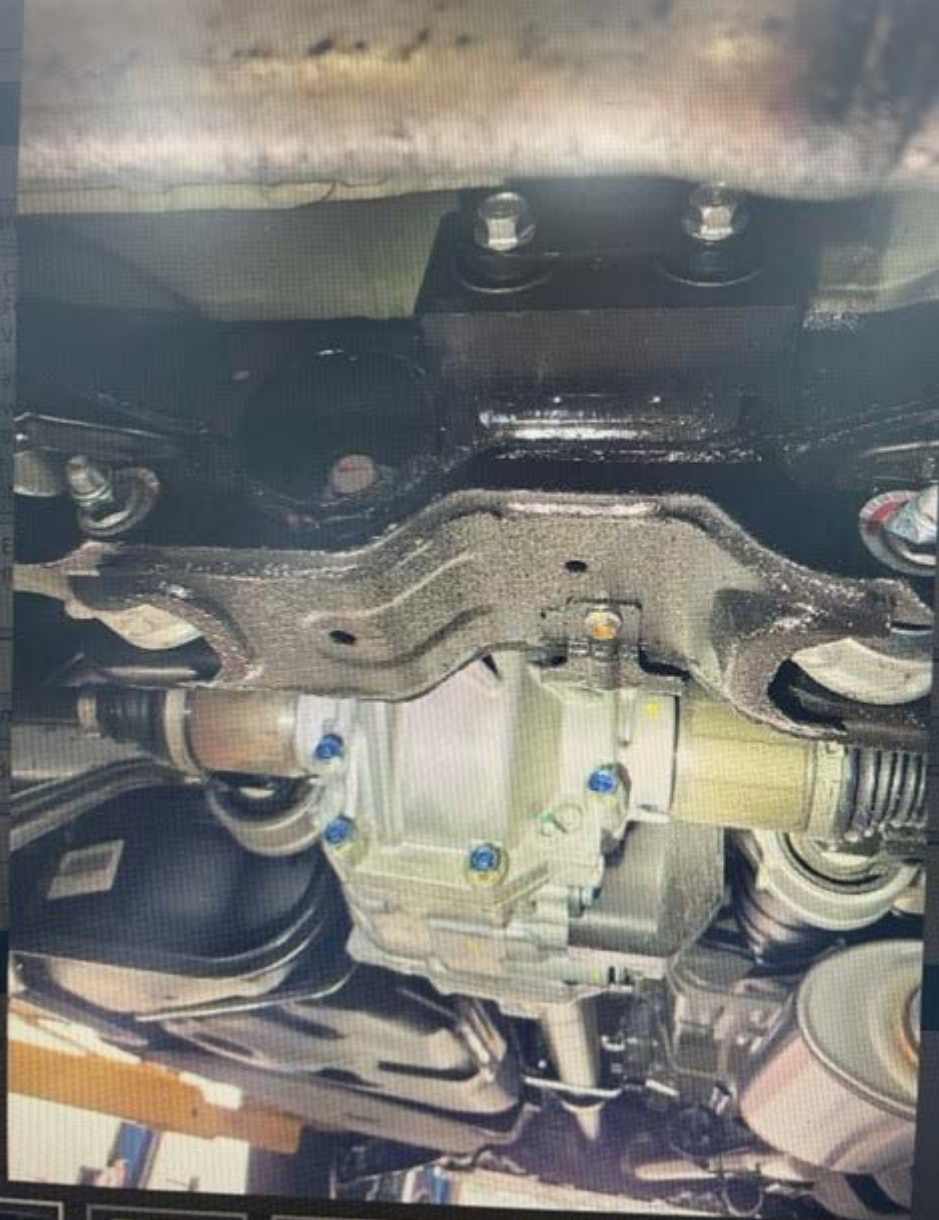
Customer states they heard a very oud noise whi e driving and then there was a message for AWD System Prob em

Inspected vehic e and found the rear differentia sea eaked out a the fluid causing damage to the rear differentia carrier. Checked and did not see any signs of impact at a .

Dea er ordered rear diff.

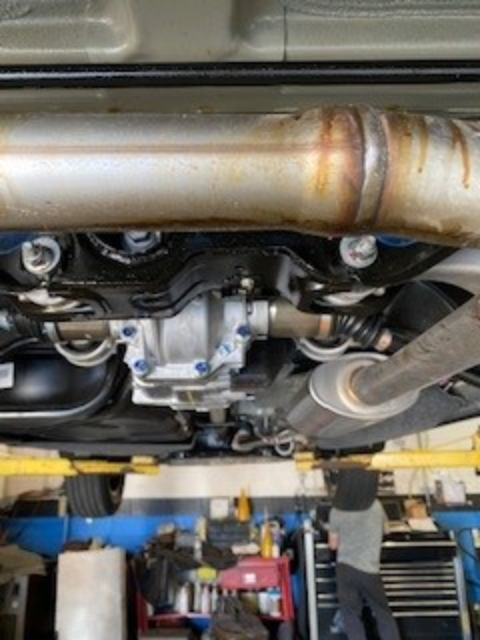
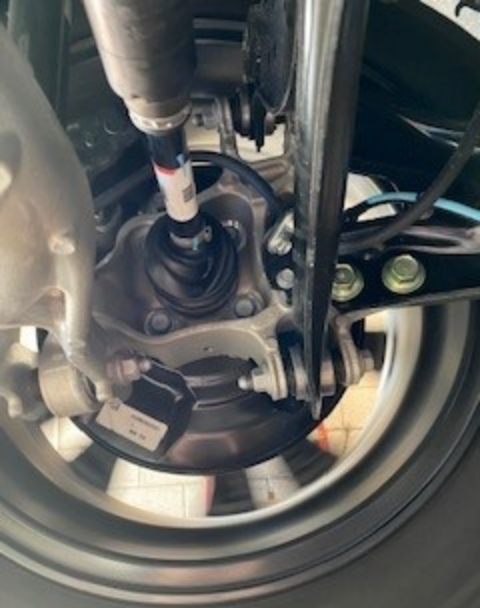
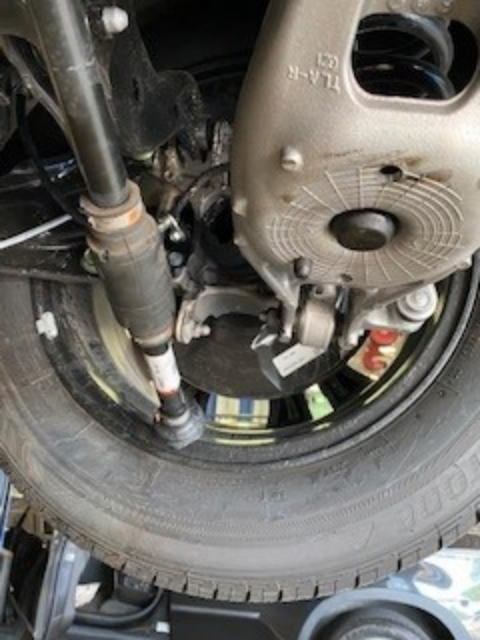
The right rear shaft came apart, ooks ike diff fluid leak,and left side shaft seems damaged.

Fai ed Part Numbers are: 42310-TLA-A21 Drive shaft Assembly quantity of two 41200-5TG-010 Carrier Assembly

Rep aced Differentia axle

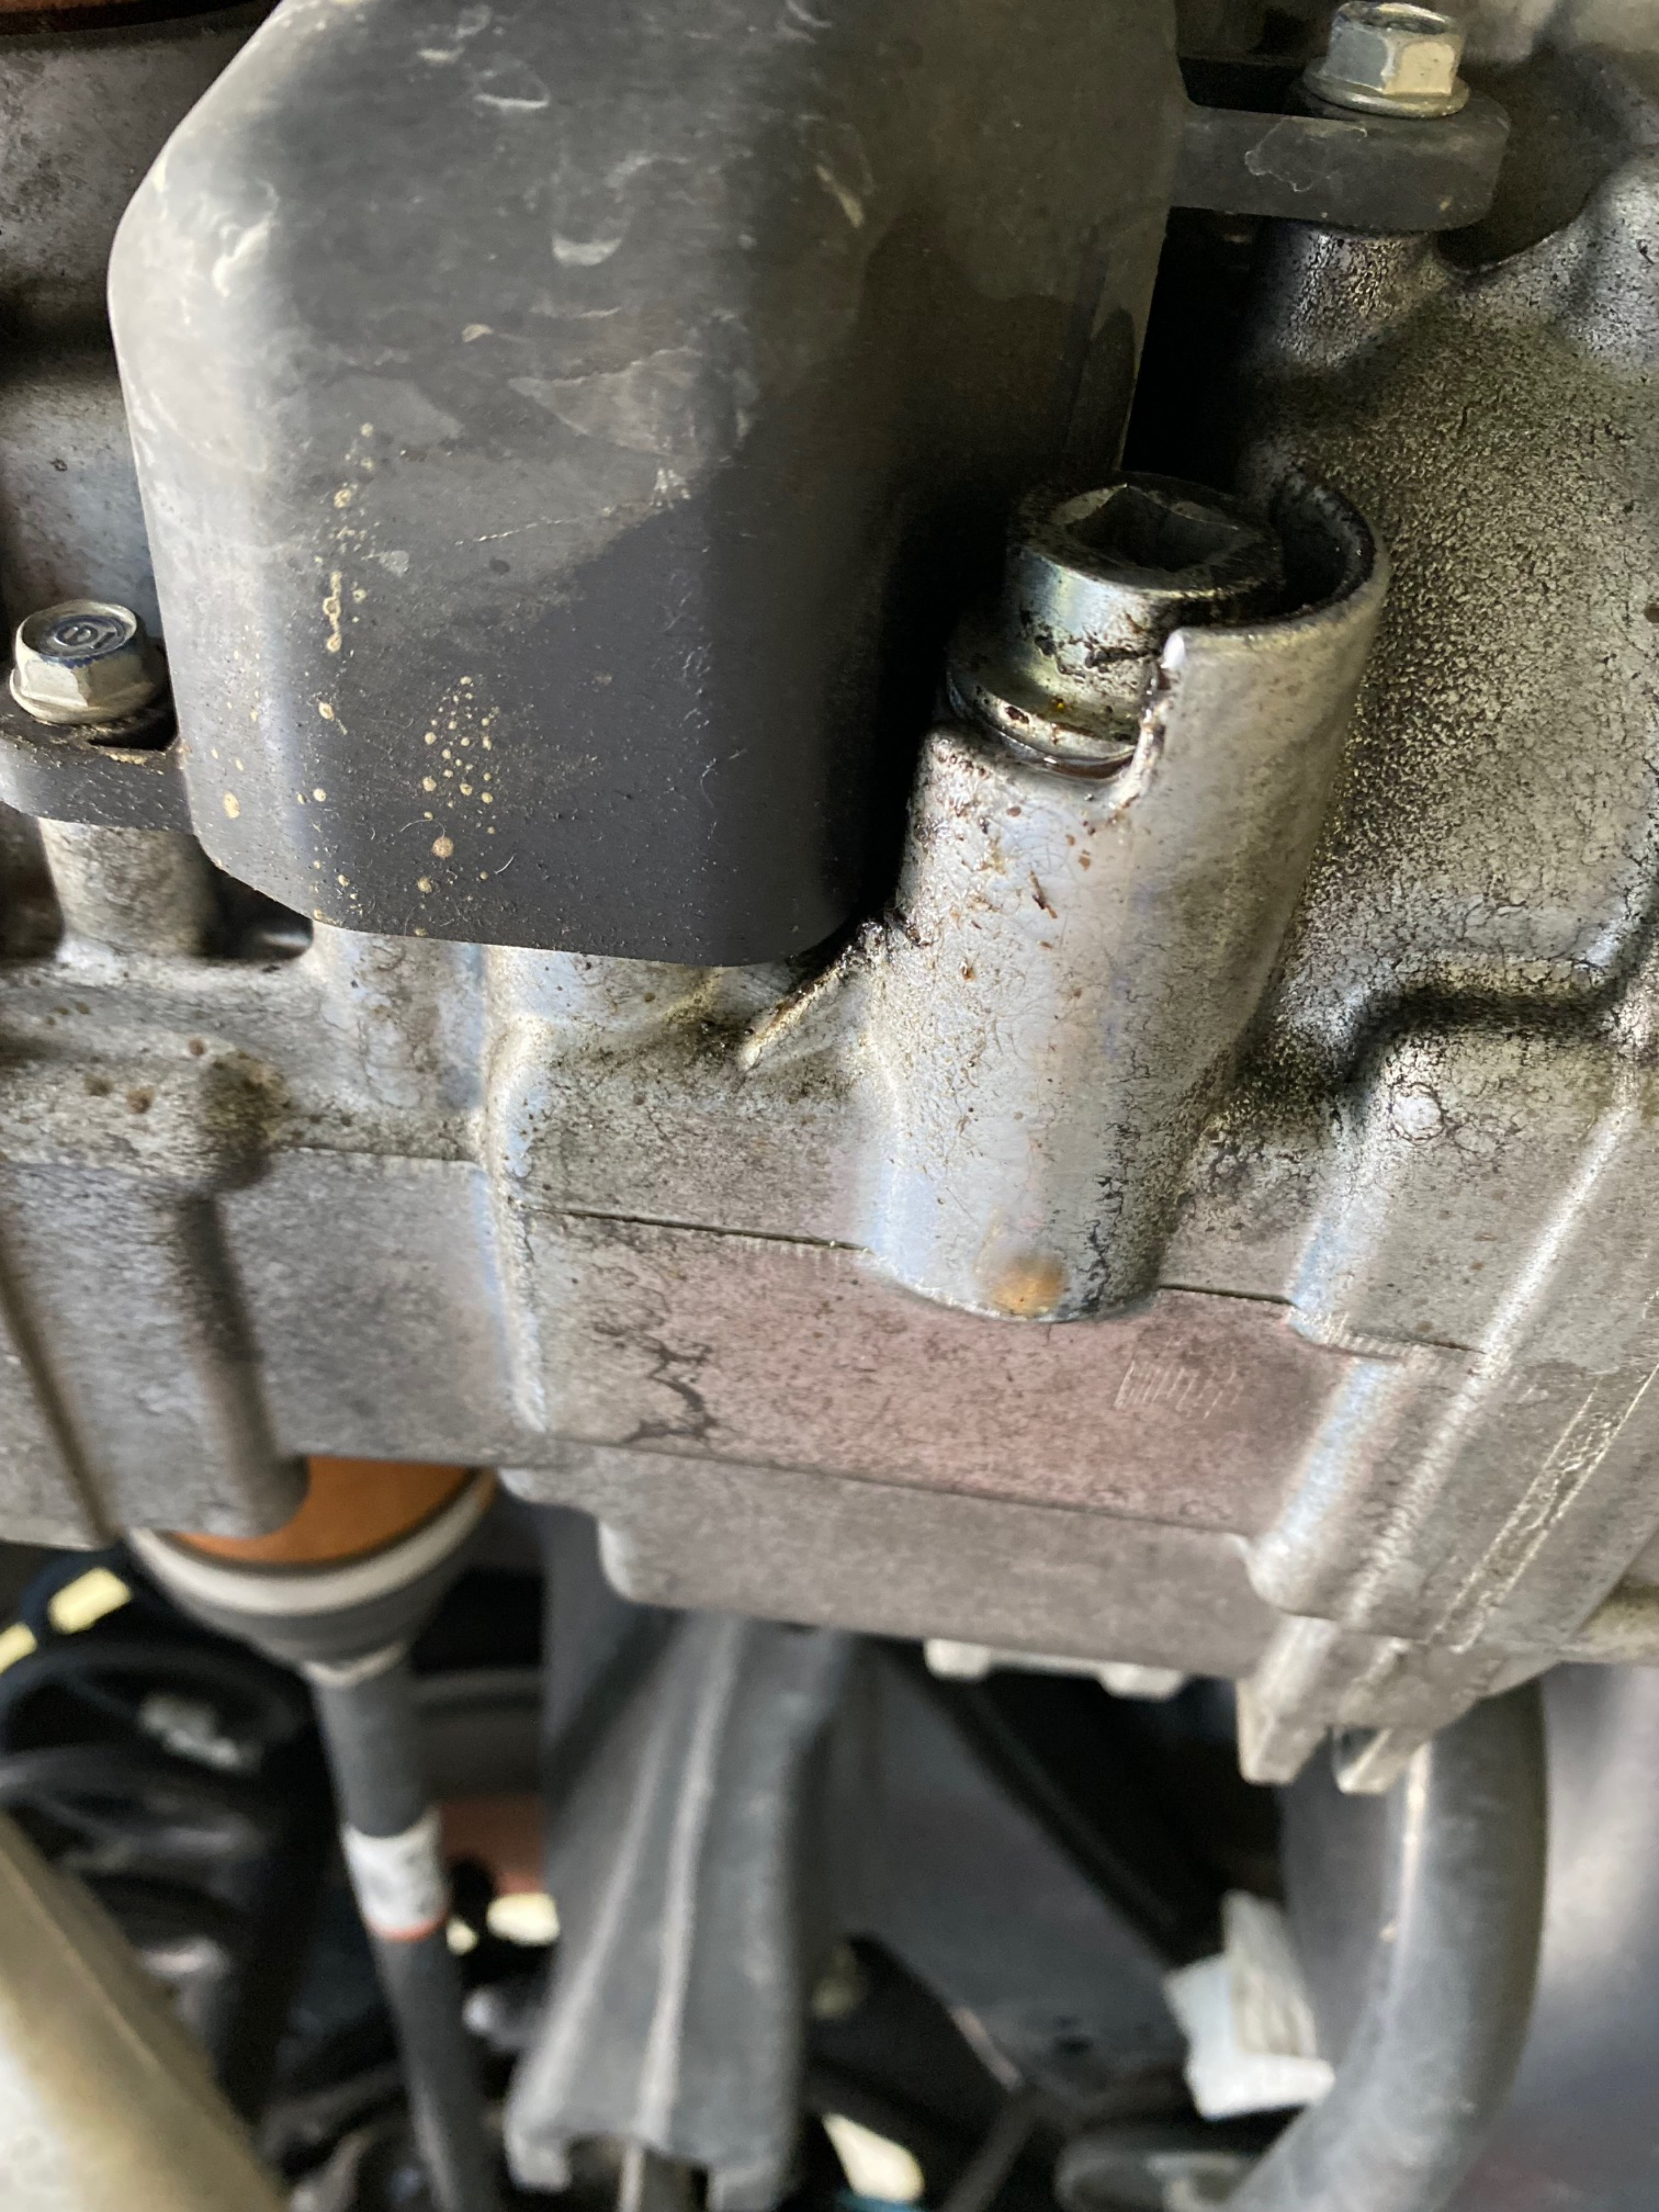
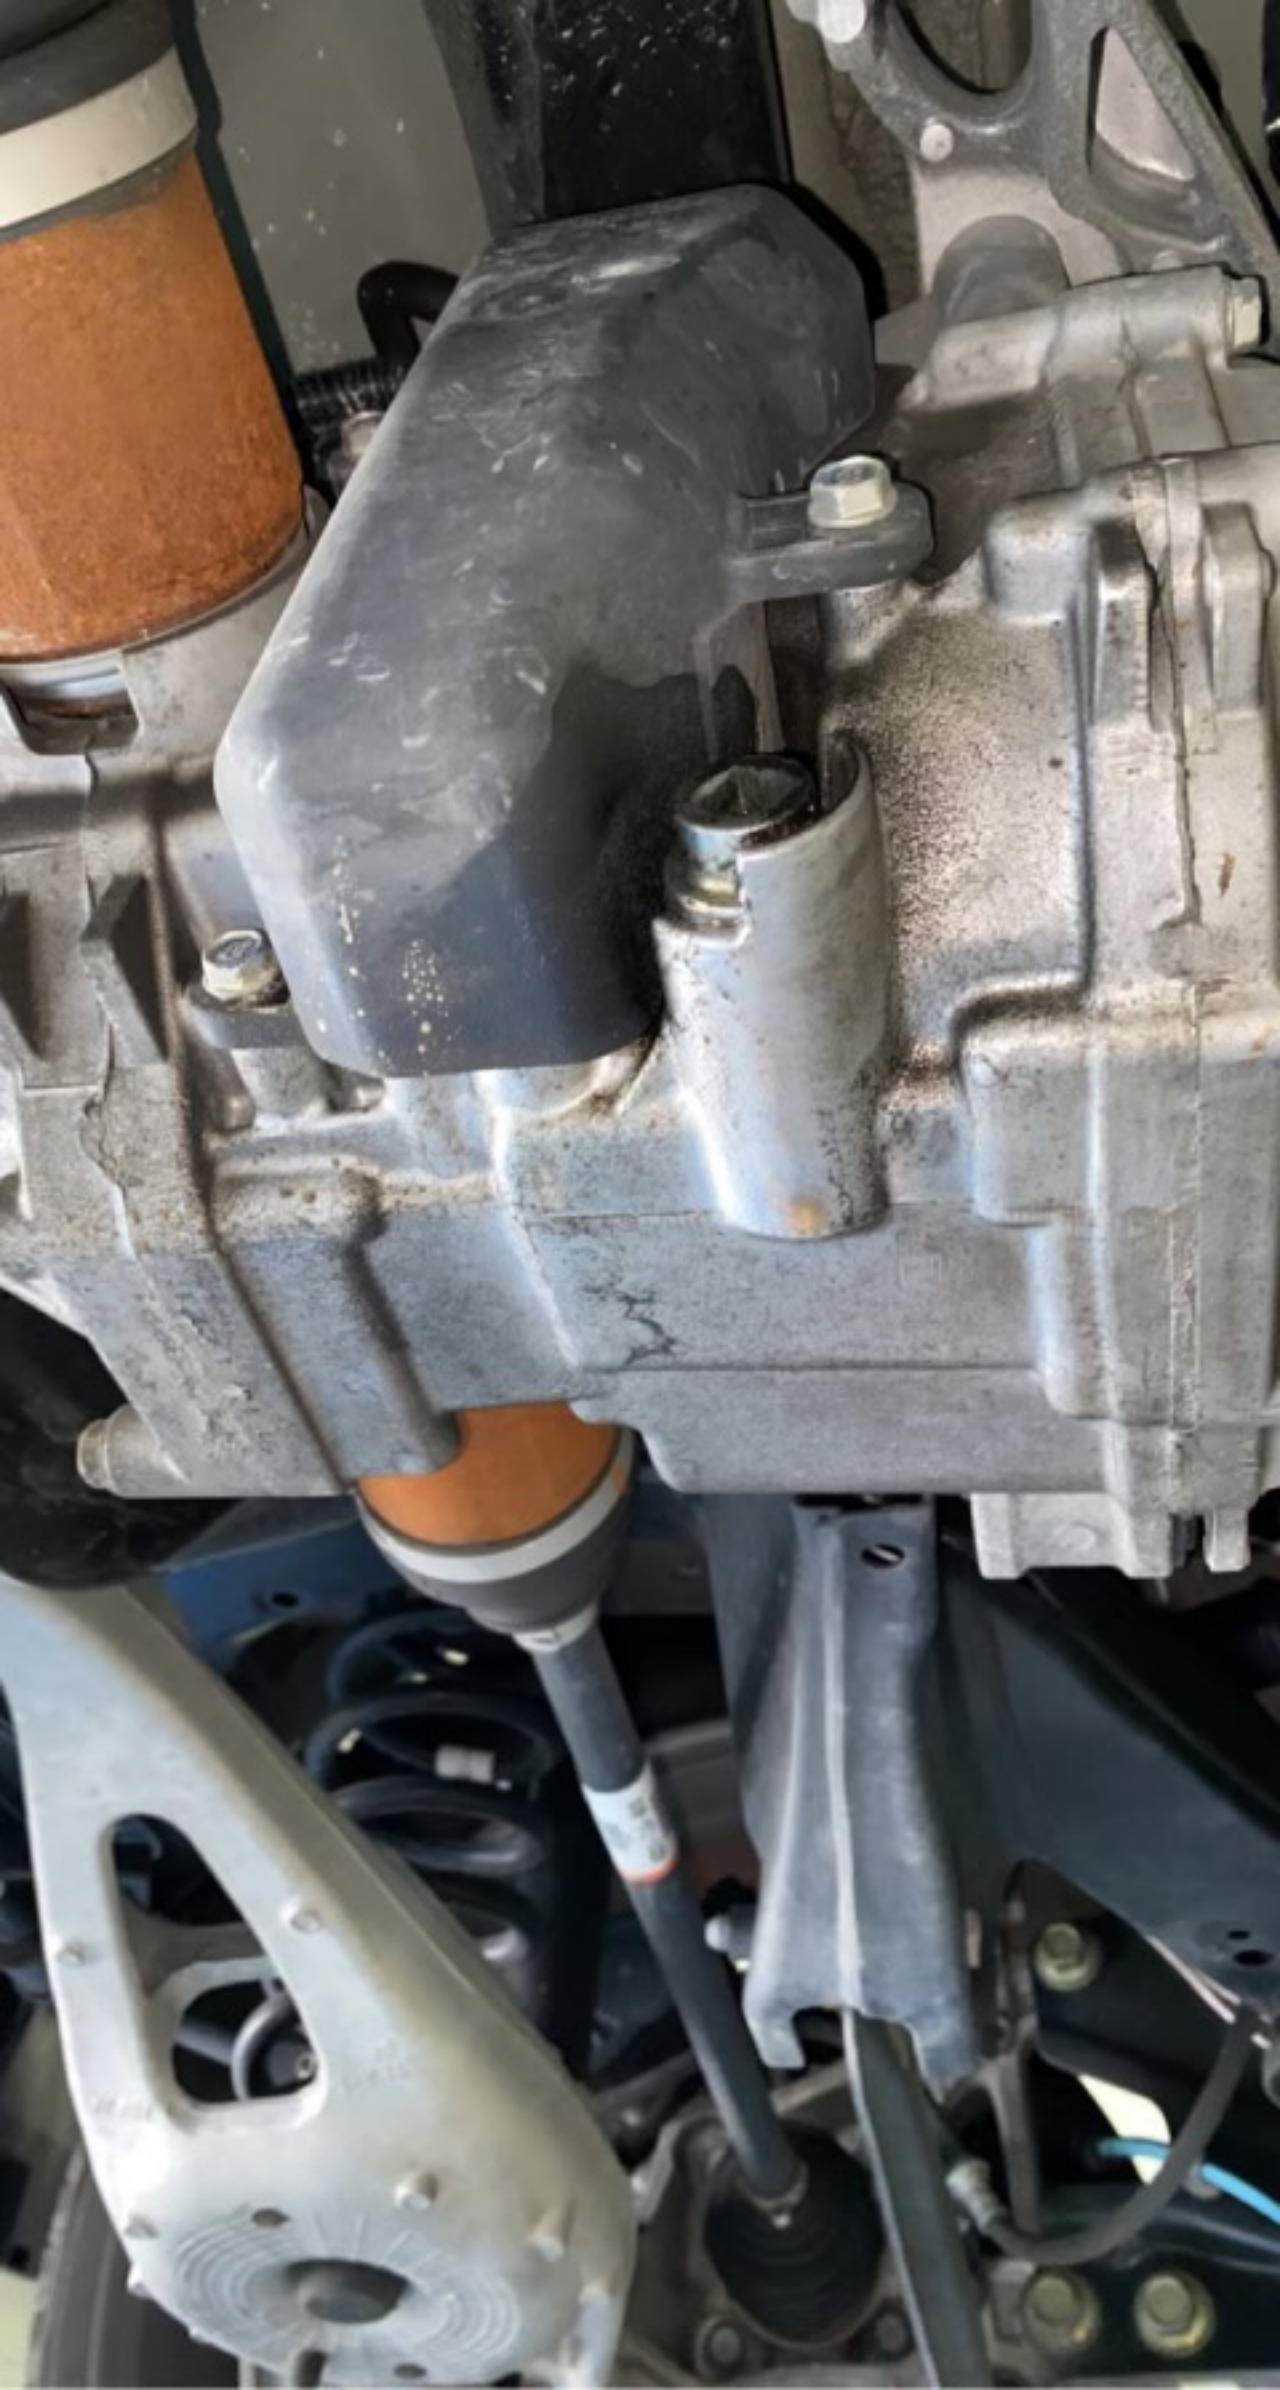
customer states fluid is eaking from rear

Unknown- Tech found threading in the rear differentia unit fai ed causing a eak

Rep aced Rear Differentia
