Honda Motor Co. Light Vehicles	NHTSA Report for TREAD Act	NHTSA Reporting Period:
--	-----------------------------------	--------------------------------

Report ID : [REDACTED]	# of Attachments : 4	Zone / District : 03 / 03G
Report Method : V s t	Create Date : 06/20/2022 12:16:48	
Brief Description : Rear d fferent a eak

Make : Honda	Model Series : CR-V	Engine Number : L15BE6529417
NHTSA Model : CR-V	Model ID : RW2H9NKNW	Style :
Model Year : 2022	Mileage : 5750	Transmission : CVT
VIN : [REDACTED]	Unit Status : So d to Customer	Body : AWDTRG
	Date of Occurrence : 06/20/2022	Engine Type:

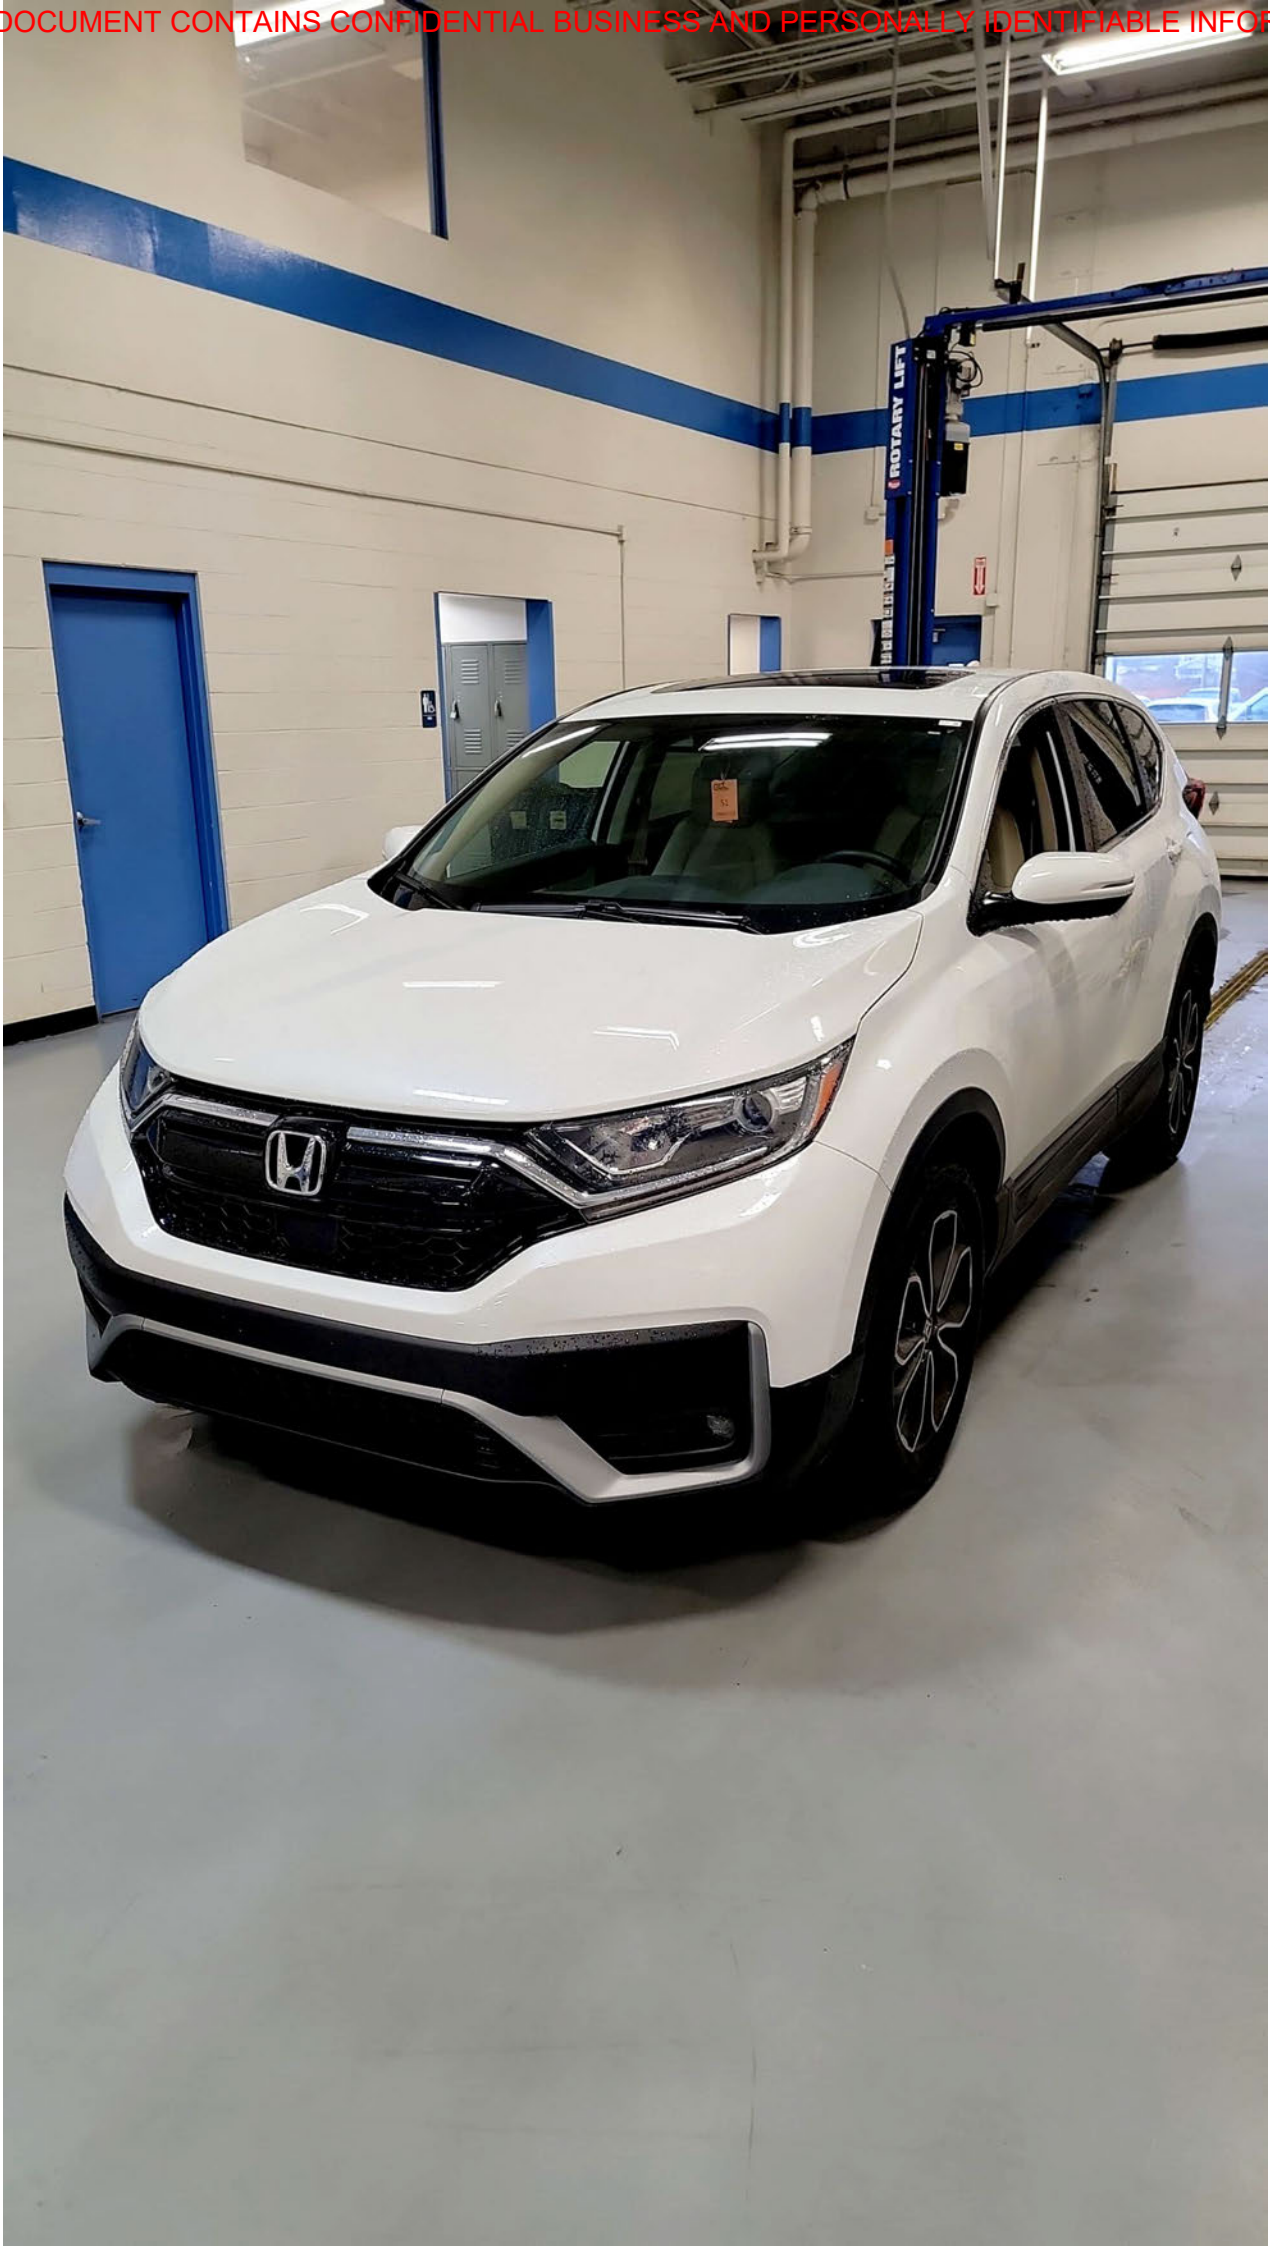
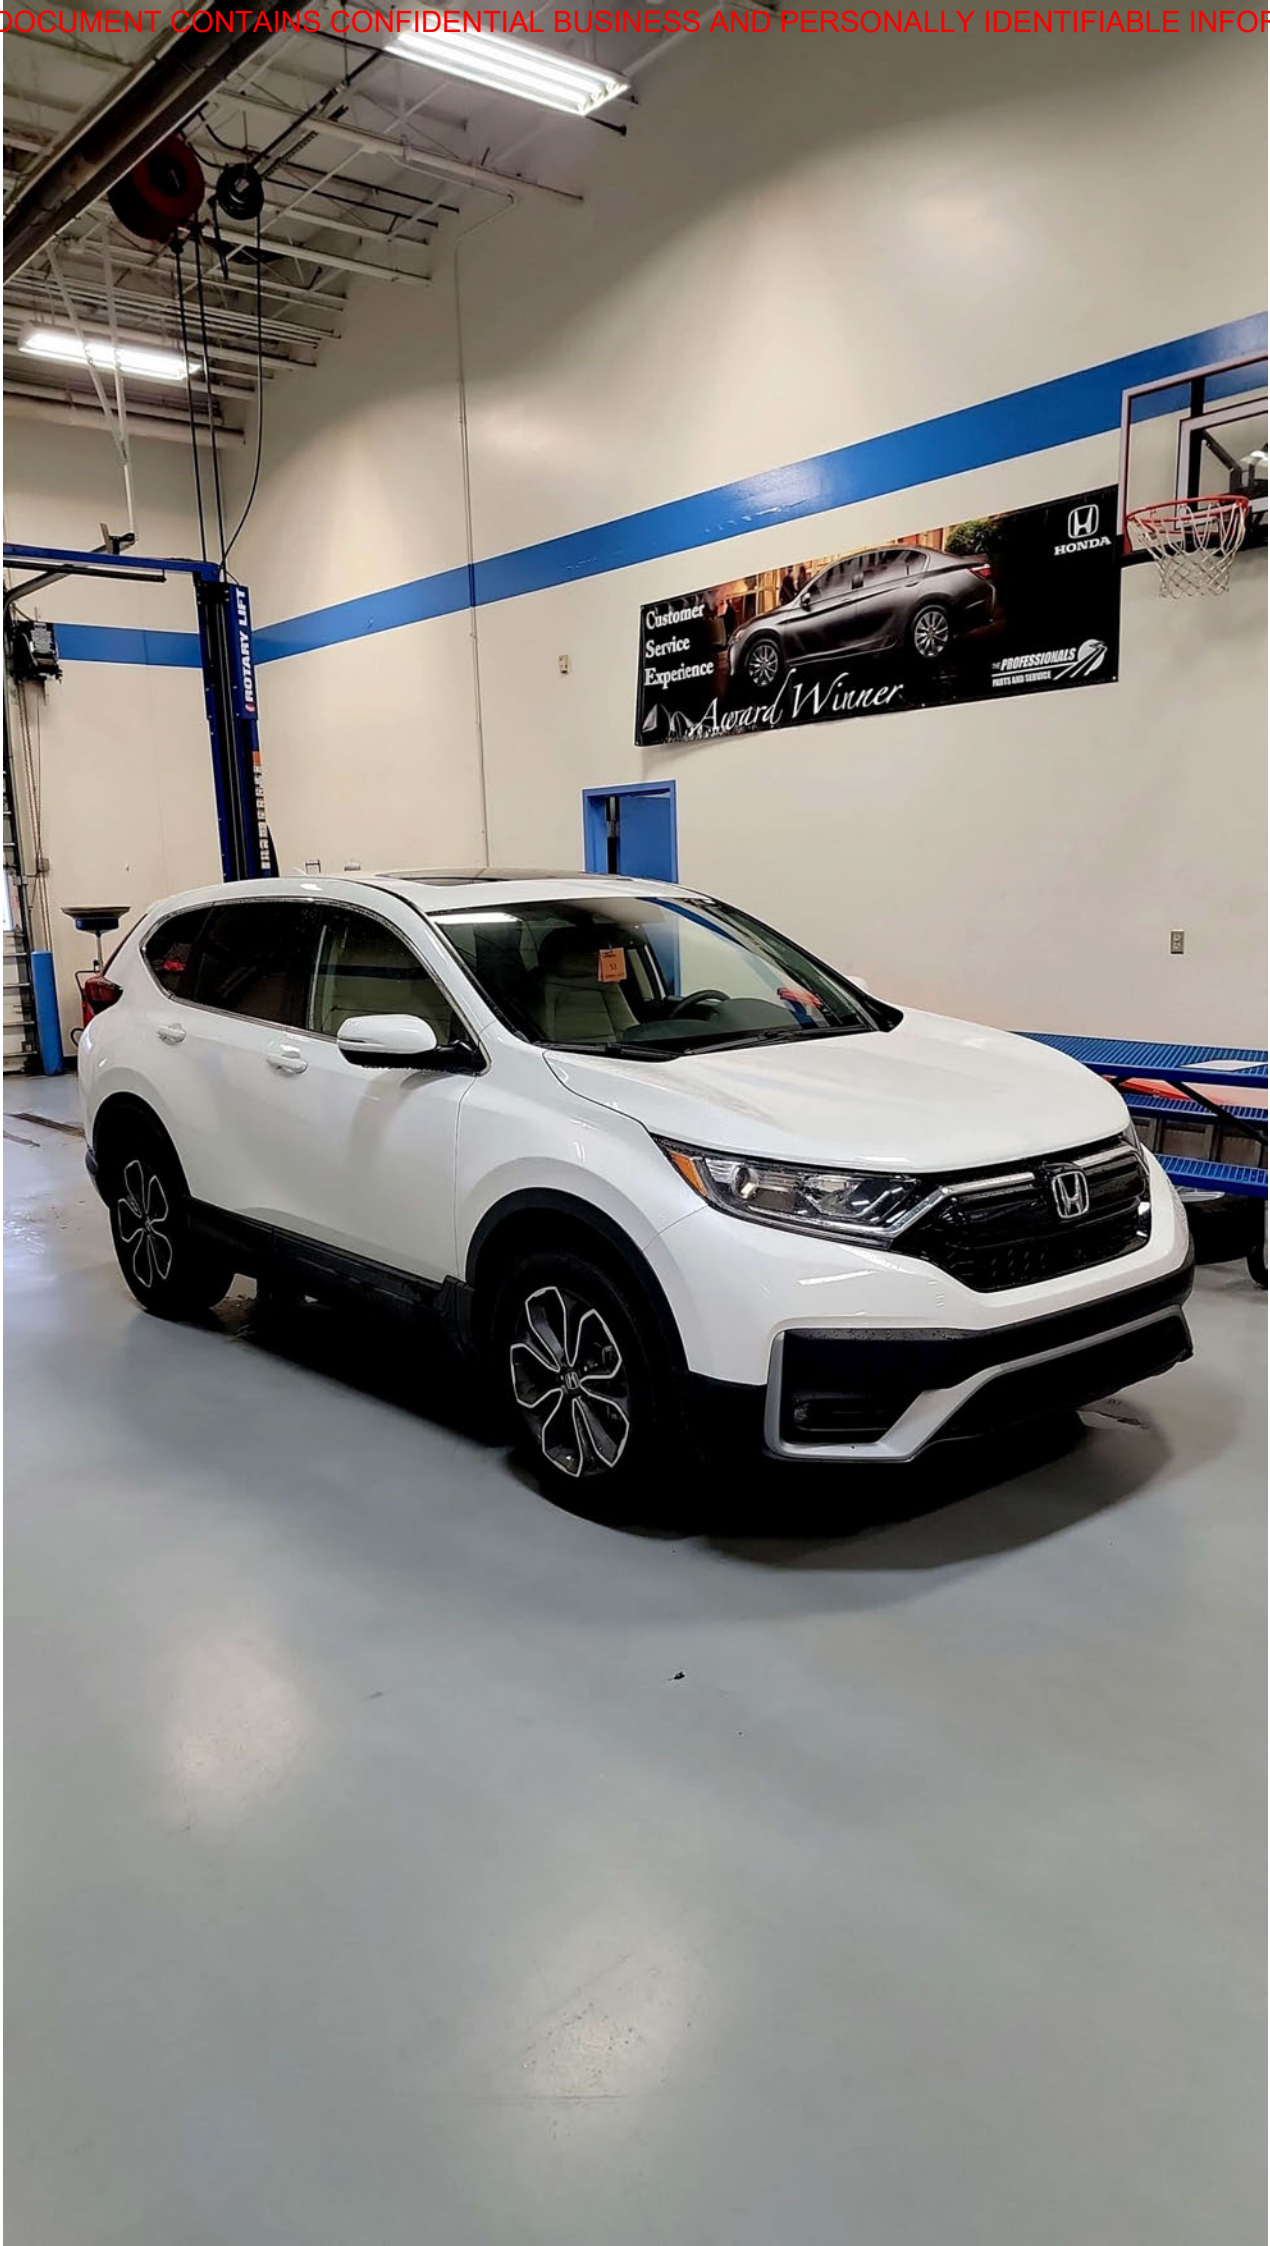
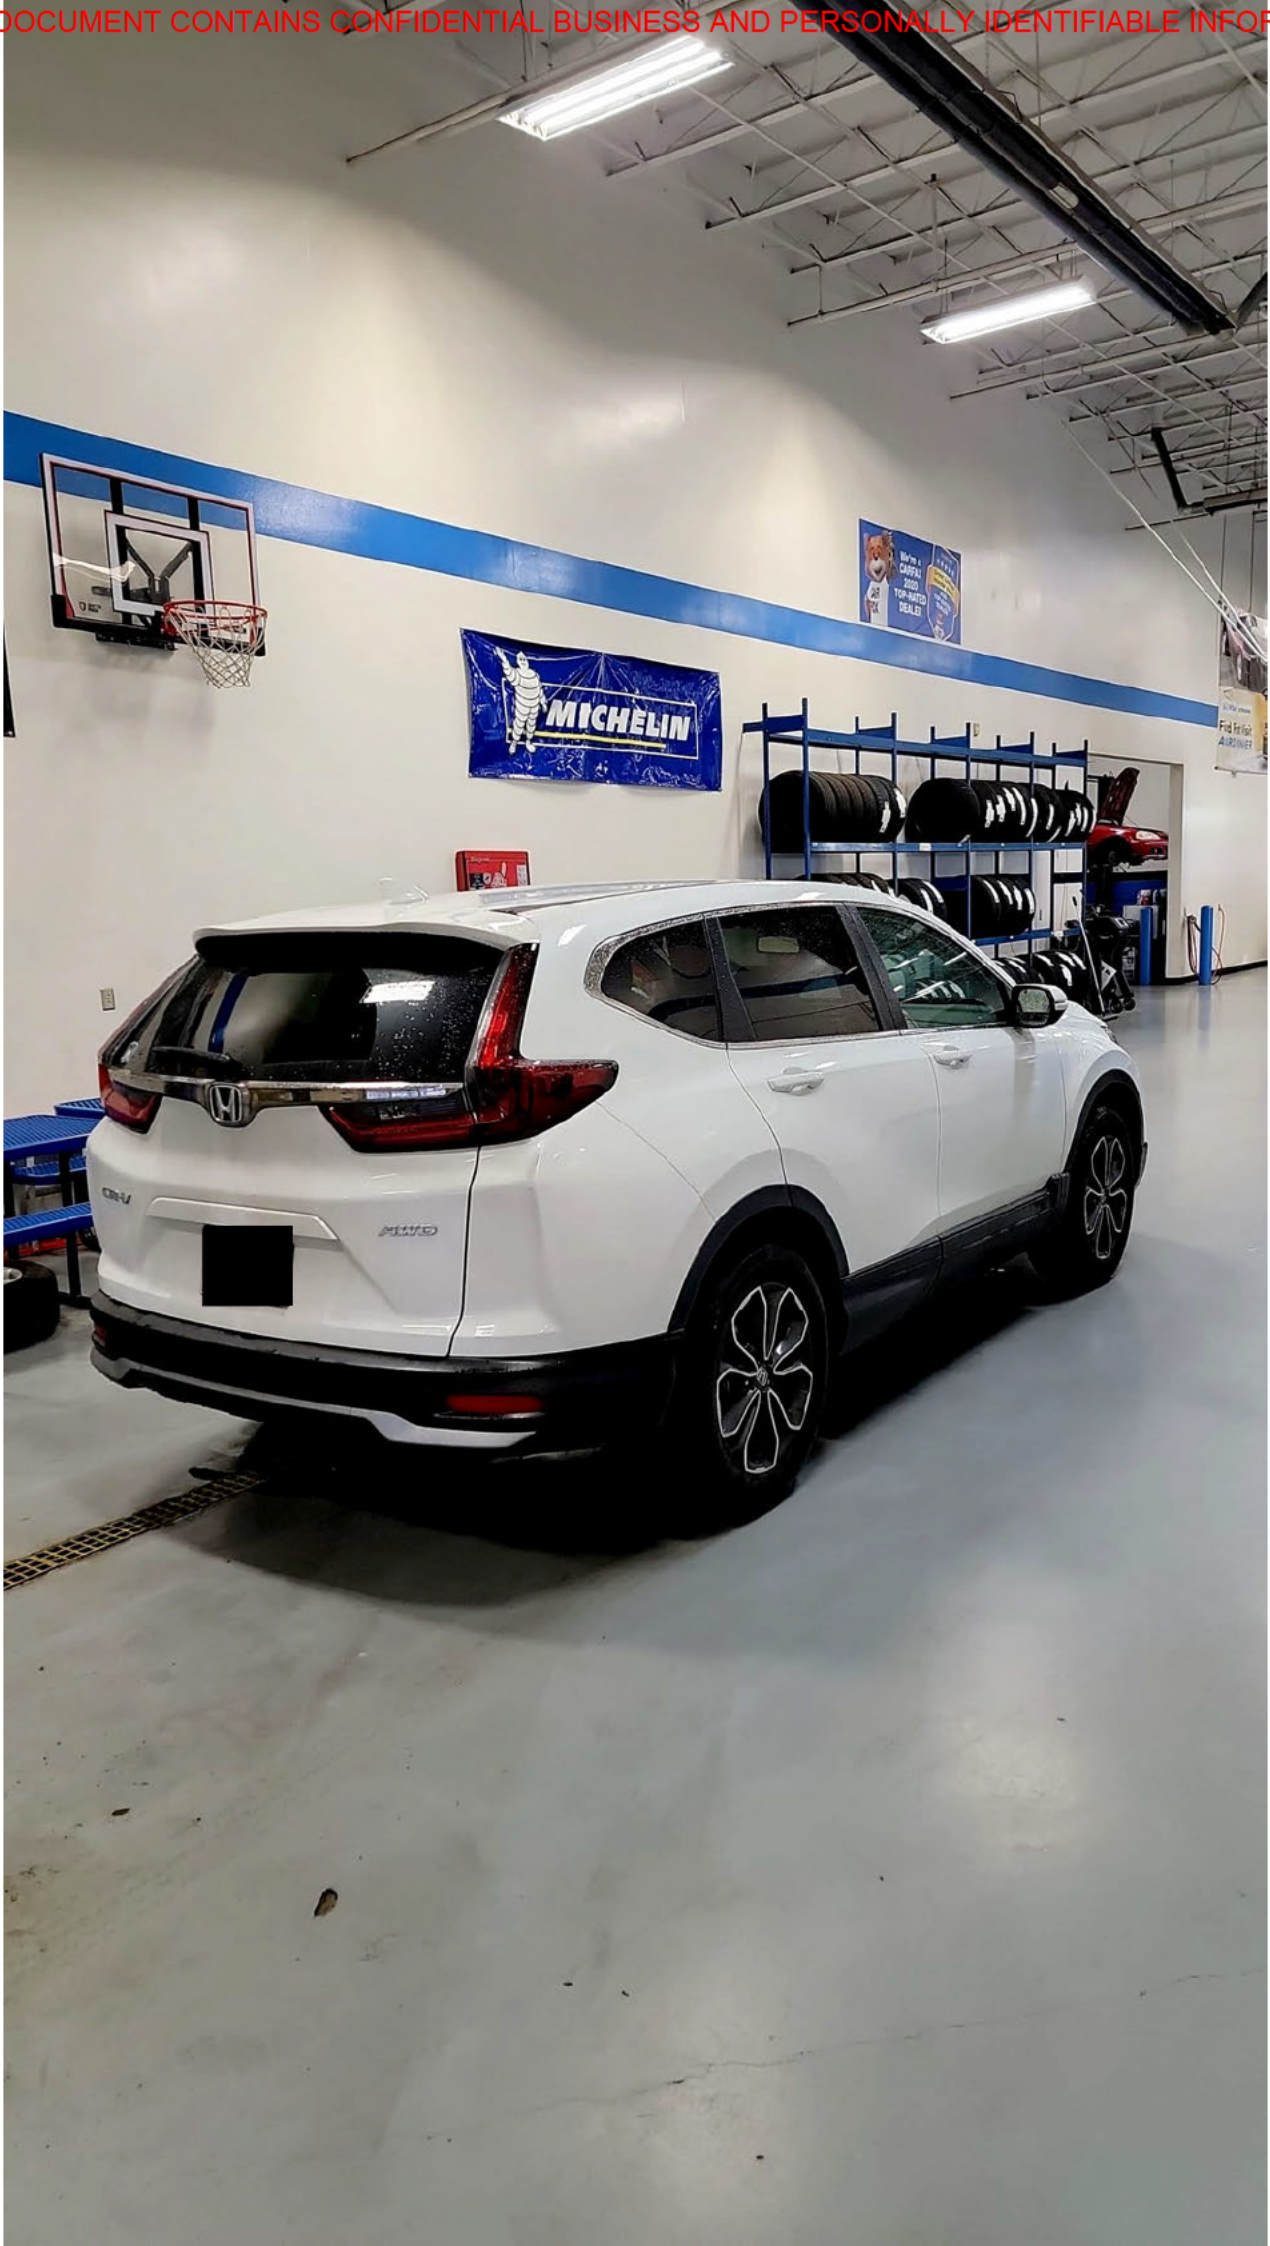
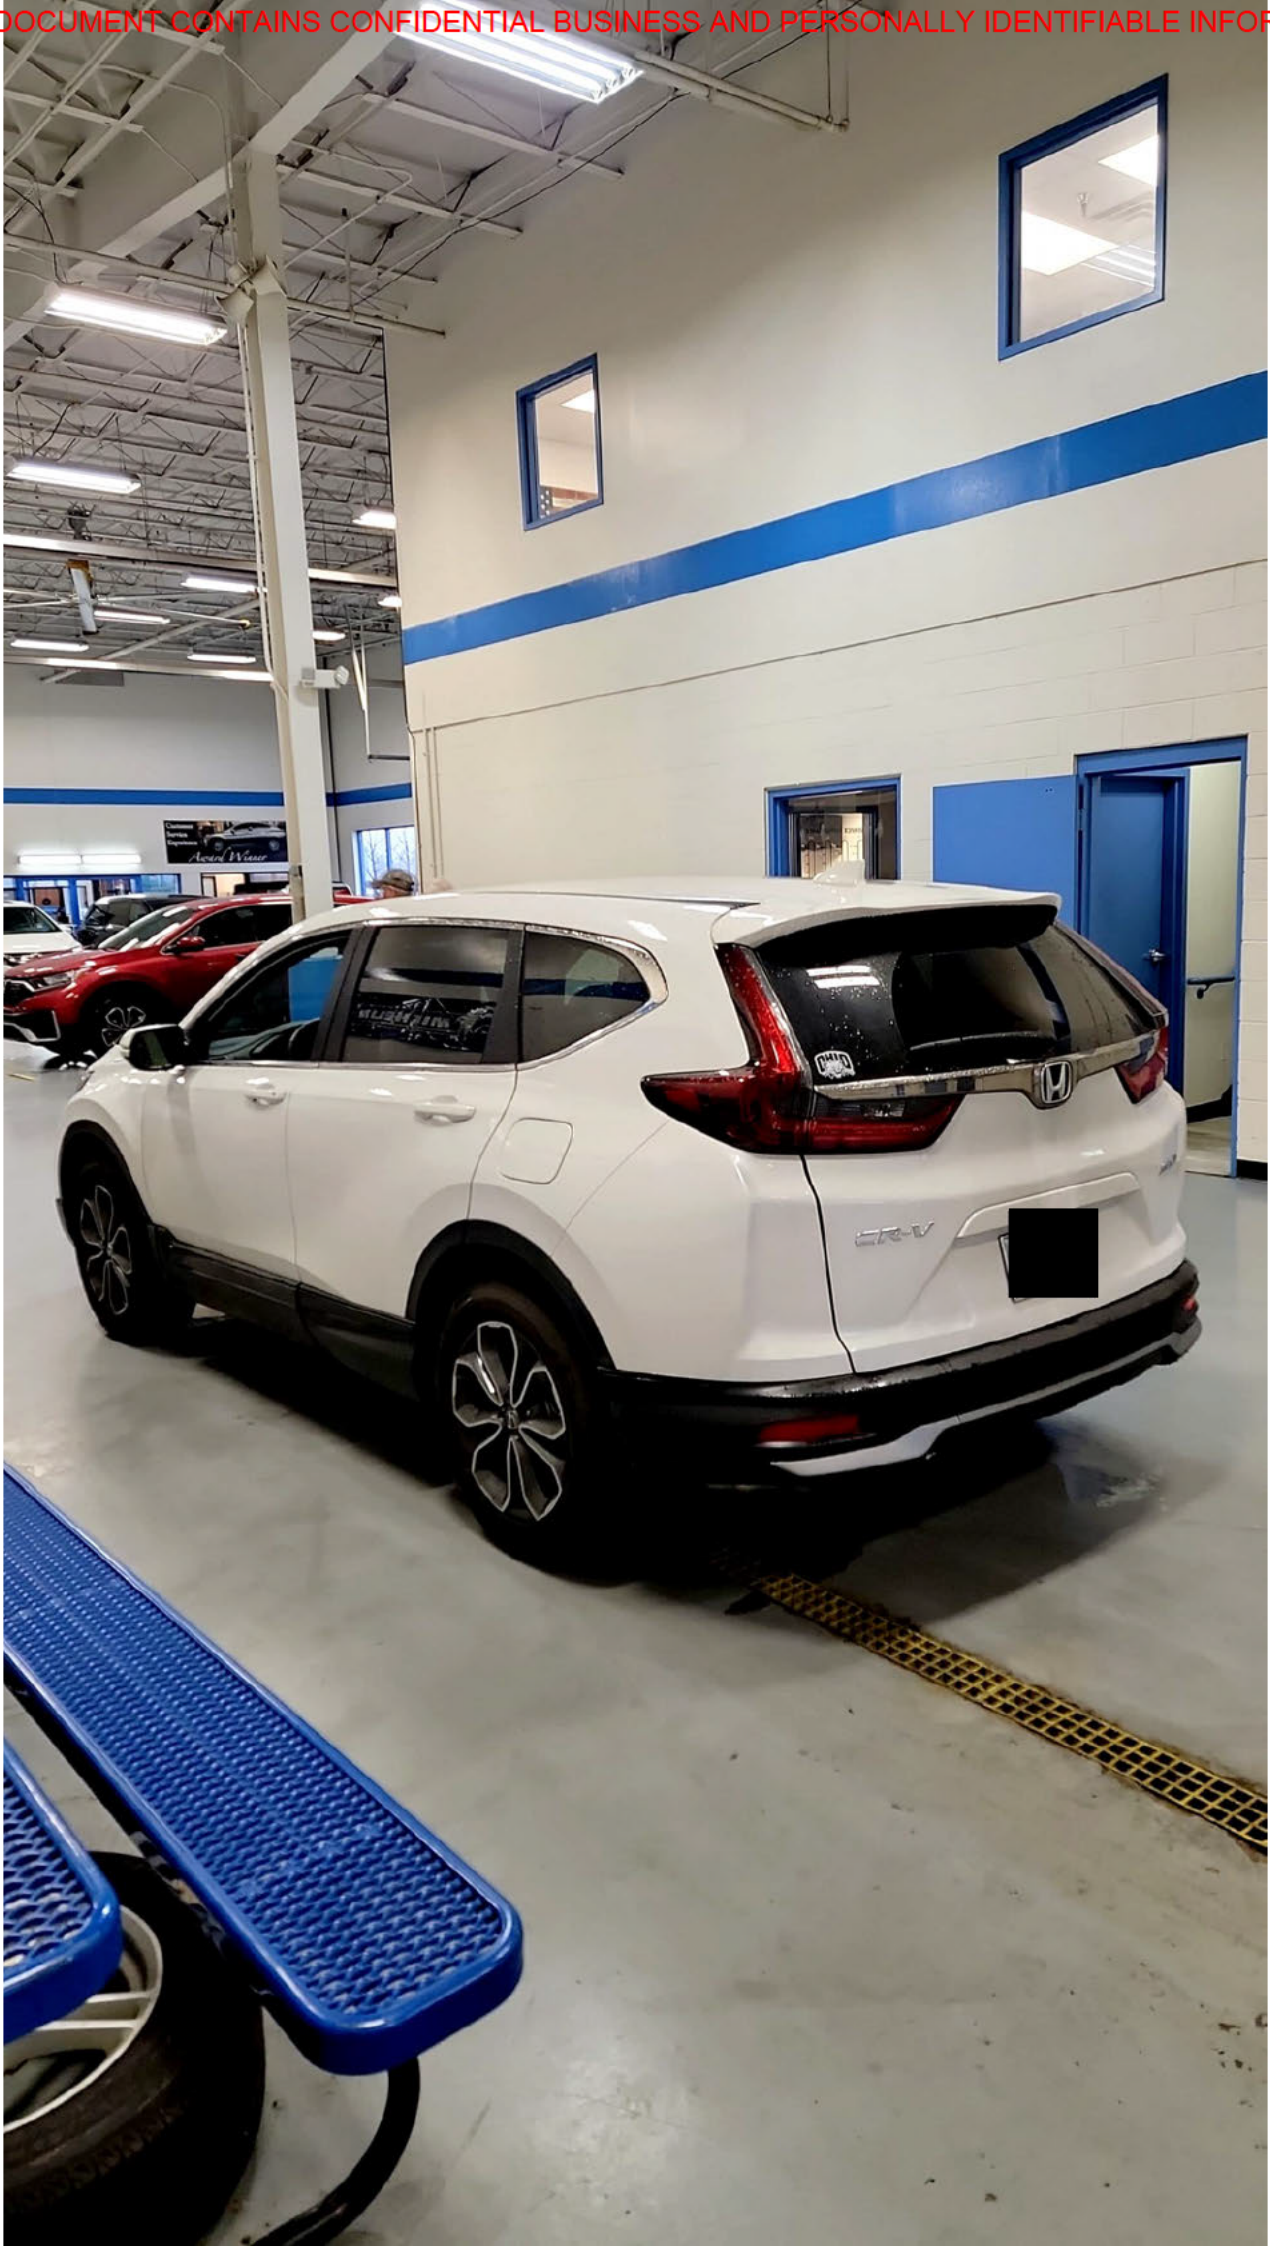
Rear driver side axe twisted and broke. Passenger side rear showing signs of twisting. Rear differentia eaking.

Excessive fluid loss.

Rep ace rear differentia and rear axes.
