## Motor Vehicle Defect Petition to Recall All Tesla Vehicles Due to Sudden Unintended Acceleration

**Investigation:** DP 23-002  
**Prompted by:** DEFECT PETITION  
**Date Opened:** 06/29/2023  
**Investigator:** Tariq Bond  
**Approver:** Tanya Topka  
**Subject:** Sudden Unintended Acceleration  
**Reviewer:** Gregory Magno

**Manufacturer:** Tesla, Inc.  
**Products:** MY 2013 - 2023 Tesla Model 3, Model Y, Model S, Model X  
**Population:** 1,800,000 (Estimated)  
**Problem Description:** The petition alleges a theory that the subject vehicles contain a defect that can cause sudden unintended acceleration, which may result in crash and injury.

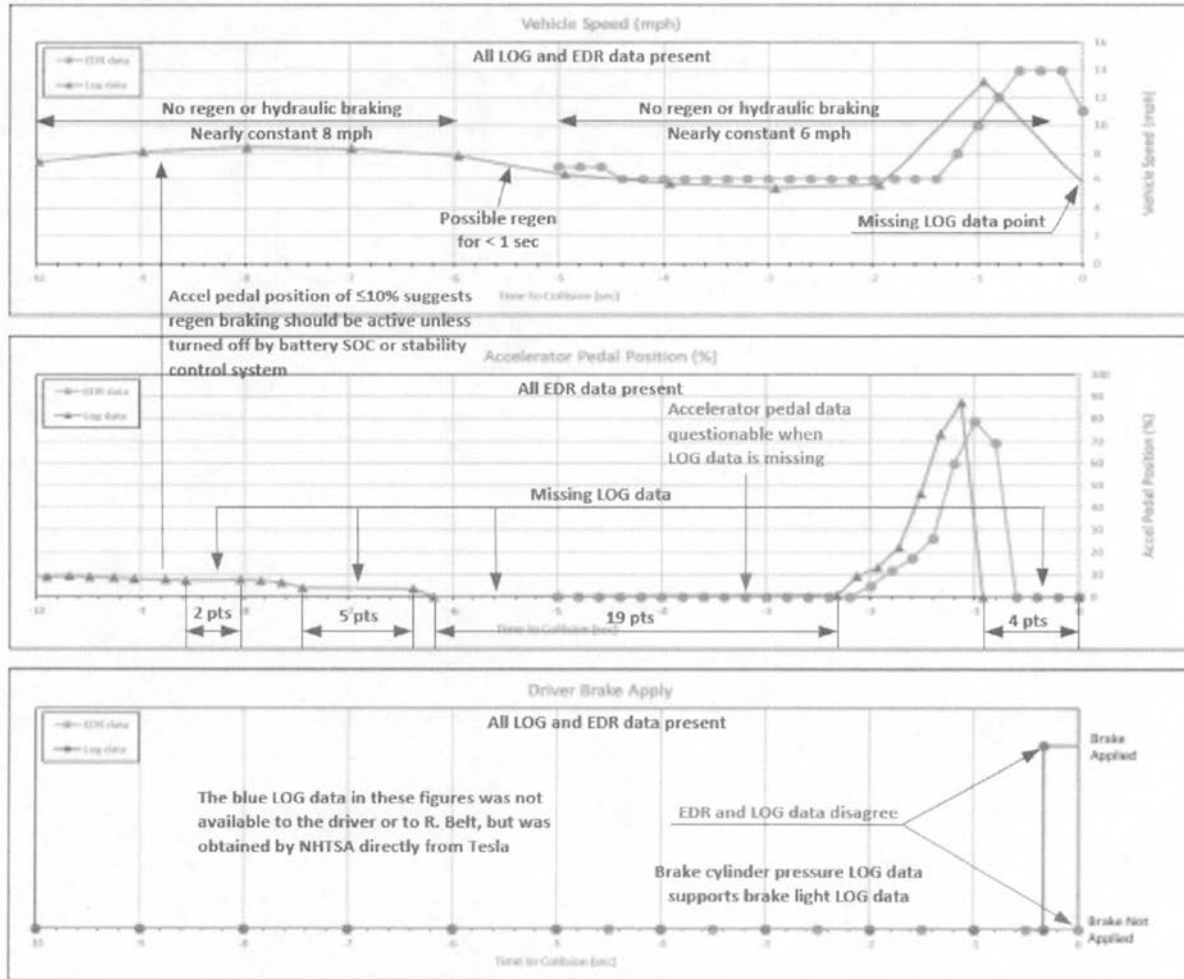
Figure 1. Data from NHTSA's denial of Brian Spark's petition of Jan 8, 2021, page 9.<sup>[2]</sup>

In Figure 1, notice that the blue vehicle LOG data for the vehicle speed and brake pedal data have no missing data values. Only the blue vehicle LOG data for the accelerator pedal % data has missing data values. Recall that we said earlier that we are unable to determine the cause of these missing accelerator pedal values because we cannot localize the source of these faults to specific nodes or CAN bus modules. However, we can localize the source of these faults if we bring in other valid data.

So let's assume that the cause of this missing accelerator pedal data in Figure 1 is the same as for Figures 5 and 6. Then, the cause of these missing accelerator pedal values is that the PMIC device in the motor controller is going into reset at these times. This assumption is supported by the durations of two of the intervals with missing data in Figure 1; namely one interval with five missing data points making it exactly one second long, and the other with nineteen missing data points making it very close to twenty seconds long or four one-second intervals. This explains the missing accelerator pedal data in Figure 1 because when the PMIC device goes into reset, the CAN transmitter in the motor controller loses its supply voltage, causing it to become inoperable. It also explains why the blue vehicle LOG data for the vehicle speed and brake pedal data have no missing data values, because these two types of data originate in a separate brake control module that has its own CAN transmitter and PMIC device that differ from the CAN transmitter and PMIC device in the motor controller module and that remain ON at all times.

Observe also in Figure 1 that a note says that the brown accelerator pedal EDR data is questionable when vehicle LOG data is missing. This note is included because the same CAN bus transmitter in the drive control module is used for the vehicle LOG data as for the EDR data. So when the PMIC device goes into reset to cause this CAN bus transmitter to become inoperable, it creates missing data to both the vehicle LOG and

the EDR. In the EDR, however, missing data in the incoming data stream does not cause missing data in the EDR. If an incoming EDR value is missing, then the current EDR value remains unchanged while writing into the EDR. This means that when a value  $P_{ti}$  is missing in the incoming data stream, the value stored in the EDR becomes  $P_{ti} = P_{ti-N}$  where  $N$  = the number of memory locations needed to store five seconds worth of  $P_{ti}$  data. Therefore, the EDR data will never have any missing data points. But some data points may be incorrect because they may repeat data that occurred five seconds earlier. In Figure 1, this means that the points in the EDR accelerator pedal % data between 5.0 seconds and 3.2 seconds, which correspond to missing points data in the vehicle LOG data caused by an inoperable CAN bus transmitter, likely occurred five seconds earlier (or more), placing them out of the figure.

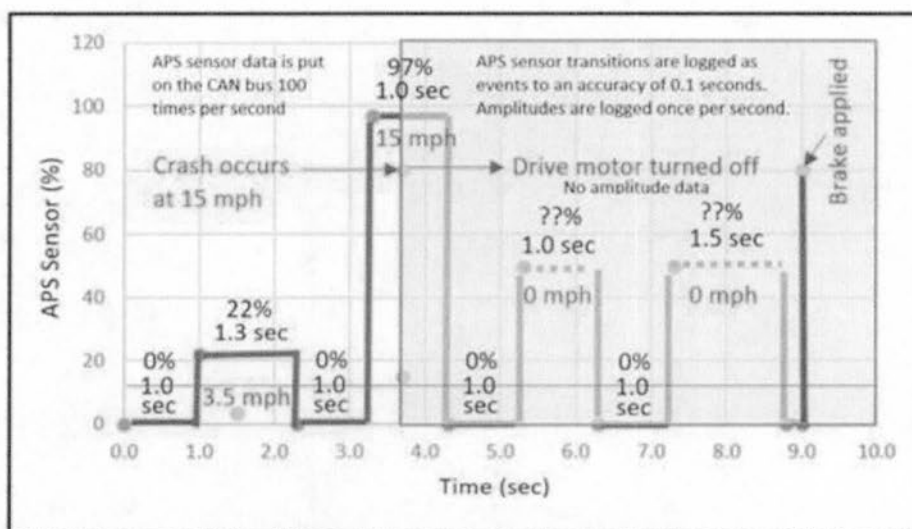
Figure 5. OTA LOG accelerator pedal % data for a sudden unintended acceleration incident as summarized in NHTSA's denial of Brian Sparks' petition. NHTSA states on p16 that "Dr. Belt's reconstruction imagines the APPS log data as a square wave ..." and on p17 that "ODI does not believe that Dr. Belt's reconstruction of the log data is accurate. The data log is not capable of recording a square wave with 1 Hz sampling rate of the APPS data." These statements by NHTSA falsely describe the data in Figure 5 above, which NHTSA could have found out by asking Dr. Belt for an explanation of this OTA LOG data, just as they asked Tesla to supply the LOG data for their report in Figure 1. Figure 6 below provides the explanation that would have been given to NHTSA had they asked.

- 5) There are two intervals of data after the crash for which the maximum values could not be determined by the Tesla engineer. It is believed that the Tesla engineer couldn't give the accelerator % pedal values for these two intervals in the OTA LOG data because the intervals contained no data values instead of just showing "0" values. This could happen if the data packets containing the % pedal values for these two intervals failed to get from the vehicle to the centrally located Tesla server that stores the OTA LOG data. This is explained in more detail in Appendices A and B.

Finally, the author had found a possible reason for why the OTA LOG data in Figure 5 had four intervals of 0% data that were exactly 1.0 seconds long. It was because the

In summary, the "0%" values in the four one-second long intervals of the OTA LOG data in Figures 5 and 6 are not caused by the accelerator pedal being released by the driver. Instead, they are caused by the preset memory values of zero on the SD card when pedal % values are missing in the data stream as it is being read into the SD card of the vehicle LOG, from which the OTA LOG data is obtained.

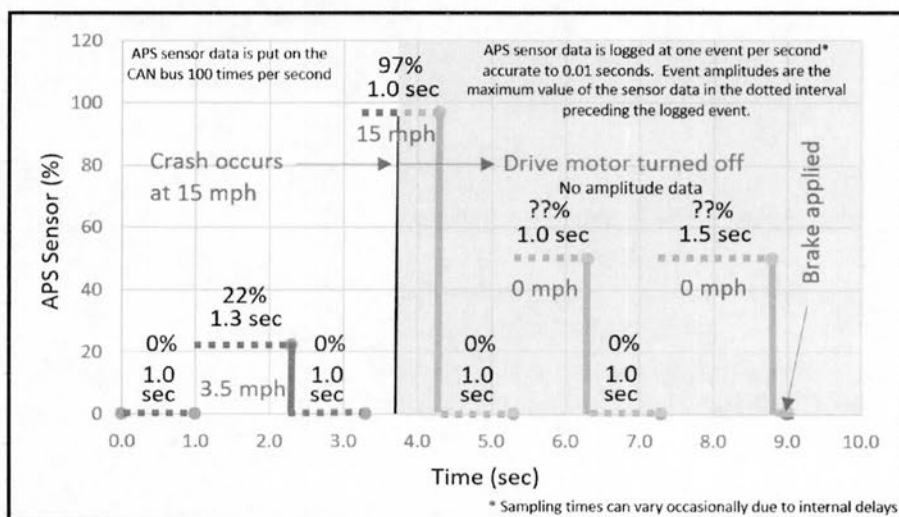
Figure 6. This figure shows the same OTA LOG data as in Figure 5, but with the graphics modified to clarify what the data represents. The APPS data in the OTA LOG is stored at one sample per second as shown by the blue dots in Figure 6. The timing of these dotted events is accurate to less than 0.1 second. Some intervals are longer than one second because the sampling times can vary due to internal delays. The amplitude for each dotted event is the maximum value of the sensor data in the interval before the

dotted event. This amplitude is represented by only one vertical line in Figure 6 instead of two vertical lines in Figure 5, to clarify that the maximum amplitude is associated with a single dotted event. The horizontal dashed lines preceding each dotted event indicate the interval from which the maximum value was obtained. They are included as an aid to the reader to show the length of each interval and the upper limit of all the sensor amplitudes within that interval. The dashed lines do not imply that all the sensor outputs within that interval have the same value, or that the sensor data is a square wave. Note that the horizontal dashed lines for two intervals after the crash are shown in red instead of blue. This is because their amplitudes could not be determined by Tesla. However, the start and end times of these two intervals could be determined from the time stamps associated with the zero-valued intervals on either side of the intervals with missing data.

- 1) The accelerator pedal % values for the last two “non-zero” intervals are completely missing because the cellular telephone data packets were not received by Tesla. This is why it was impossible for the Tesla engineer to give the maximum values for these intervals.

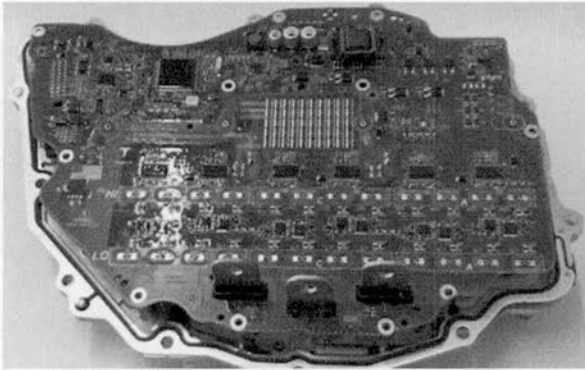
It is easy to see how the PMIC device can overheat to cause reset. Figure 7 shows the Tesla Model 3 inverter with the PMIC device circled in red near the upper left-hand corner of a rectangular-shaped resistor bank in the center of the inverter. This resistor bank can carry a heavy current at times which causes it to heat up to a high temperature. The heat can be so intense that Tesla engineers have covered the resistors with a compressible silicone heat spreader as shown in Figure 8 that provides a better heat-conductive path to the water-cooled aluminum chassis than the air path used for all other devices on the inverter. Clearly, Tesla engineers would not do this unless this resistor heating was a problem. And one problem is that the PMIC device has a short

conductive heat path to the resistor bank so that its temperature can exceed 85°C, causing it to reset.

Figure 7. Tesla Model 3 inverter showing resistor bank close to PMIC device circled in red.

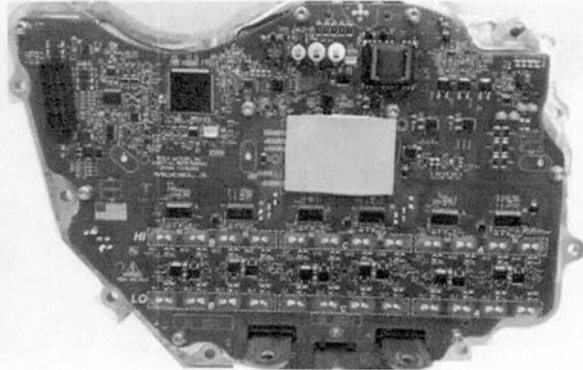
Figure 8. Resistor bank requires a silicone pad to improve heat conduction to the water-cooled chassis.
