## **Motor Vehicle Defect Petition to Recall All Tesla Vehicles Due to Sudden Unintended Acceleration**

24 April 2025

ODI — DP.23-002

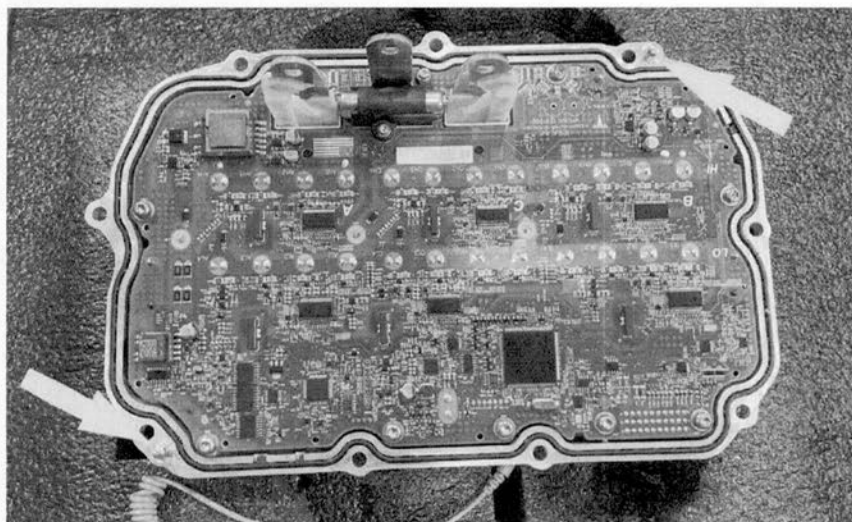
- 4) The new Tesla Model Y inverter board is shown in Figure 1. Notice that it does not have a braking resistor bank covered by a silicone heat spreader. This suggests that Tesla engineers may be aware of the fact that heat from the braking resistor can cause an increase in the junction temperature of TLF35584 PMIC

device, which is still used in this new design.<sup>[Footnote 2]</sup> Tesla may claim that the braking resistor was removed for other reasons, such as reducing the board size. However, if this claim of board size reduction were valid, it would have been applied to the original Model 3 inverter board as well. But in that case the braking resistor was left on the board.

Figure 1. The newer Model Y inverter board has no braking resistor.

- 5) A simple way to prevent the TLF35584 PMIC device on the Model 3 inverter board from going into reset by exceeding the junction temperature is to put a silicone heat spreader directly on the TLF35584 PMIC device itself, just like the one on the braking resistor. If this is so simple, then why doesn't Tesla do this? The answer may be that this would make it obvious to all concerned that Tesla knows that PMIC device heating is a problem. This would almost certainly lead to a mandatory recall to add the heat spreader to the PMIC in all Tesla Model 3 vehicles. This recall would drain Tesla's financial resources because it would require opening up the inverter housing on all Tesla Model 3's currently on the road. It would also risk losing many court cases for unintended acceleration caused by the reset of the TLF35584 PMIC device. Therefore, it is better for Tesla to not modify the Model 3 inverter boards, and to claim ignorance of, or even deny the fact that, reset of the TLF35584 PMIC device can occur that may lead to unintended acceleration.
